Reliability assessment and system performance improvement of ORV *Sagar Nidhi* propulsion system

National Institute of Ocean Technology, Ministry of Earth Sciences, Chennai 600 100, India

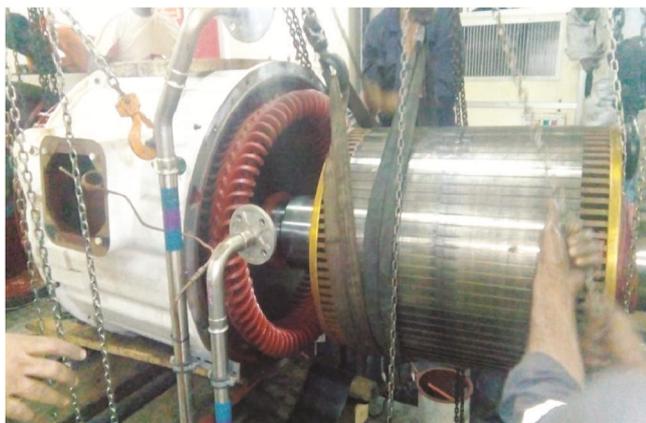
Figure 2. Loose coils in slot.

The failure of the motor is due to degradation of winding over nine years of continuous operation. Being a research vessel, *Sagar Nidhi* was kept in DP mode more frequently which resulted in sudden load change on motor. It was also observed that starboard thruster motor has more running hours compared to Port Azimuth motor. The root cause¹ and inference are mentioned below.

- (d) Inference: The motor fault could have been incipient in nature initially which could have been matured into a multiple earth fault, during the time ACB tripped.

Cooler unit was dismantled and visual inspections were carried out. It was decided to dismantle the motor and accordingly rotor was removed for inspection. It was found that few wedges were missing in stator slot, which may have led to zero insulation in winding. It was inferred that the failure is due to degradation of winding². It was found that the lead time for supply of new motor is around ten months and three months for carrying out rewinding of stator. Damaged winding were taken out from the slots and special insulation tape was wrapped on the winding. New wedges were fixed on the slots wherever necessary. Complete re-varnishing was done in order to improve insulation of the winding. Megger test in 1000 V (ref. 3) mode was carried out and it was found that the insulation has improved to 6 Giga ohms.

After completion of standard repair procedure, the motor was re-assembled and it was tested under no load condition with 400 to 500 revolutions per minute (RPM) prior sea trials. The speed of motor gradually increased up to 810 RPM (ref. 4) and it was observed that all parameters were normal. Upon completion of no load test, the motor was assembled to thruster unit. Sea trial was carried out for 6 h with different speeds initially and at full speed for one hour. The above repair work and sea trials were conducted under the supervision of surveyors from Indian Registry of Shipping (IRS) and Det Norske Veritas (DNV). Though the work was completed successfully, the reliability of propulsion system remained the same

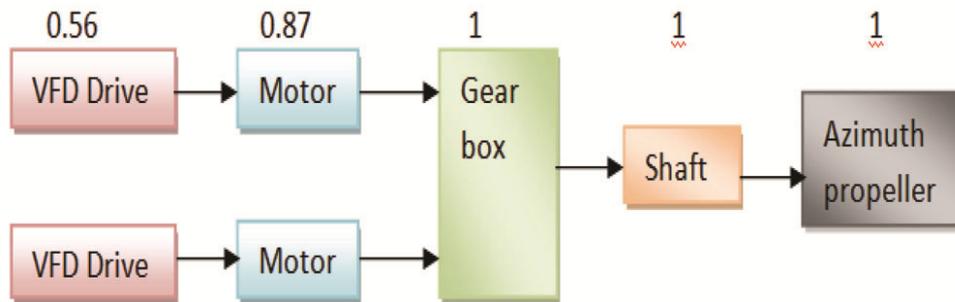
Figure 3. Proposed system reliability.

$$R_{\text{NEW SYSTEM}} = 1 - [(1 - 0.568) \times (1 - 0.878)] = 0.947.$$

The reliability of proposed propulsion system which is shown in Figure 3, has increased to 94.7% which is helpful for *Sagar Nidhi* to accomplish the critical scientific and technology demonstration operations.

(a) Redundant motor and drive in parallel configurations resulted in increasing reliability to 94.7% from the current value of 22%.

(b) It is recommended to have a motor and drive in parallel configuration compared to series configuration and dual stator configurations which resulted in increase of reliability value.
