CAUSTIC EMBRITTLEMENT OF BOILER PLATE AND RIVET STEEL

B. R. NIJHAWAN

Assistant Director, National Metallurgical Laboratory, Council of Scientific and Industrial Research, Jamshedpur (India)

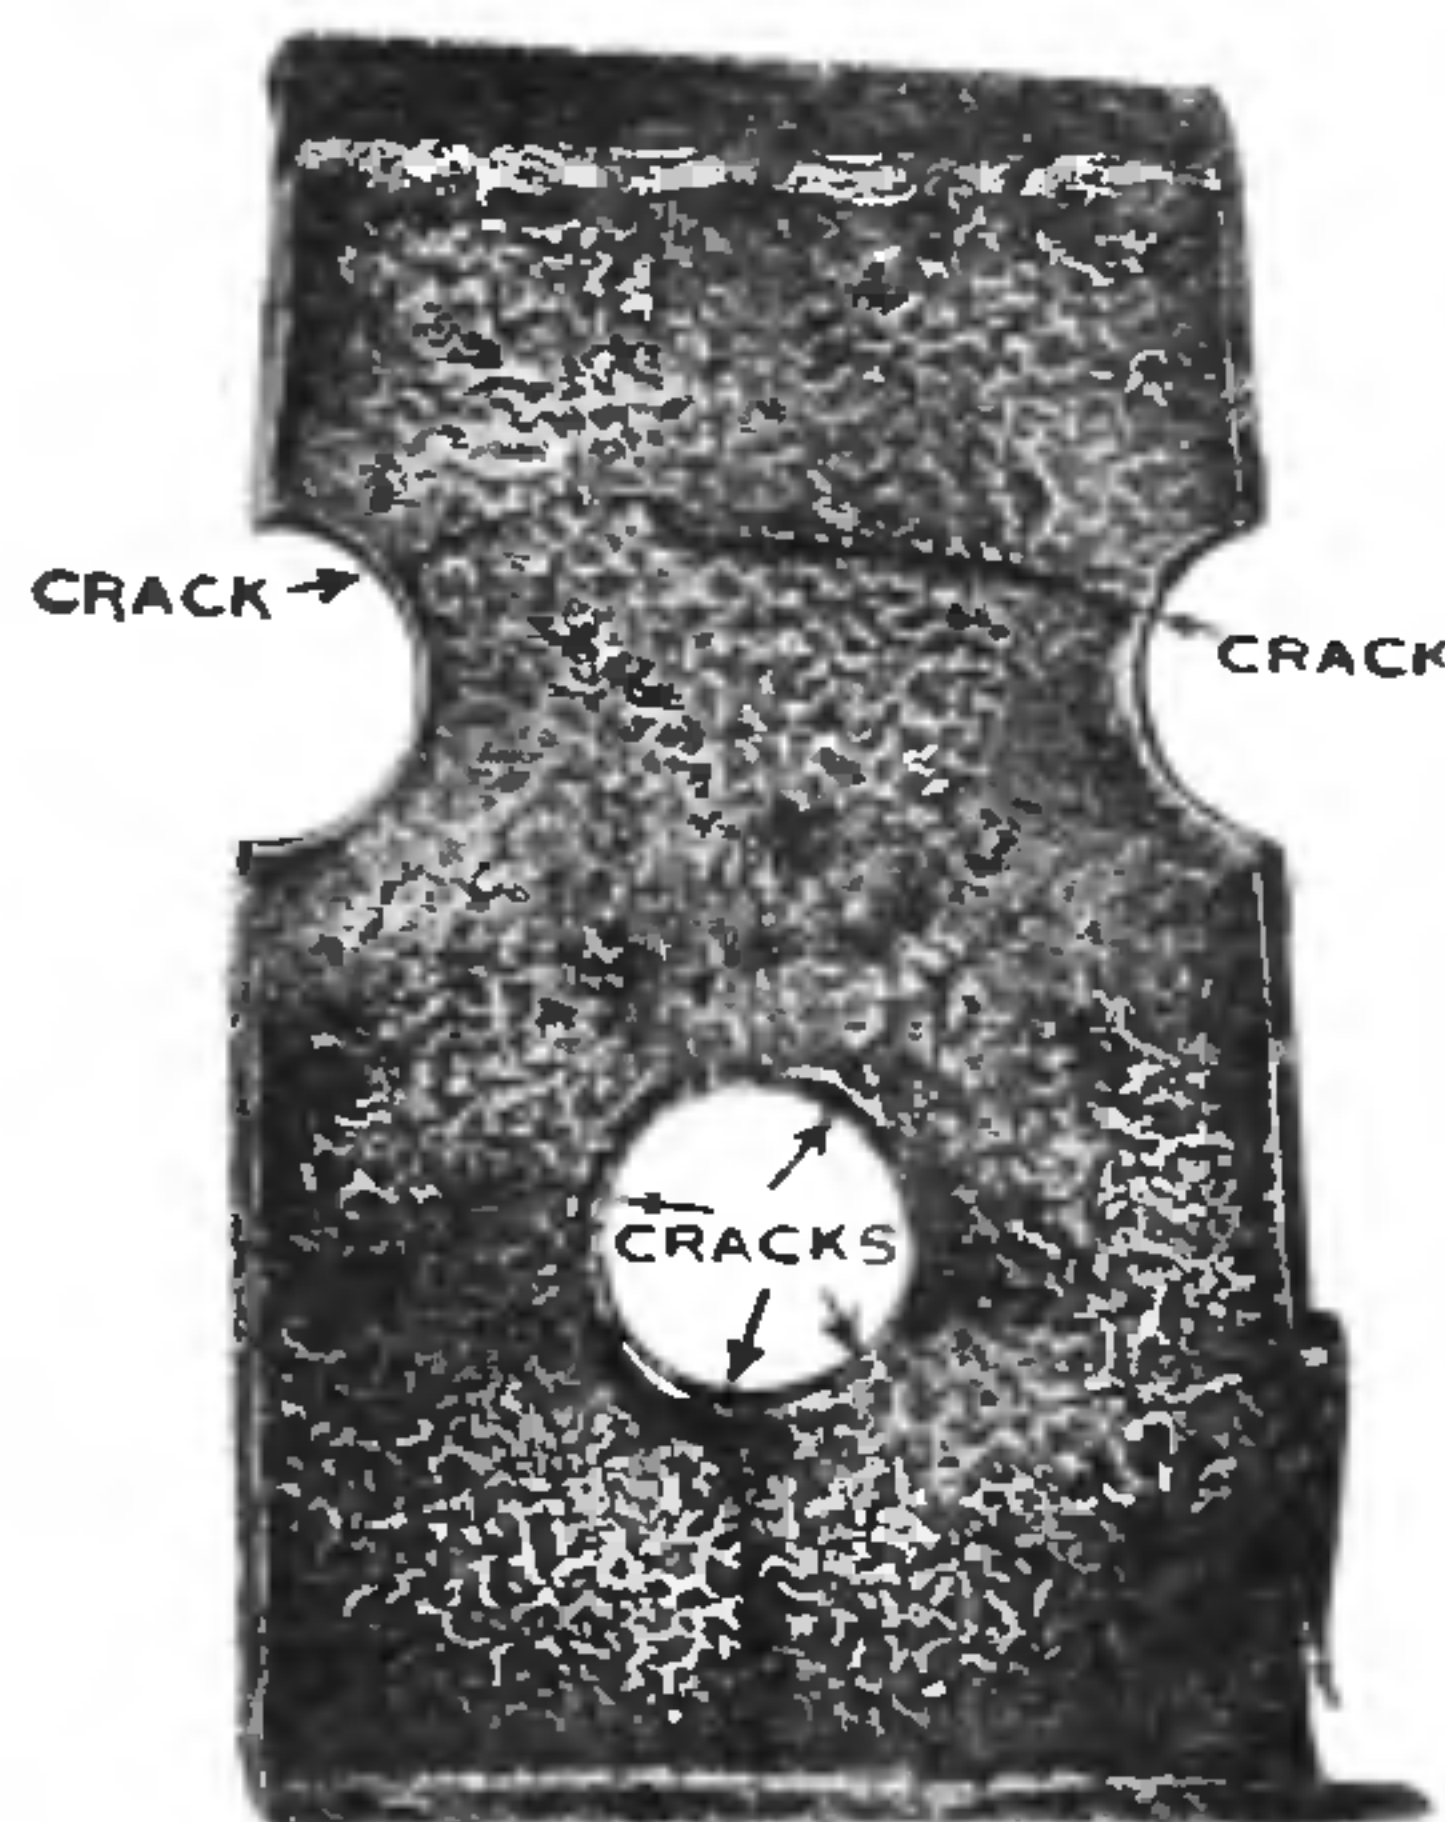
FIG. 1

In one case cracks were observed to have started from the rivet hole, extending into the interior of the plate as shown in Fig. 1. Fig. 2 shows the crack starting from the edges of a rivet hole at the joint between

Cracked Boiler Plate showing caustic-embrittlement cracks starting from rivet-hole edge

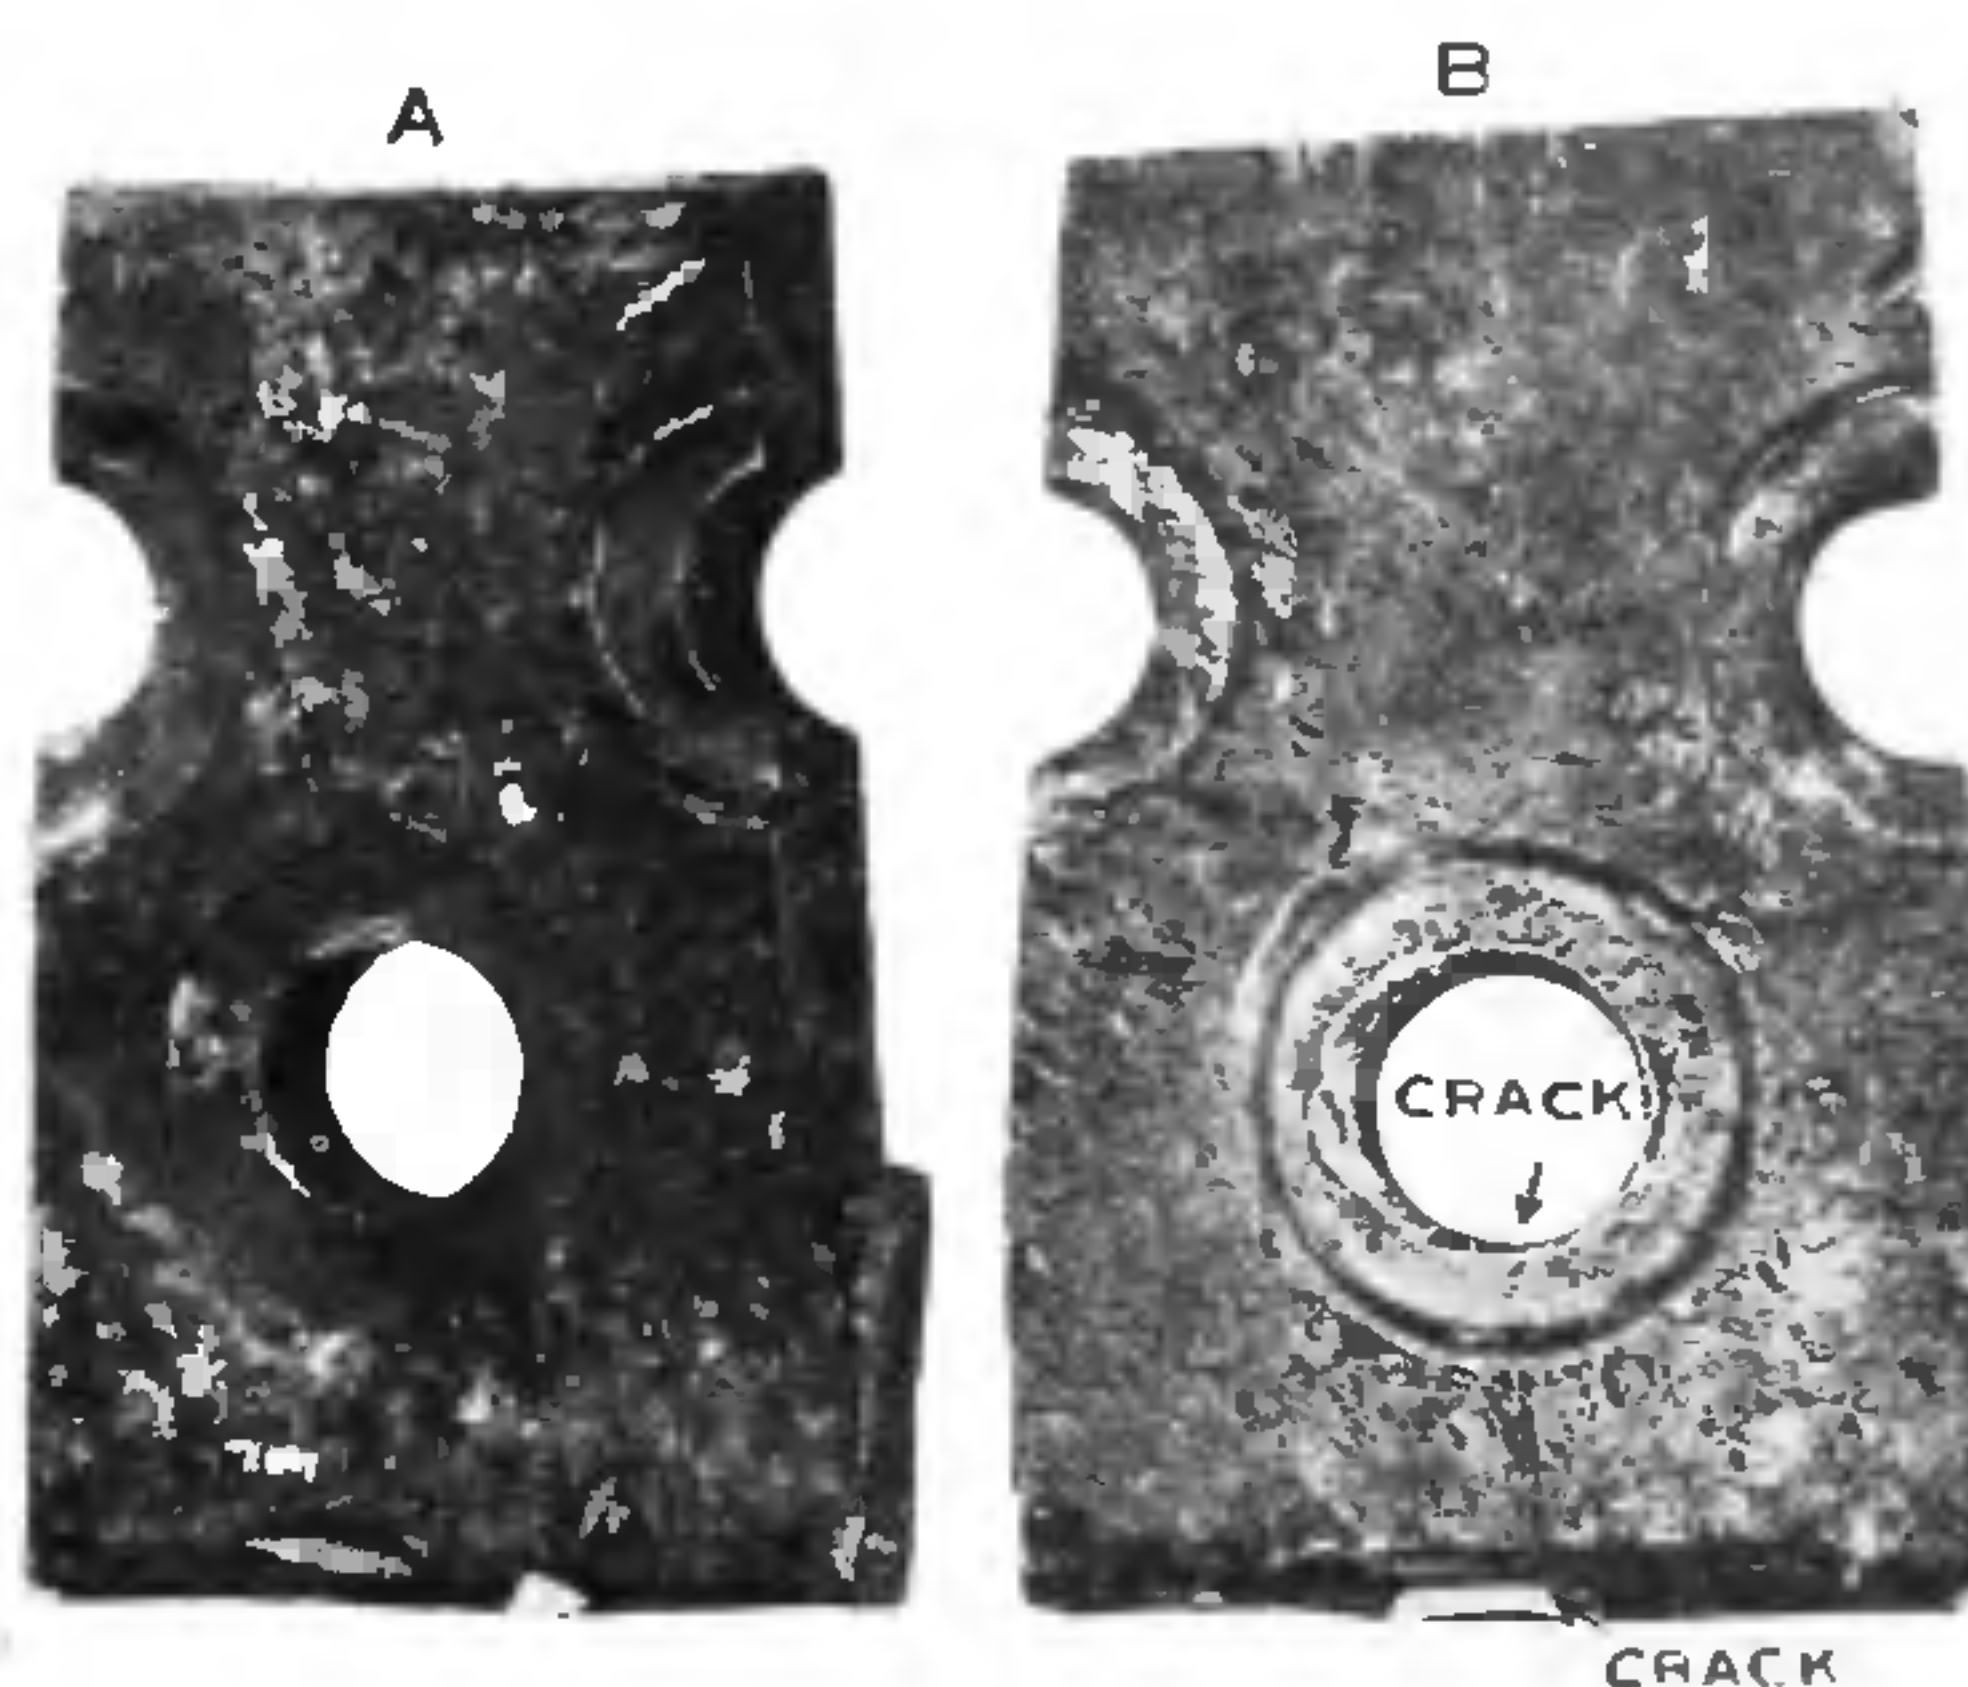
FIG. 2

the boiler plates. Evidence of excessive rivetting pressure was left on the boiler plate in the form of deep circular indentations around the rivet holes made by the snap during rivetting as shown in Fig. 2. Deposits of reddish brown scale consisting of magnetic oxide of iron were observed in the crevices and at the contact surfaces of the lap joints from where pittings and several incipient cracks were observed to radiate. The reaction that takes place at the joints is:— $3\text{Fe} + \text{NaOH} + 4\text{H}_2\text{O} \rightarrow \text{Fe}_3\text{O}_4 + \text{NaOH} + 4\text{H}_2$.

Cracked Boiler Plate showing fine cracks and deep circular indentations around rivet holes

The inter-crystalline nature of the cracks starting from the edges of the rivet holes was definitely established by microscopic examination — a phenomenon associated with caustic embrittlement of boiler plates. That there was apparently leakage of water contents of the water in the capillaries of the imperfect and leaky rivet joints where the boiler feed water could not circulate freely, was evident from the deposition of solids at the plate joints and in the crevices. The boiler plate around the rivet-holes had been damaged through bad riveting as depicted in Fig. 2 showing deep circular indentations around the rivet holes made by the snap during riveting. This had

not only damaged the boiler plate, distorted the rivets and the rivet-holes, thereby causing an imperfect and leaky joint to develop but also had left the joints and seams in a state of severe stress—one of the essential causes of caustic embrittlement and cracking of boiler plates at the rivet joints. Such cracking of the boiler plates has always been known to be inter-crystalline in nature and micro-examination of the cracked regions of the boiler plate in the present case corroborated the inter-crystalline failure of the metal. The boiler water, judged from its chemical analysis, was probably not of an embrittling character although the controversy around the chemical analysis of embrittling and non-embrittling types of boiler waters, is still far from settled in the technical literature.

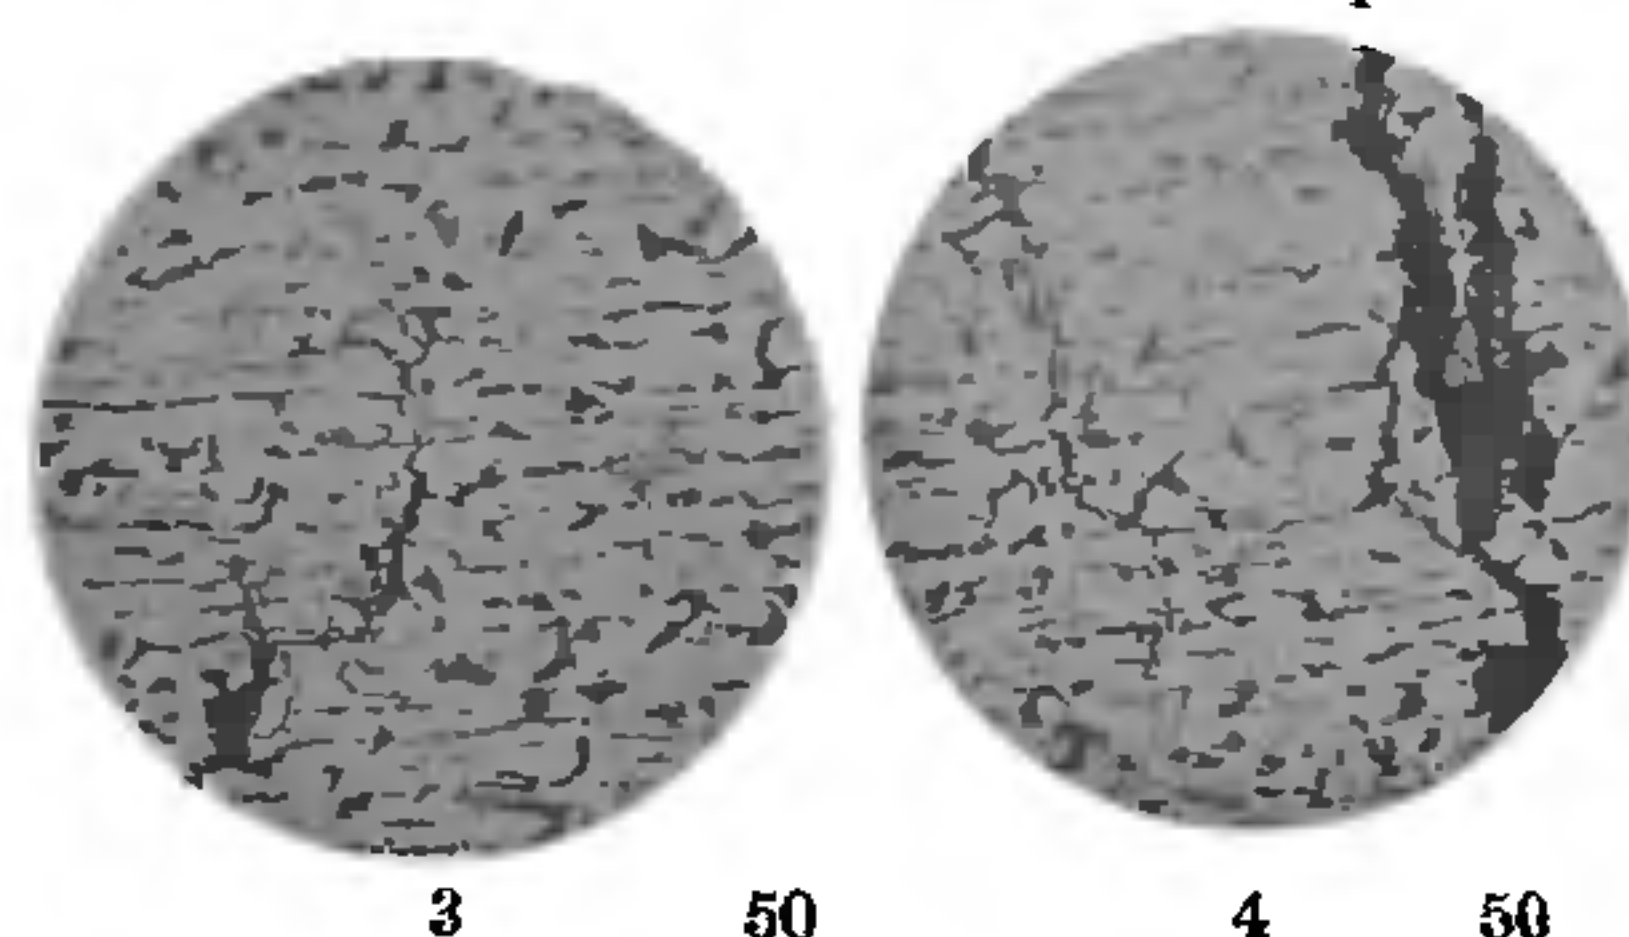
FIGS. 3 & 4

Microscopic Examination.—Section taken from near the cracked areas of the plate showed the normal fine-grained Sorbo-Pearlite and ferrite structures. Radial cracks starting from the edges of the rivet holes were observed. The main cracks had

considerably opened out through corrosion. Several branching cracks were also observed. The branching cracks were observed in every case to be inter-crystalline as depicted in photo-micrographs Nos. 3 and 4. The main cracks had in most cases extended out to either side of the plate.

Showing micro-structure of the Boiler Plate and inter-crystalline caustic embrittlement cracks

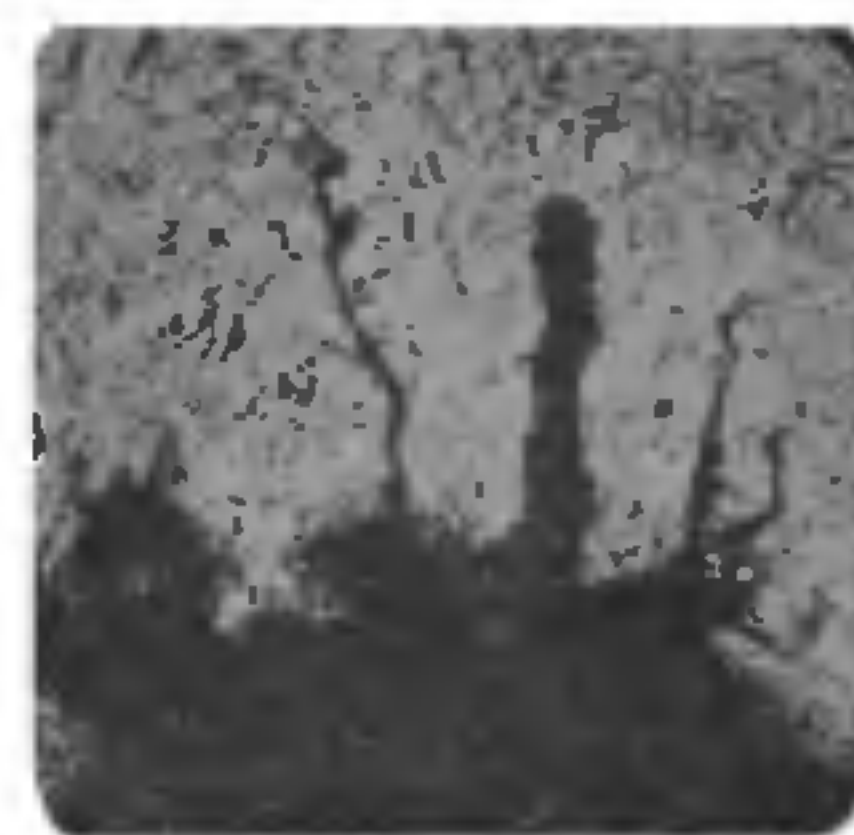
FIG. 5

Macro Examination.—Sulphur Print taken on a longitudinal section of the plates failed to reveal any abnormality. Macro-etching of the same sample showed satisfactory structure. Sulphur Print taken on the longitudinal section of one of the rivets showed freedom from sulphur segregation. On macro-etching some of the rivets, fine circumferential cracks were revealed on the undersurface of the rivet heads near the junction of the shank and head as shown in Fig. 5. Macro-structure of the rivets appeared to be satisfactory.

Circumferential cracks in the boiler rivet at the junction of the shank head—considerably opened out through corrosion

In the present case the caustic embrittlement of the boiler plate appeared probably, to be due to the rivet joints and seams having been in a state of stress by riveting which through damaging the plate, distorting the rivets and rivet-holes, had formed a leaky and imperfect joint. This caused leakage of water and consequent concentration and deposition of the mineral contents of the water and oxides of iron therein at normal boiler temperatures. Due to the same causes, the rivets had also developed cracking as shown in Fig. 5.

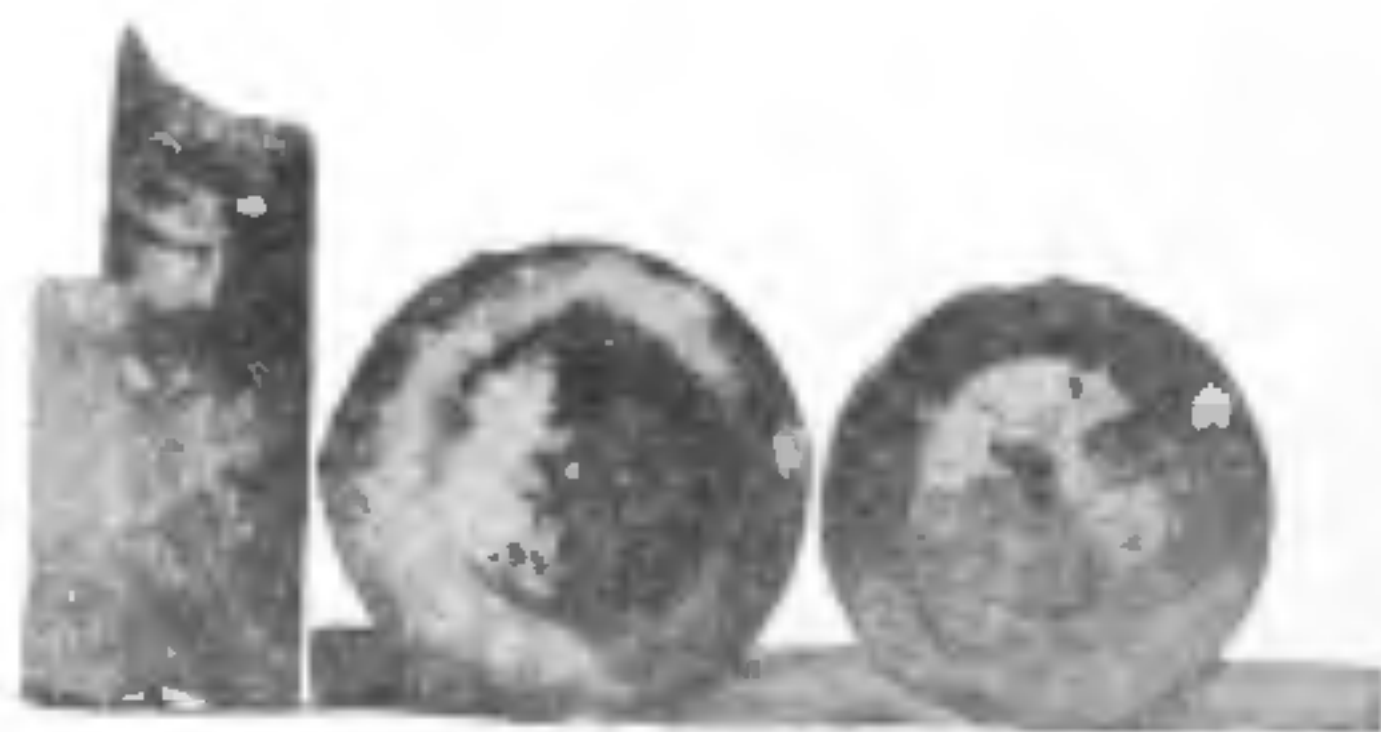
FIG. 6

Another case of caustic embrittlement of the boiler rivets showed whitish-brown alkaline deposits at the area of contact between the rivet head and the boiler plate as shown in Fig. 6. In this case the rivet-heads were severed off from the shank through caustic embrittlement of the rivets. The chemical composition as well as the quality of the steel of the rivet was quite normal.

Whitish-brown alkaline deposits at the underside of the rivet heads

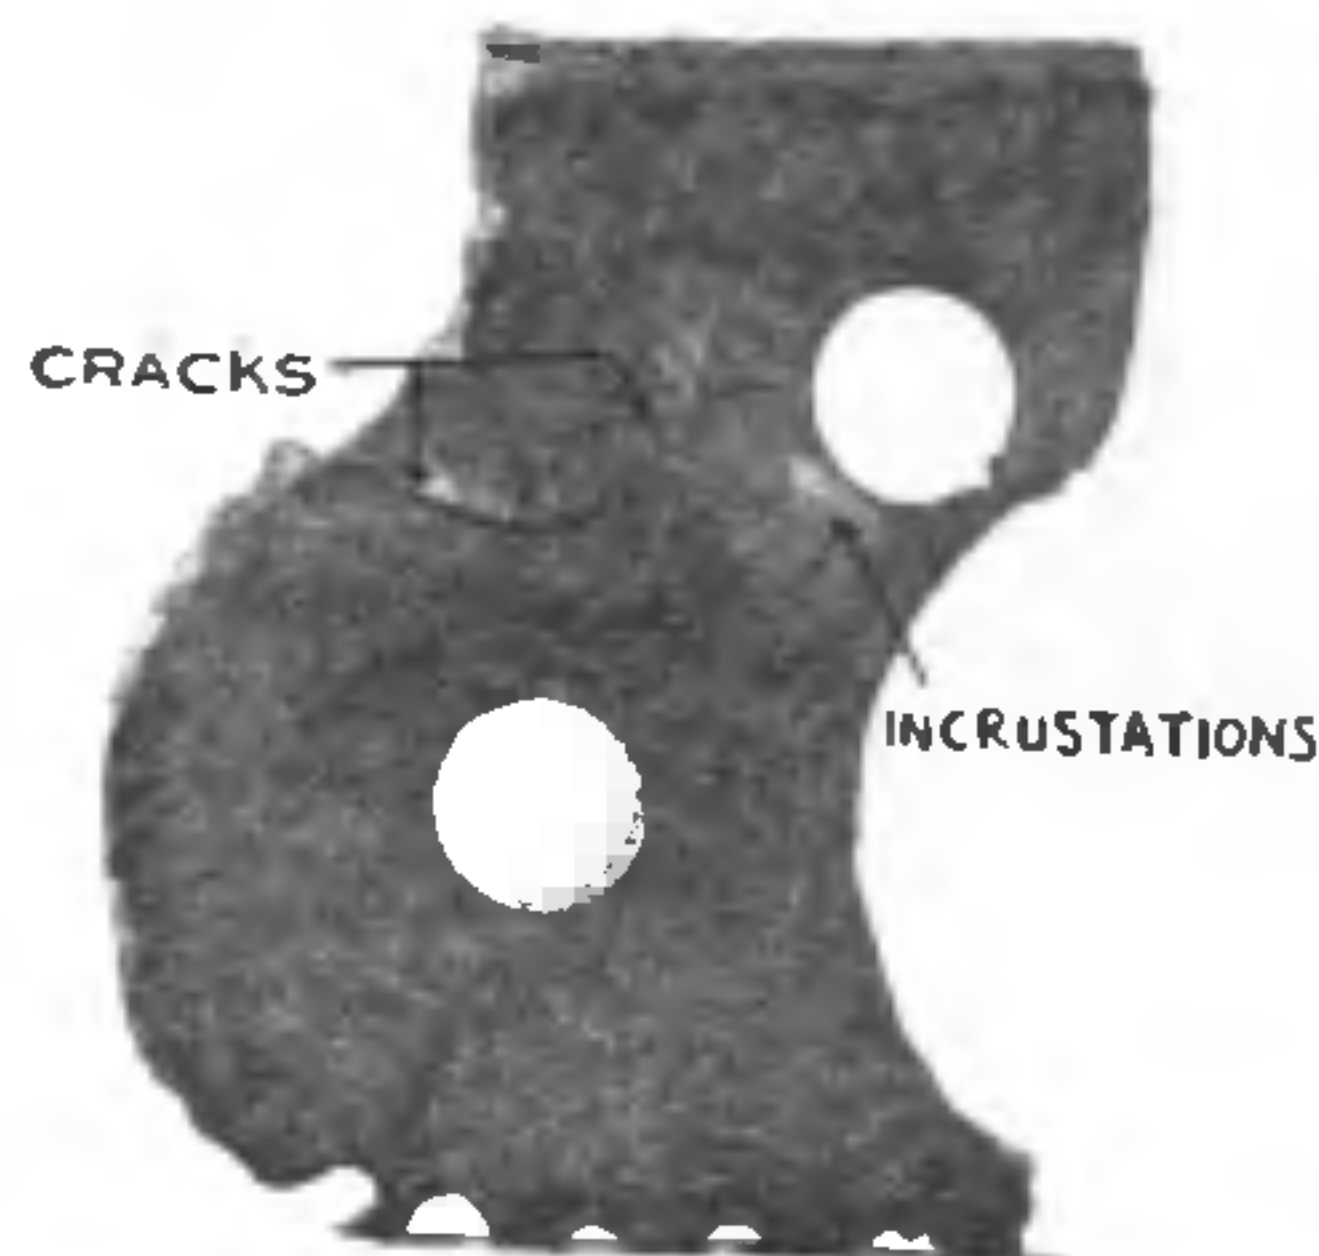
FIG. 7

Another case of caustic embrittlement cracking of the boiler plate showed the formation of cracks from rivet-holes and whitish incrustation on the plate as depicted

Showing caustic embrittlement cracks at the rivet holes and whitish incrustations on the plate's surface

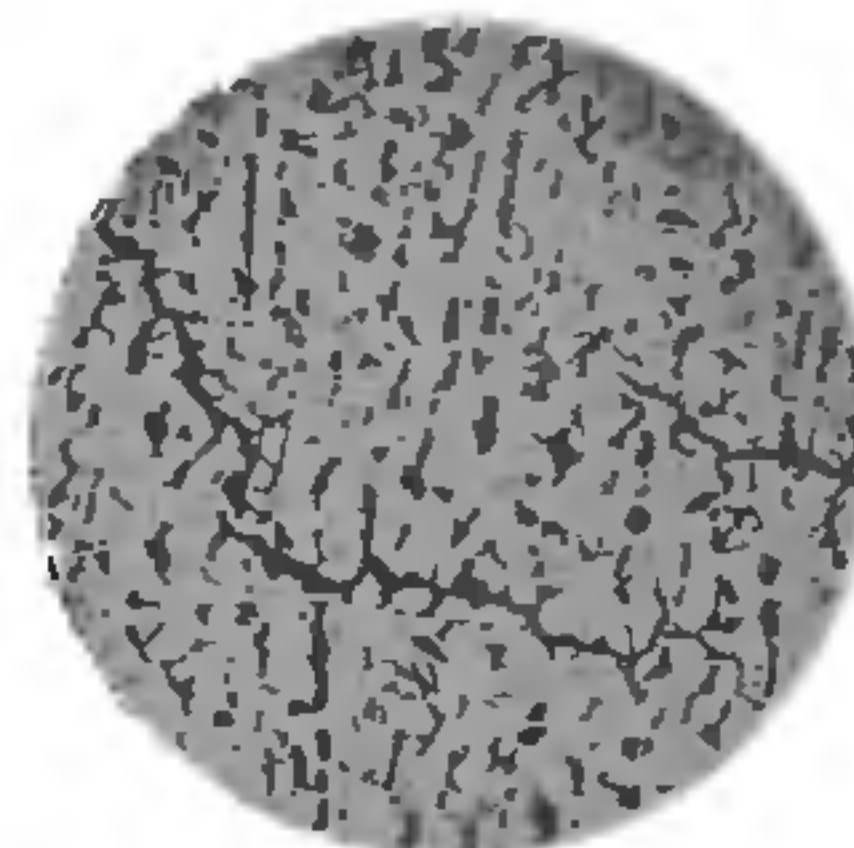
FIG. 8

in Fig. 7. The cracks on microscopic examination showed their inter-crystalline nature as shown in Micro-photograph 8. The boiler-plate steel was of sound

Showing intercrystalline cracking in Boiler Plate owing to caustic embrittlement

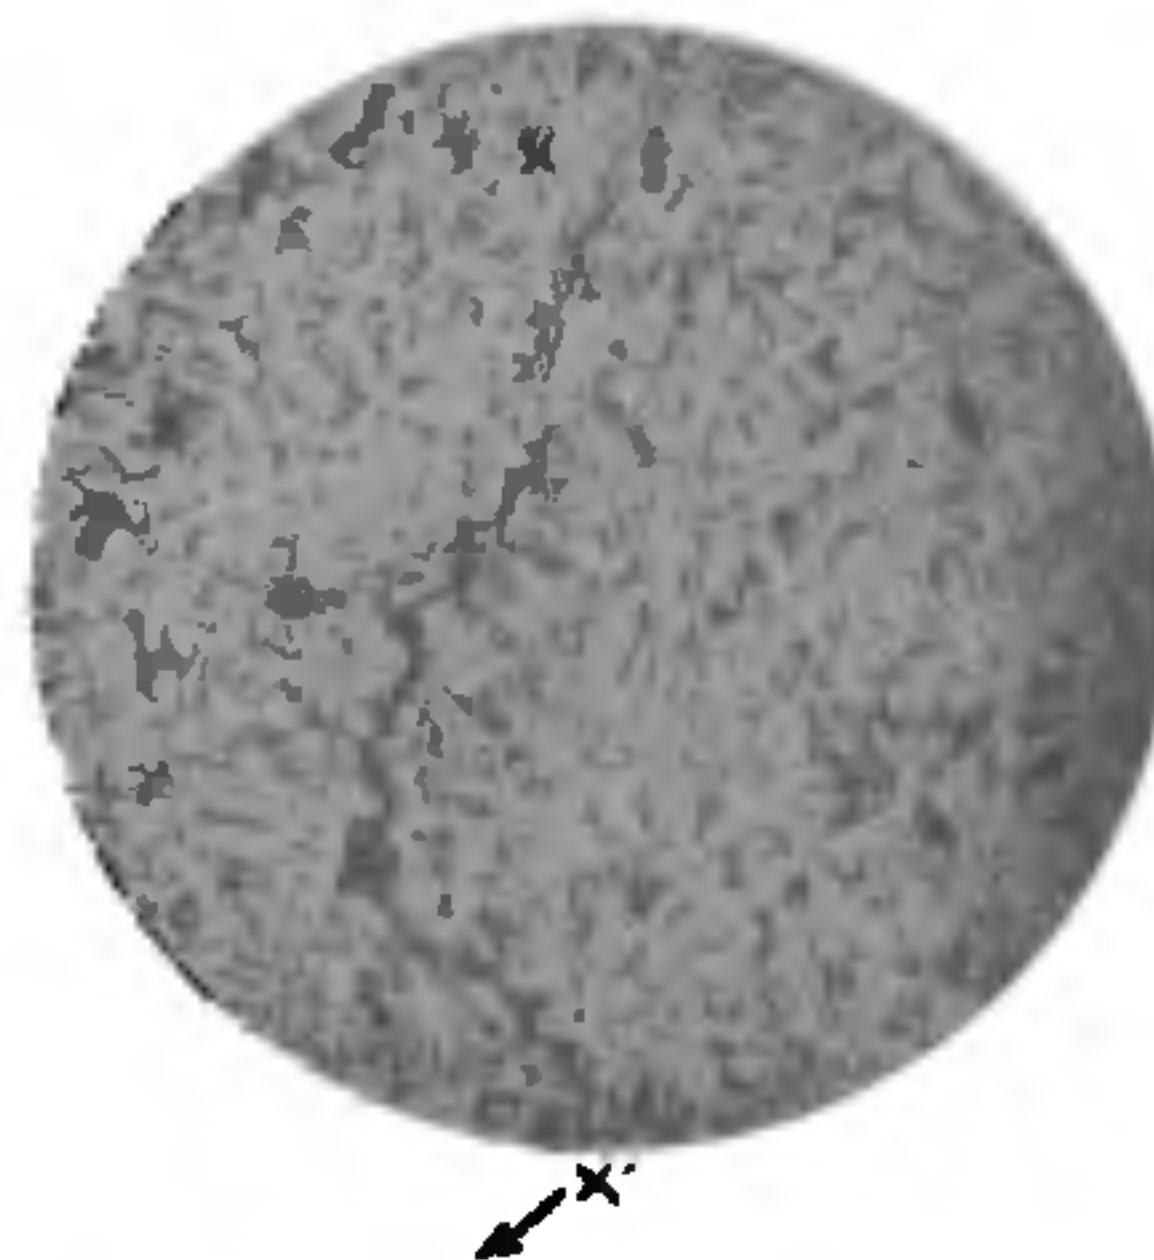
FIG. 9

Inter-crystalline cracking in boiler rivets due to caustic embrittlement

XX' shows the path of the crack.

In another similar case of boiler-rivet failure inter-crystalline cracking and whitish alkaline deposits at the rivet heads are depicted in Figs 9 and 10. The rivet steel itself gave excellent properties on physical and metallurgical tests. Its chemical composition conformed to I.R.S. specification No. -M7-39 for boiler quality rivets.

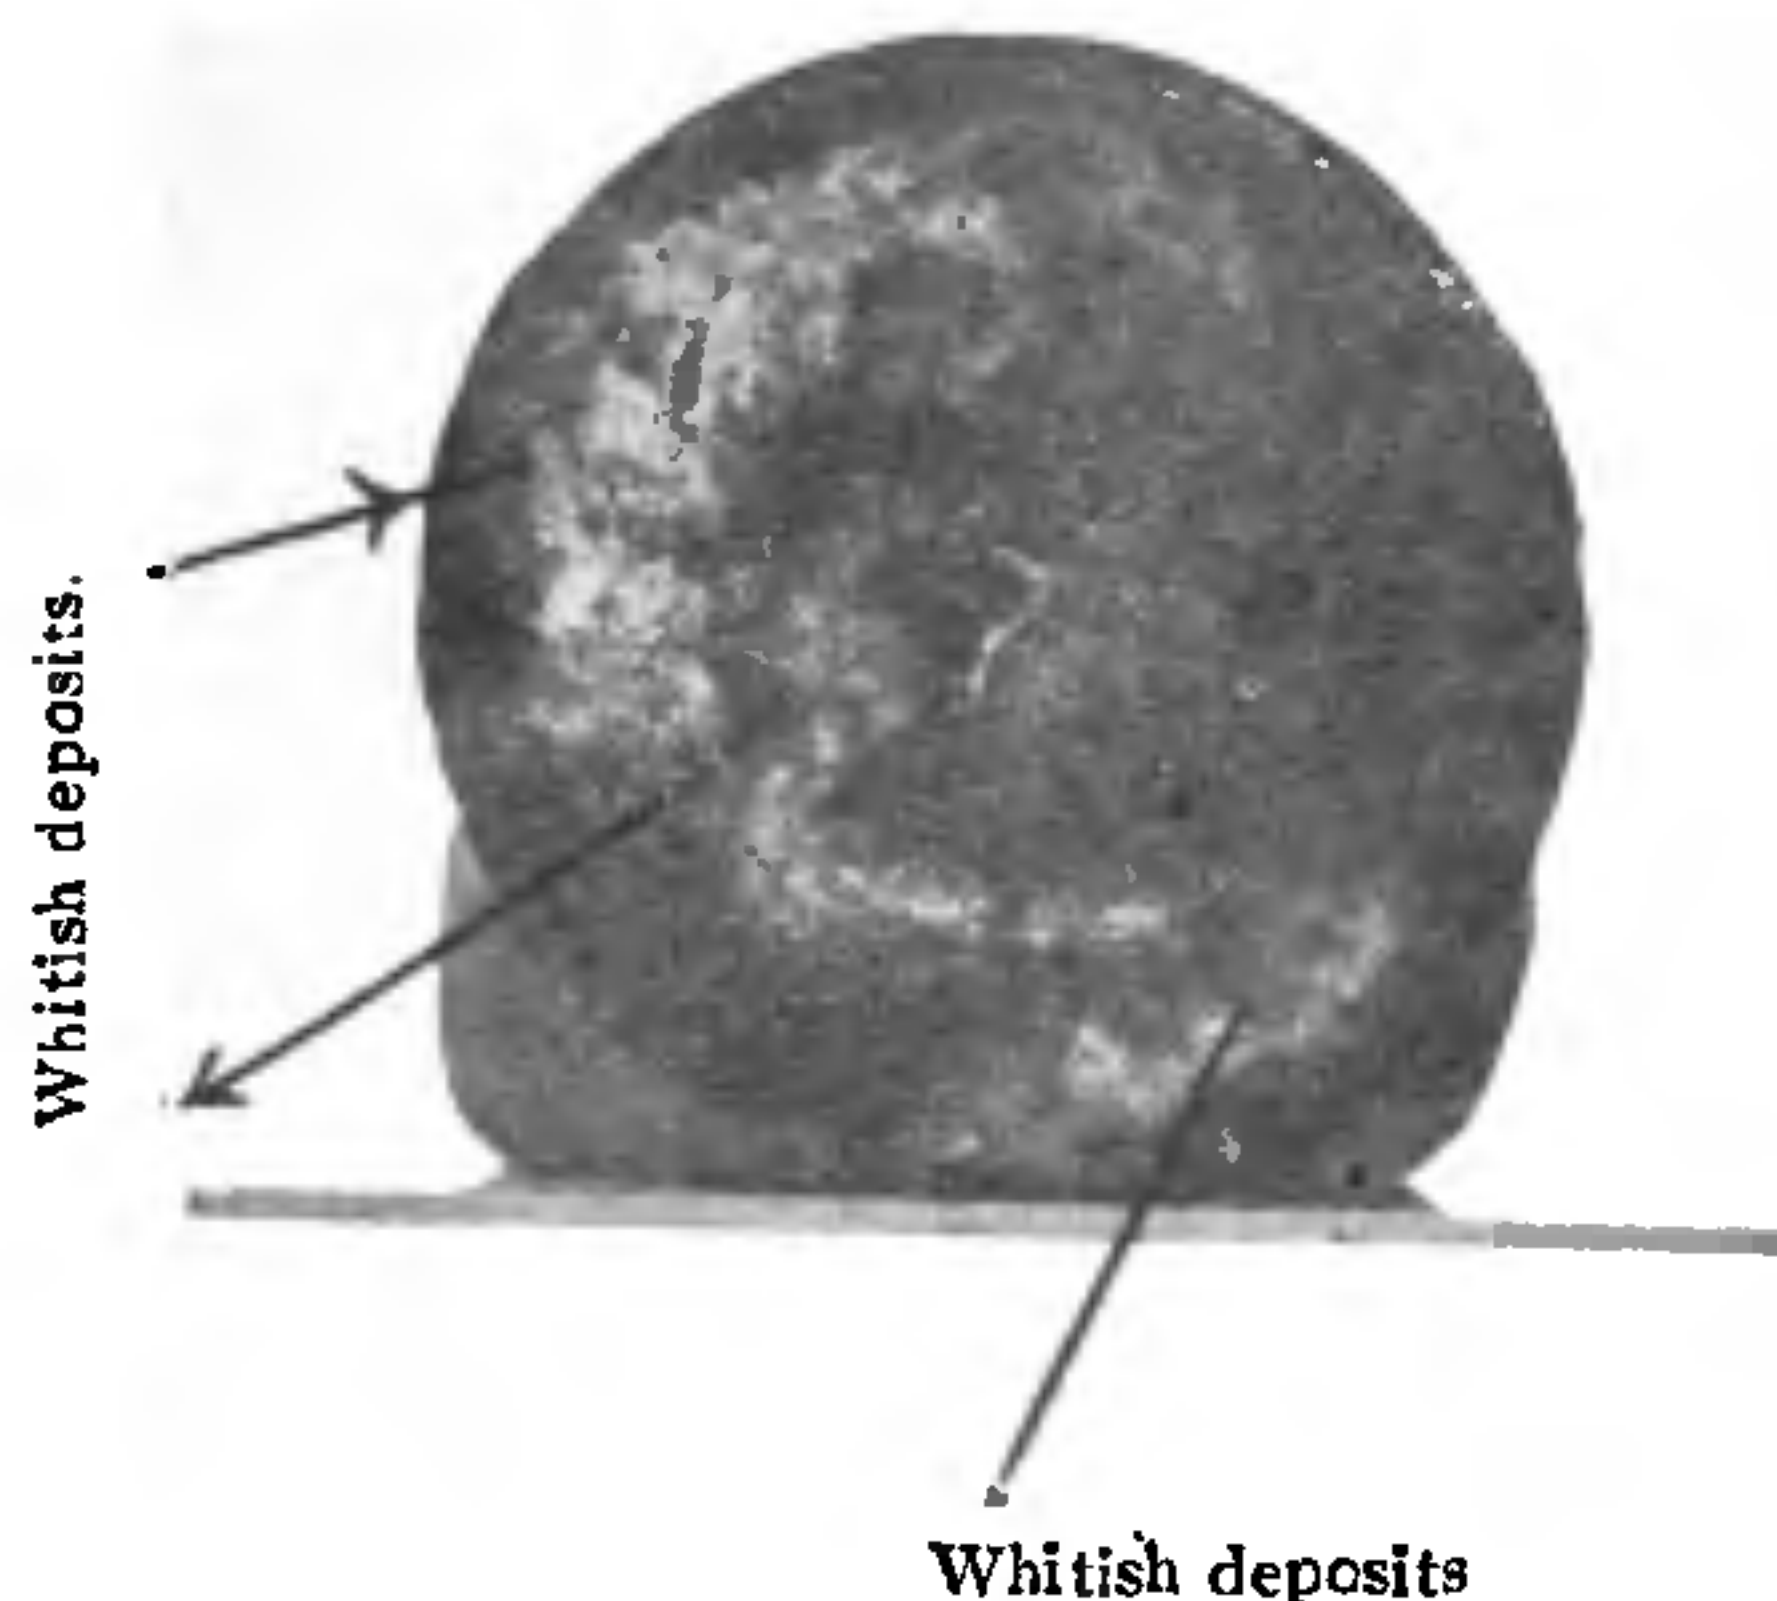
FIG 10

Whitish alkaline deposits at the rivet head
