Field investigation of the 30 September 1993 earthquake in Maharashtra

R. N. Iyengar*, C. S. Manohar and O. R. Jaiswal

Department of Civil Engineering, Indian Institute of Science, Bangalore 560 012, India

An engineering field study of the 30 September Marathwada earthquake is reported. The study covered Osmanabad, Latur, Sholapur, Bijapur, Gulbarga and Bidar districts. The level of ground acceleration was estimated based on tilting of free standing objects. The study shows that the epicentral intensity has been VIII on the UNESCO scale. The horizontal ground acceleration near the epicentre has been estimated to be about 0.2 g.

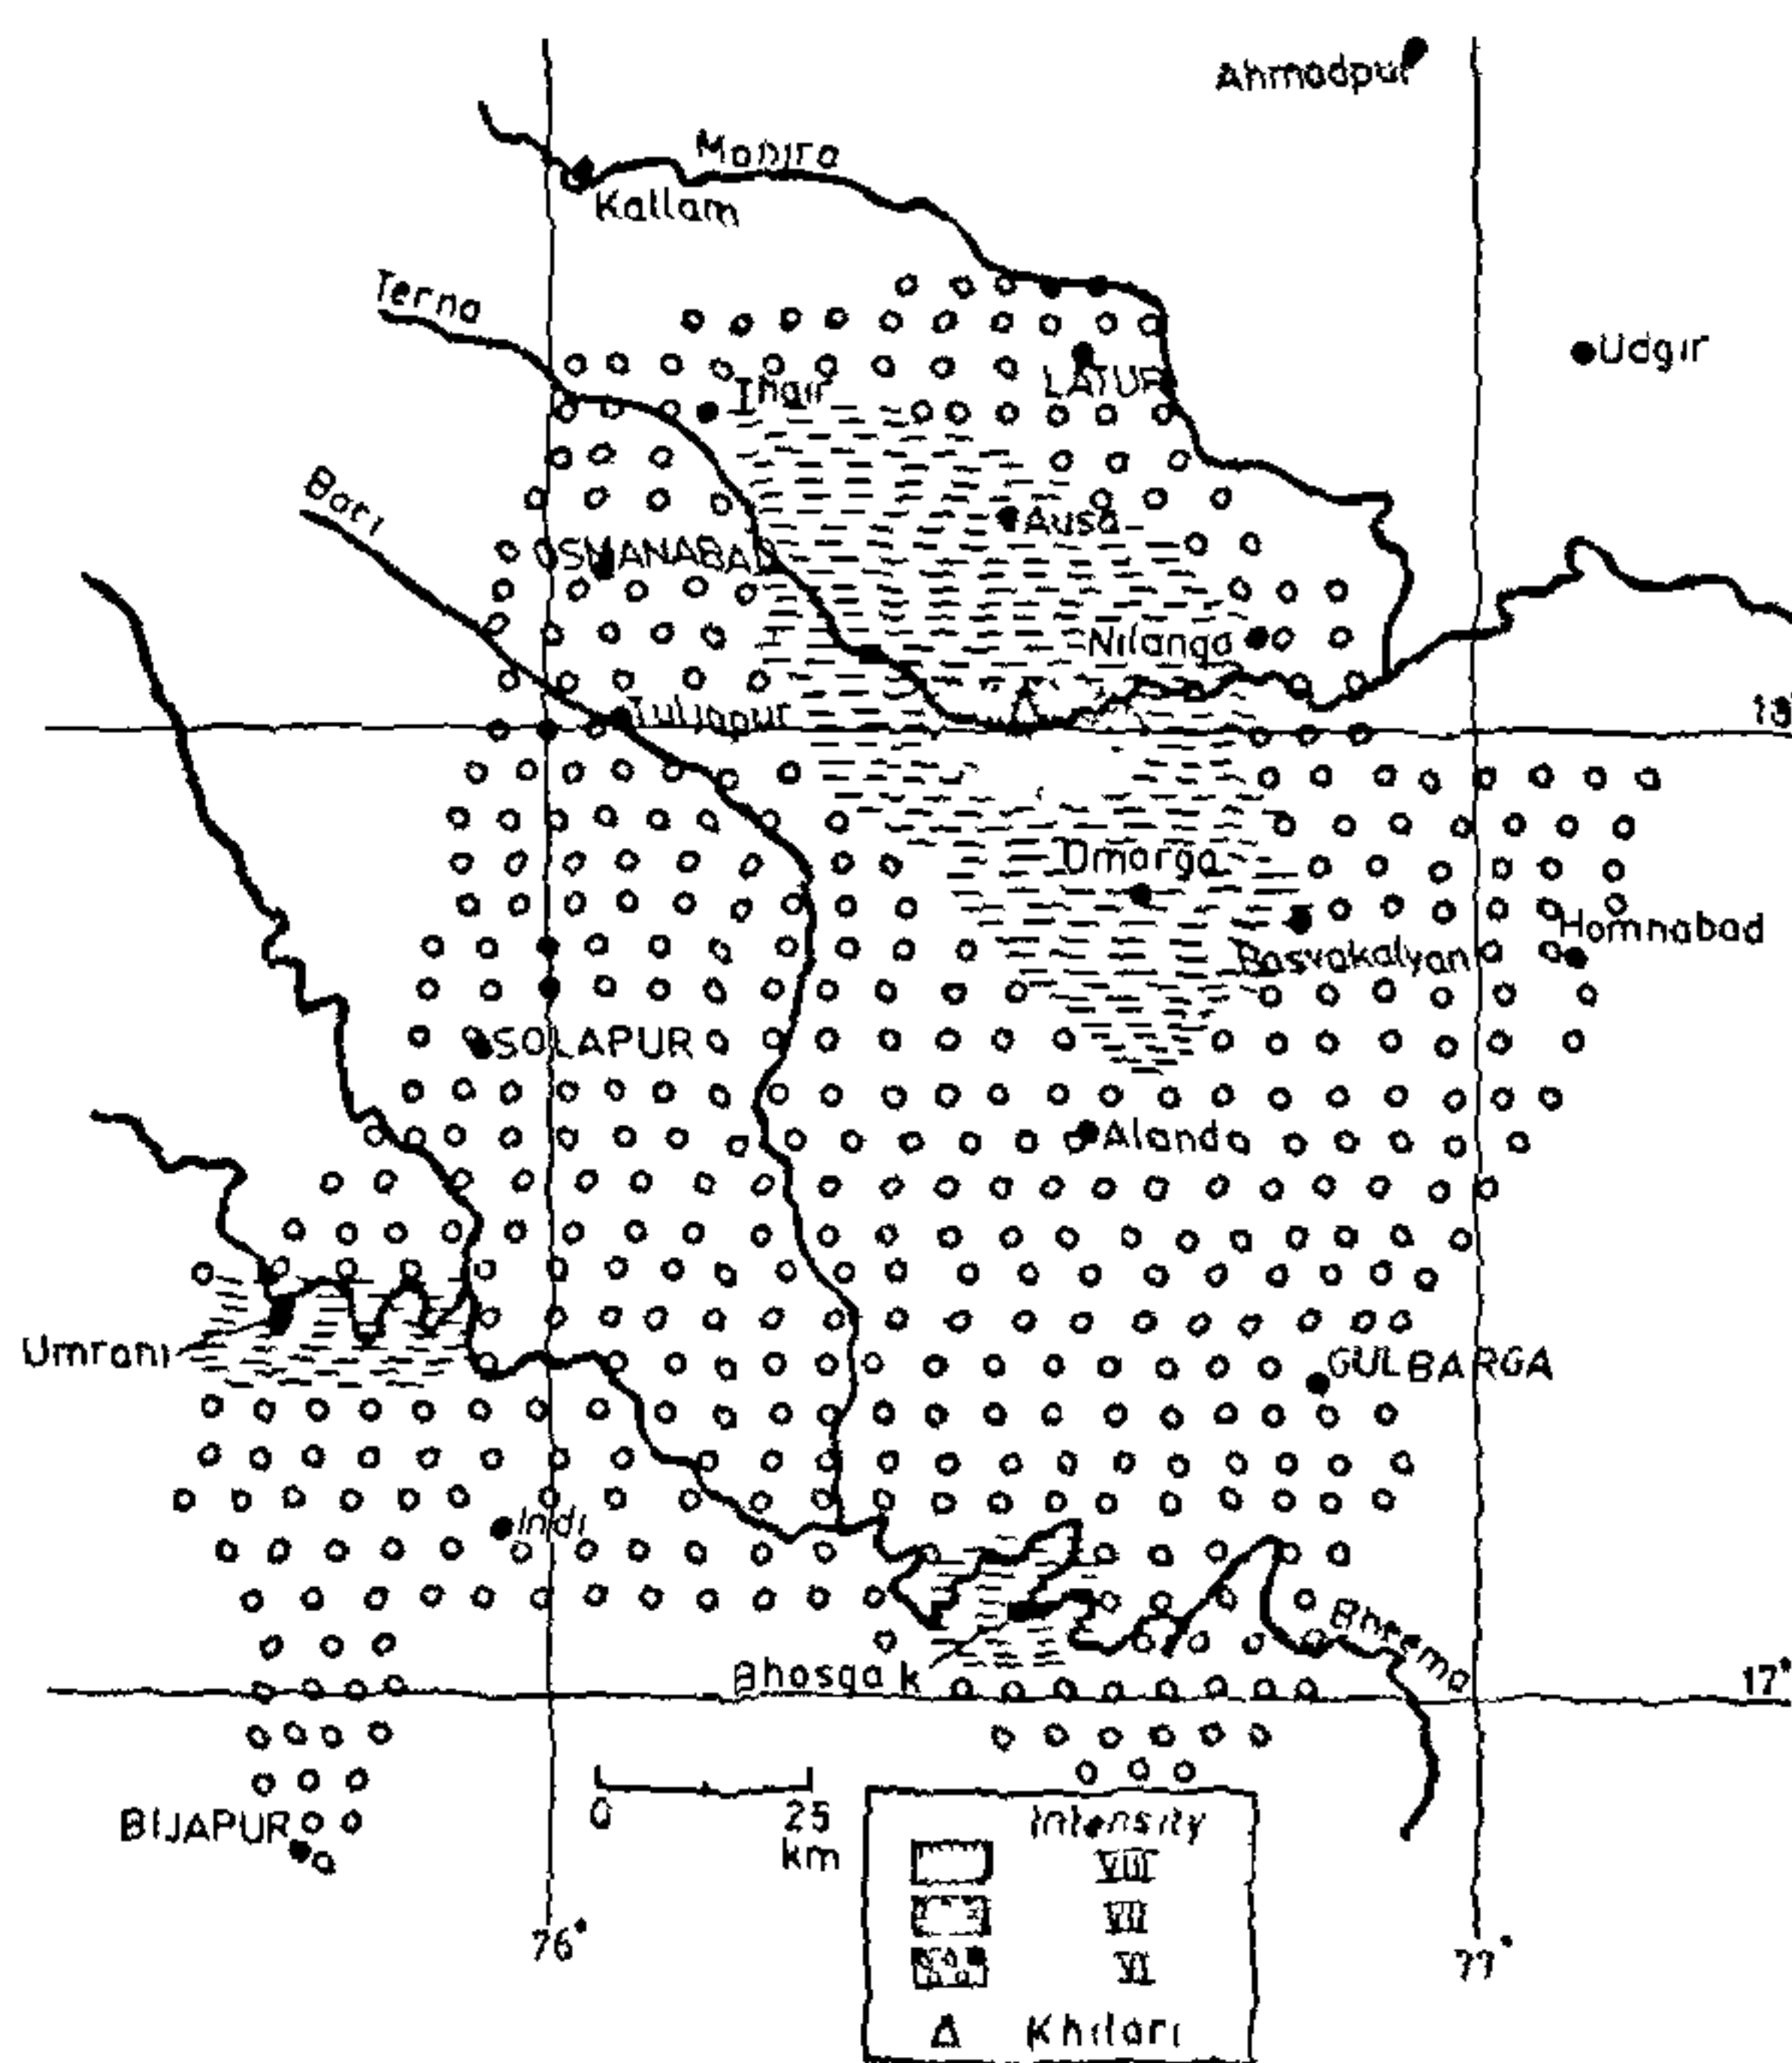
Figure 1b Damage intensity map on the UN scale

of the earthquake at a particular location. This depends not only on the site and earthquake source parameters, but also on the construction quality prevailing in the region. Presently, there are two widely accepted intensity scales, namely, the modified Mercalli intensity (MMI) scale and the UNESCO intensity scale³ (same as MSK scale). On both these scales there are twelve ratings. For an earthquake of magnitude 6 to 7, the epicentral intensity can be expected to be in the range of VII–X on either of the above scales⁴. Of the two scales, the UNESCO scale is more precise and measures the damage to buildings on a finer scale. This scale has been adopted in the present study. The UNESCO scale classifies buildings into three groups, measures damage levels on five grades and quantifies damage ratios at three percentages. On the basis of all these three informations and a few others, the intensities are worked out (Table 1). The intensity map, according to the present field study, is shown in Figure 1*b*. The epicentral intensity is estimated to be VIII. This drops by one unit beyond

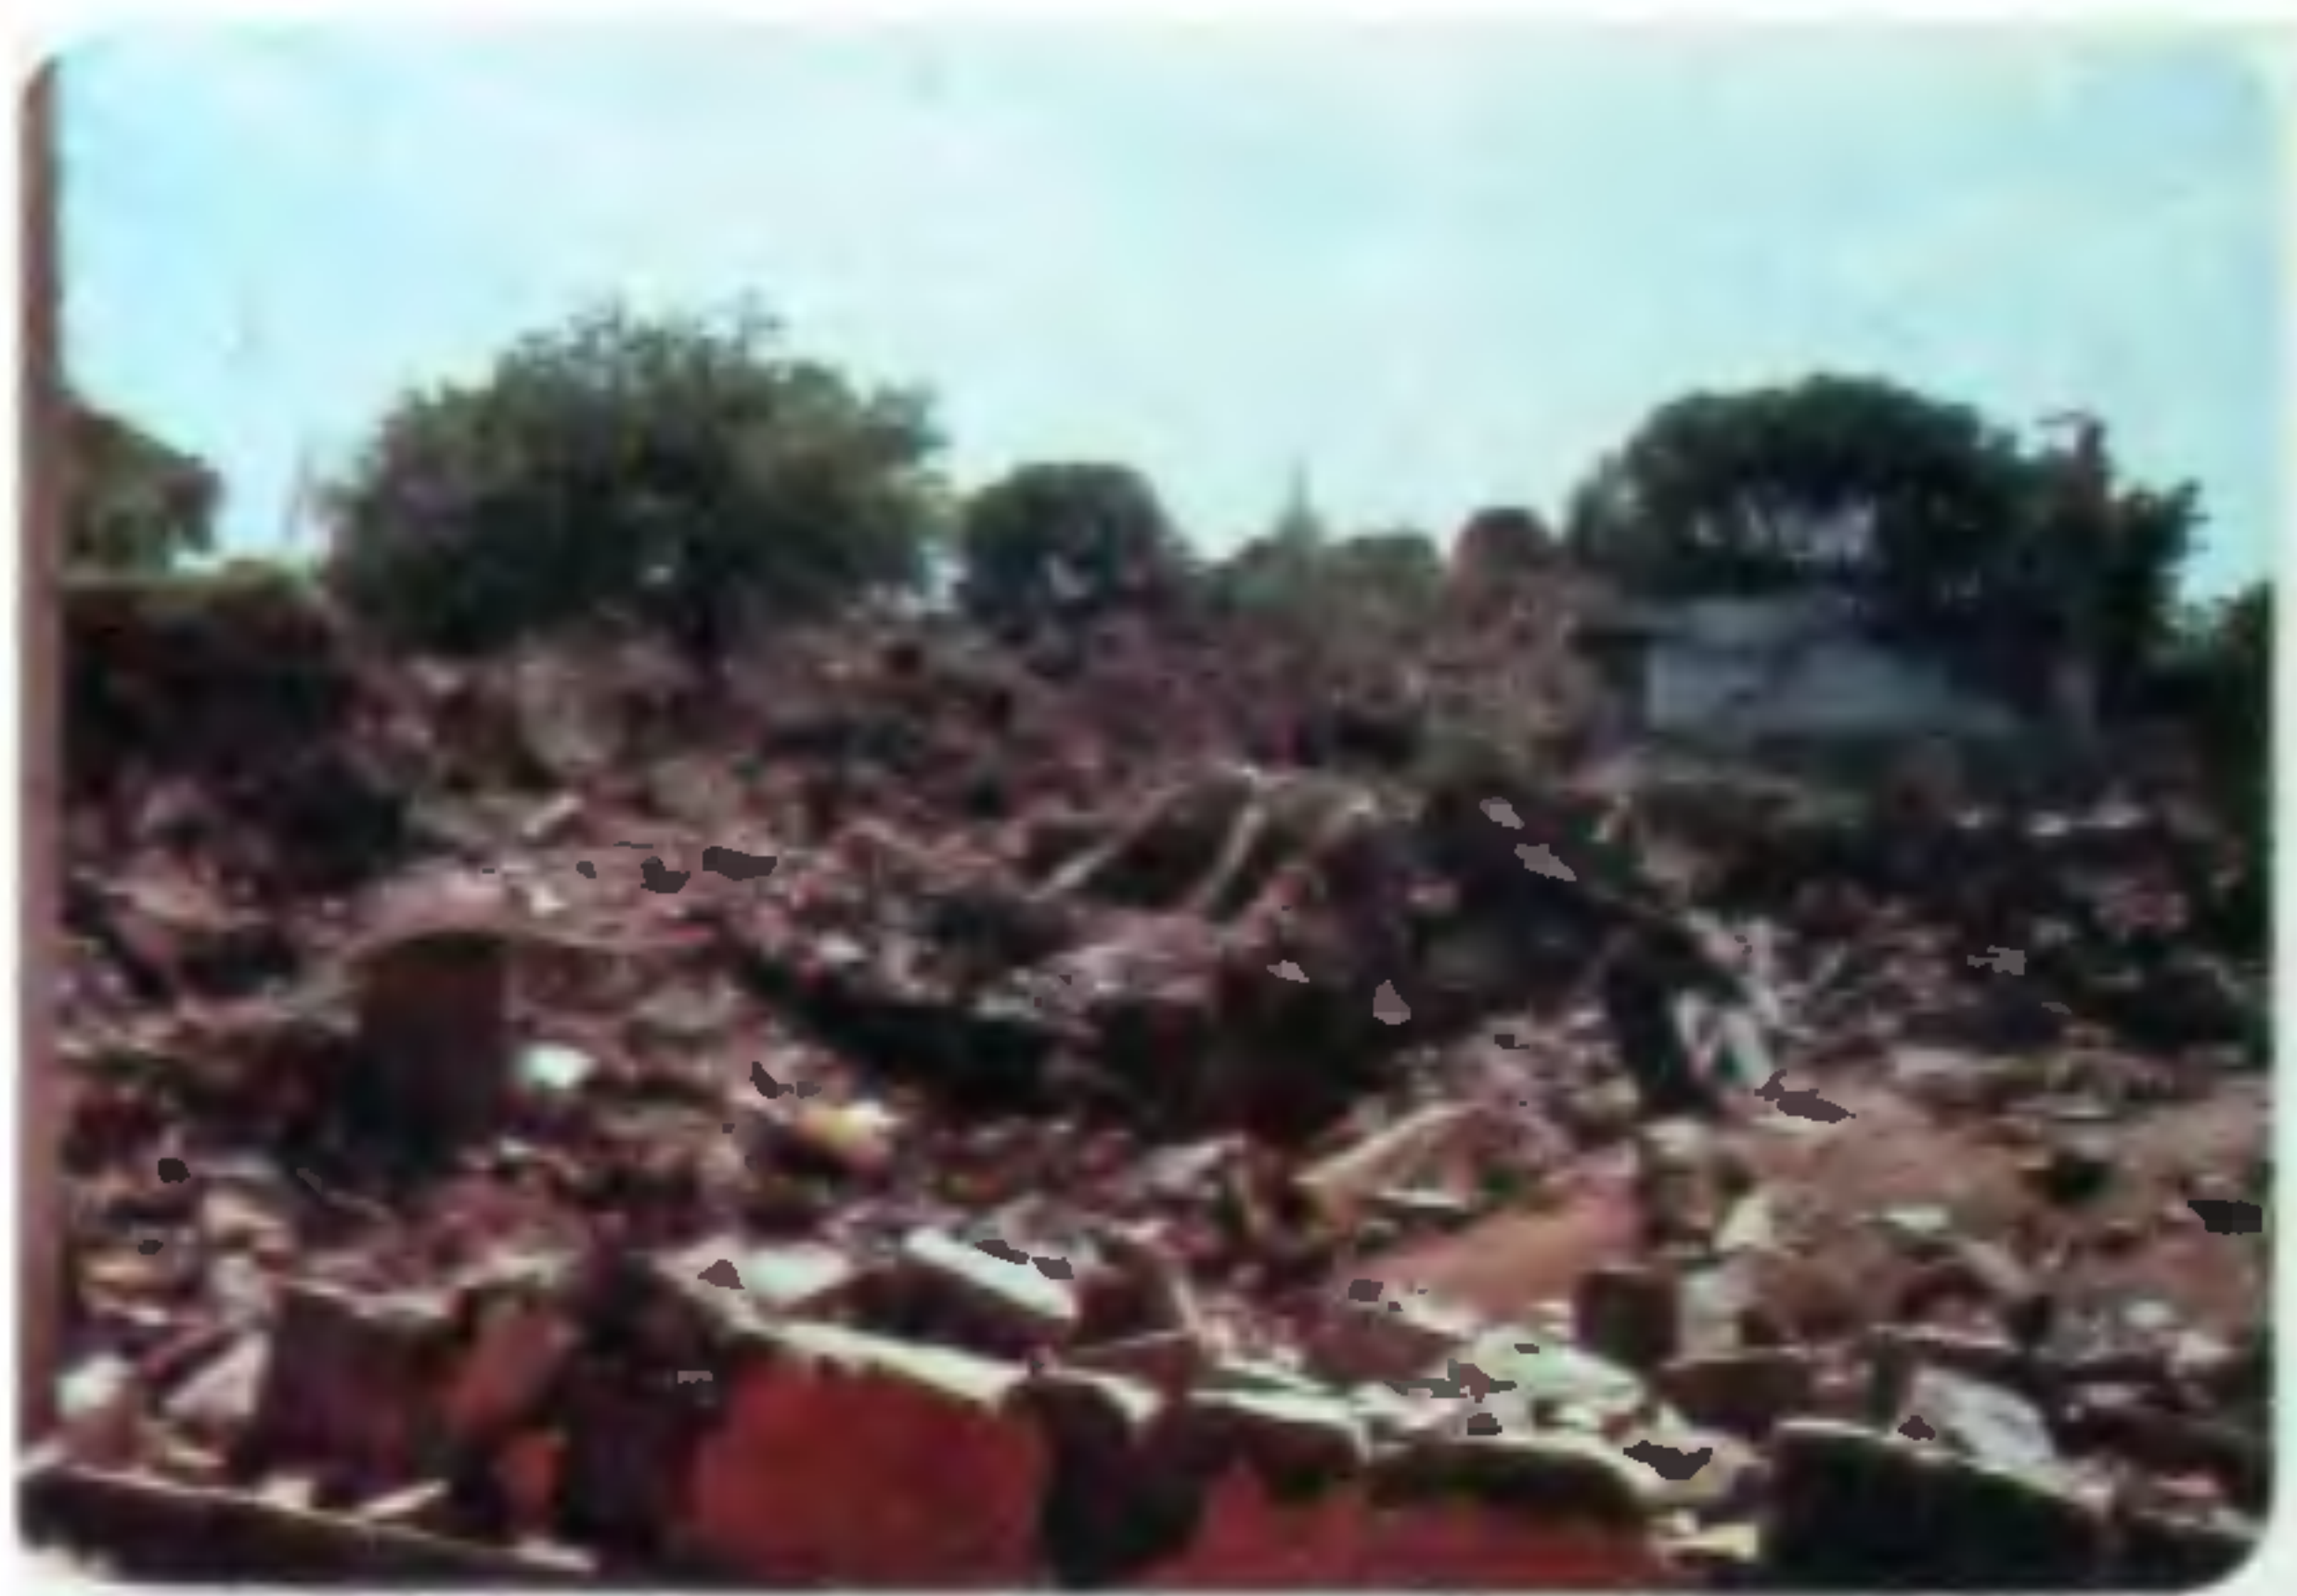
Figure 4. Khilari, Type A structures, grade 5 damage.

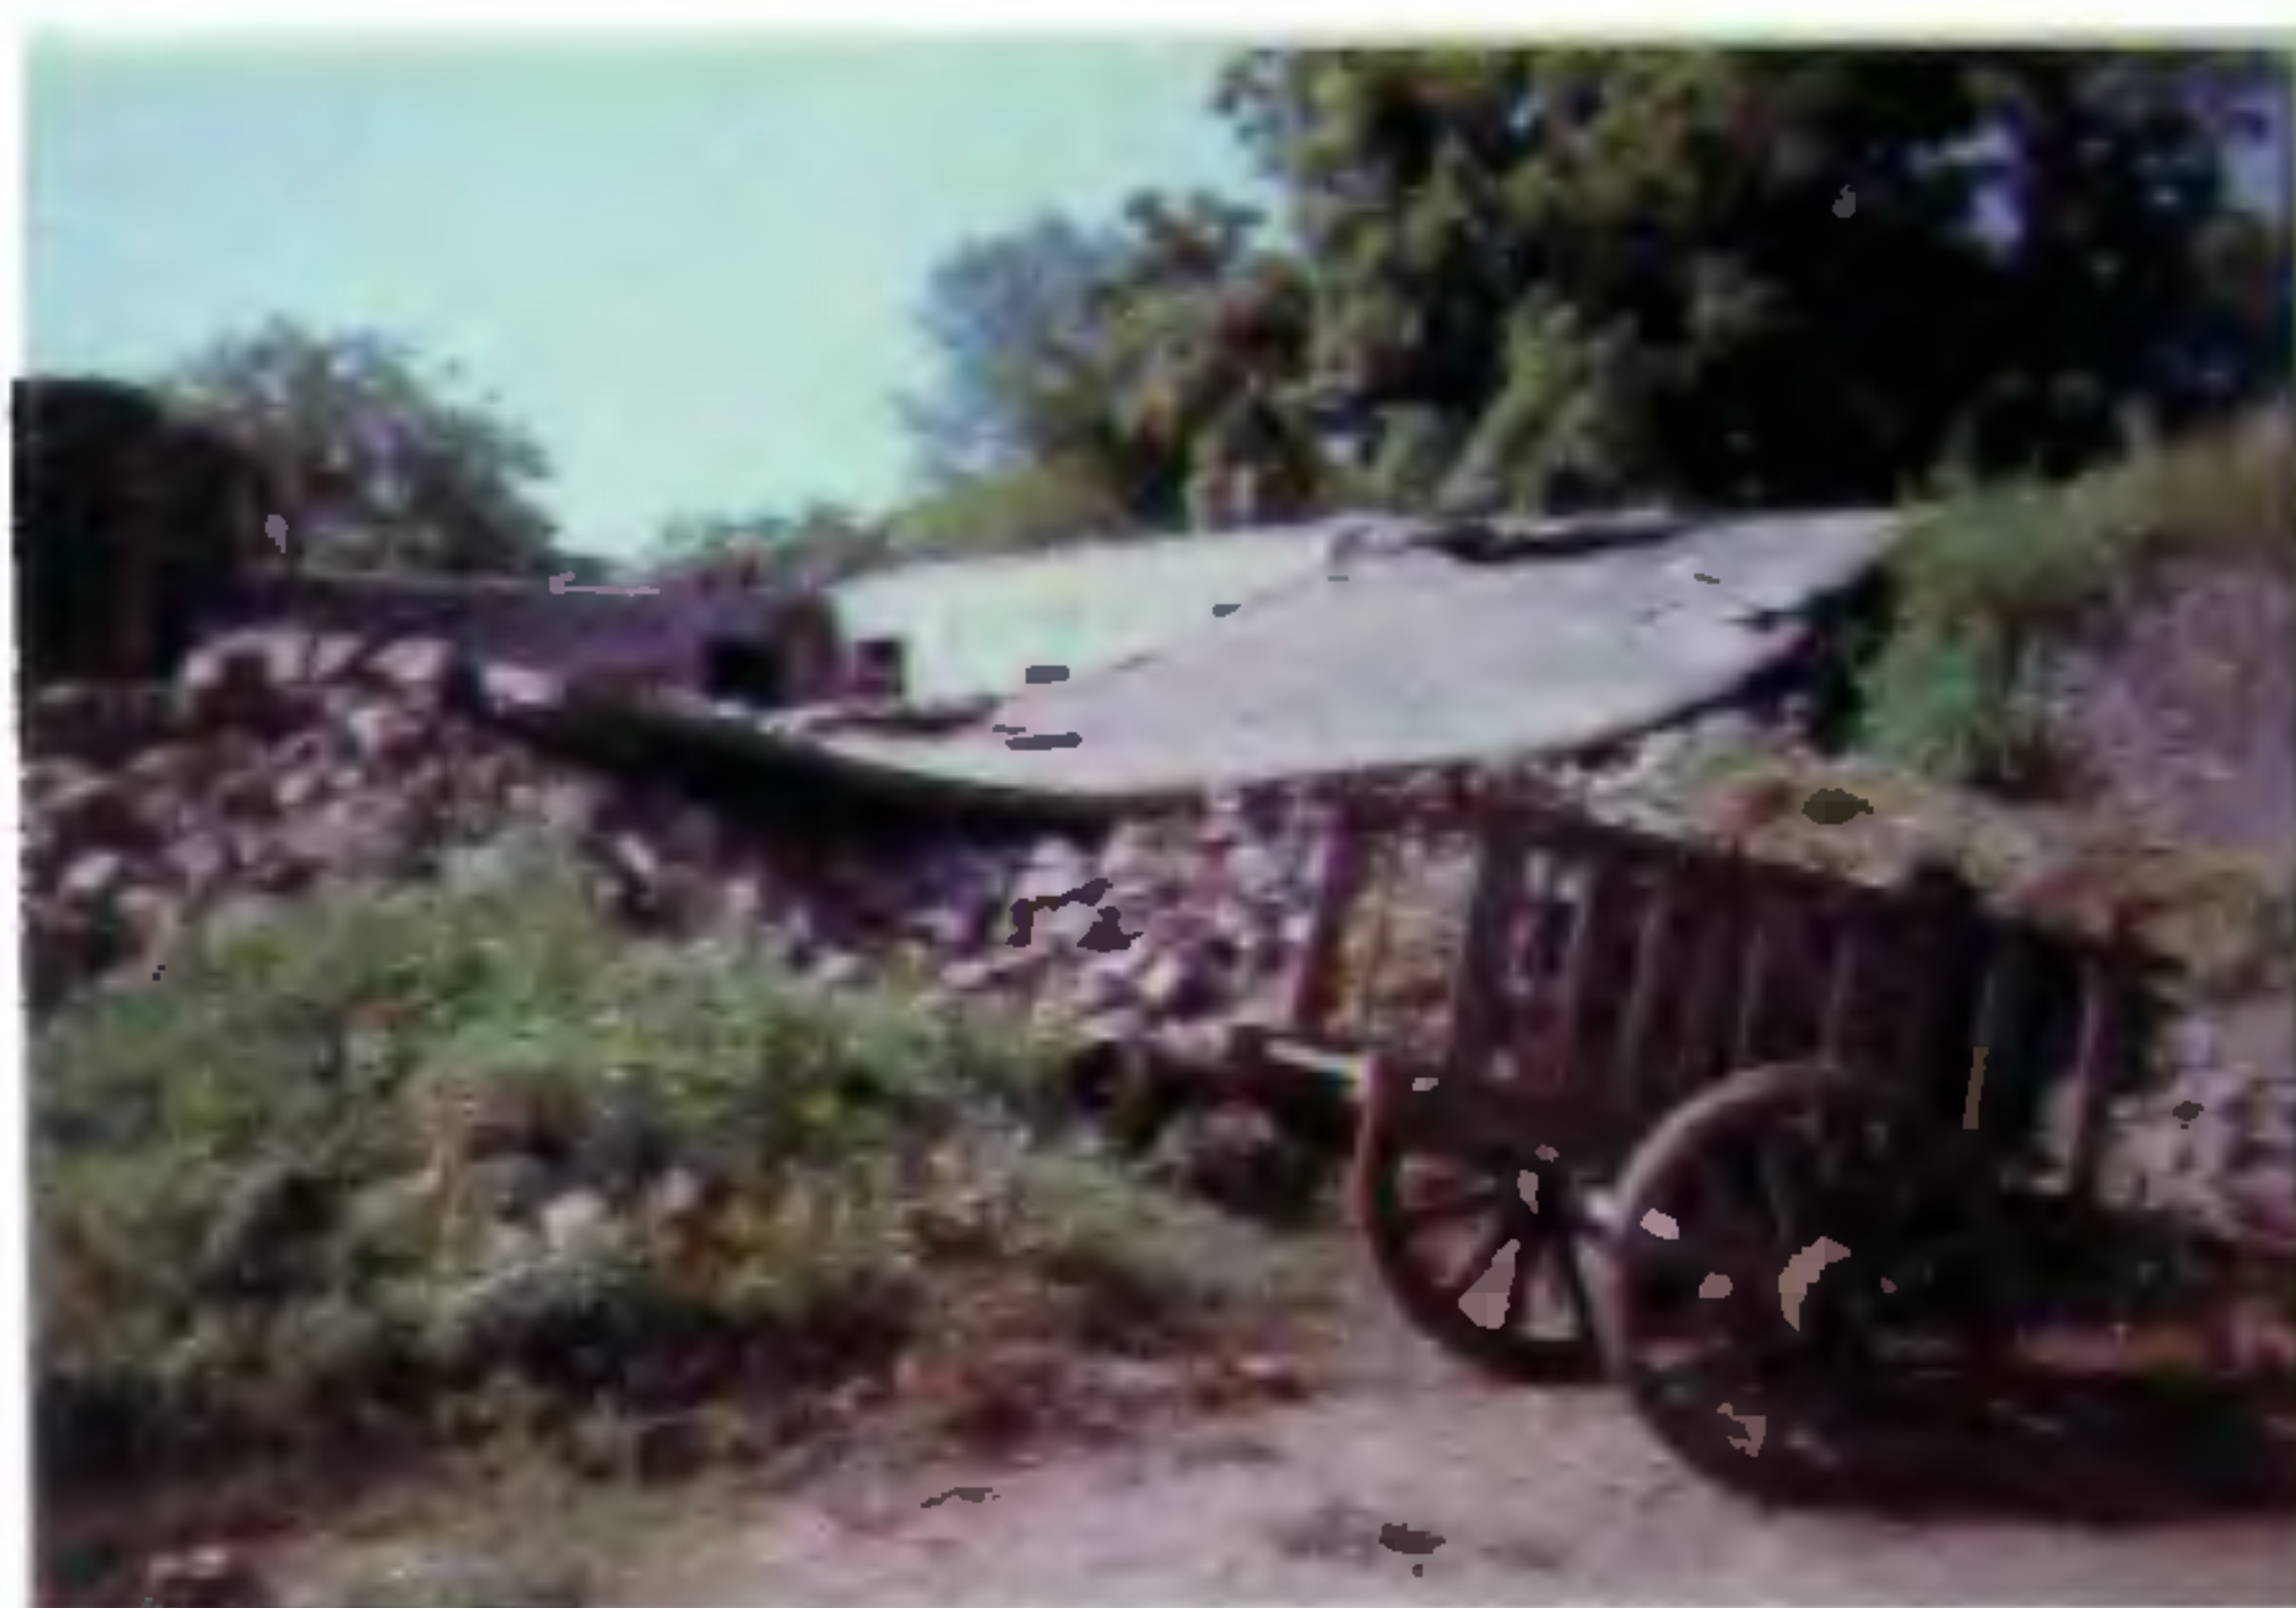
Figure 7. Kavatha: Type B structure, grade 4 damage.

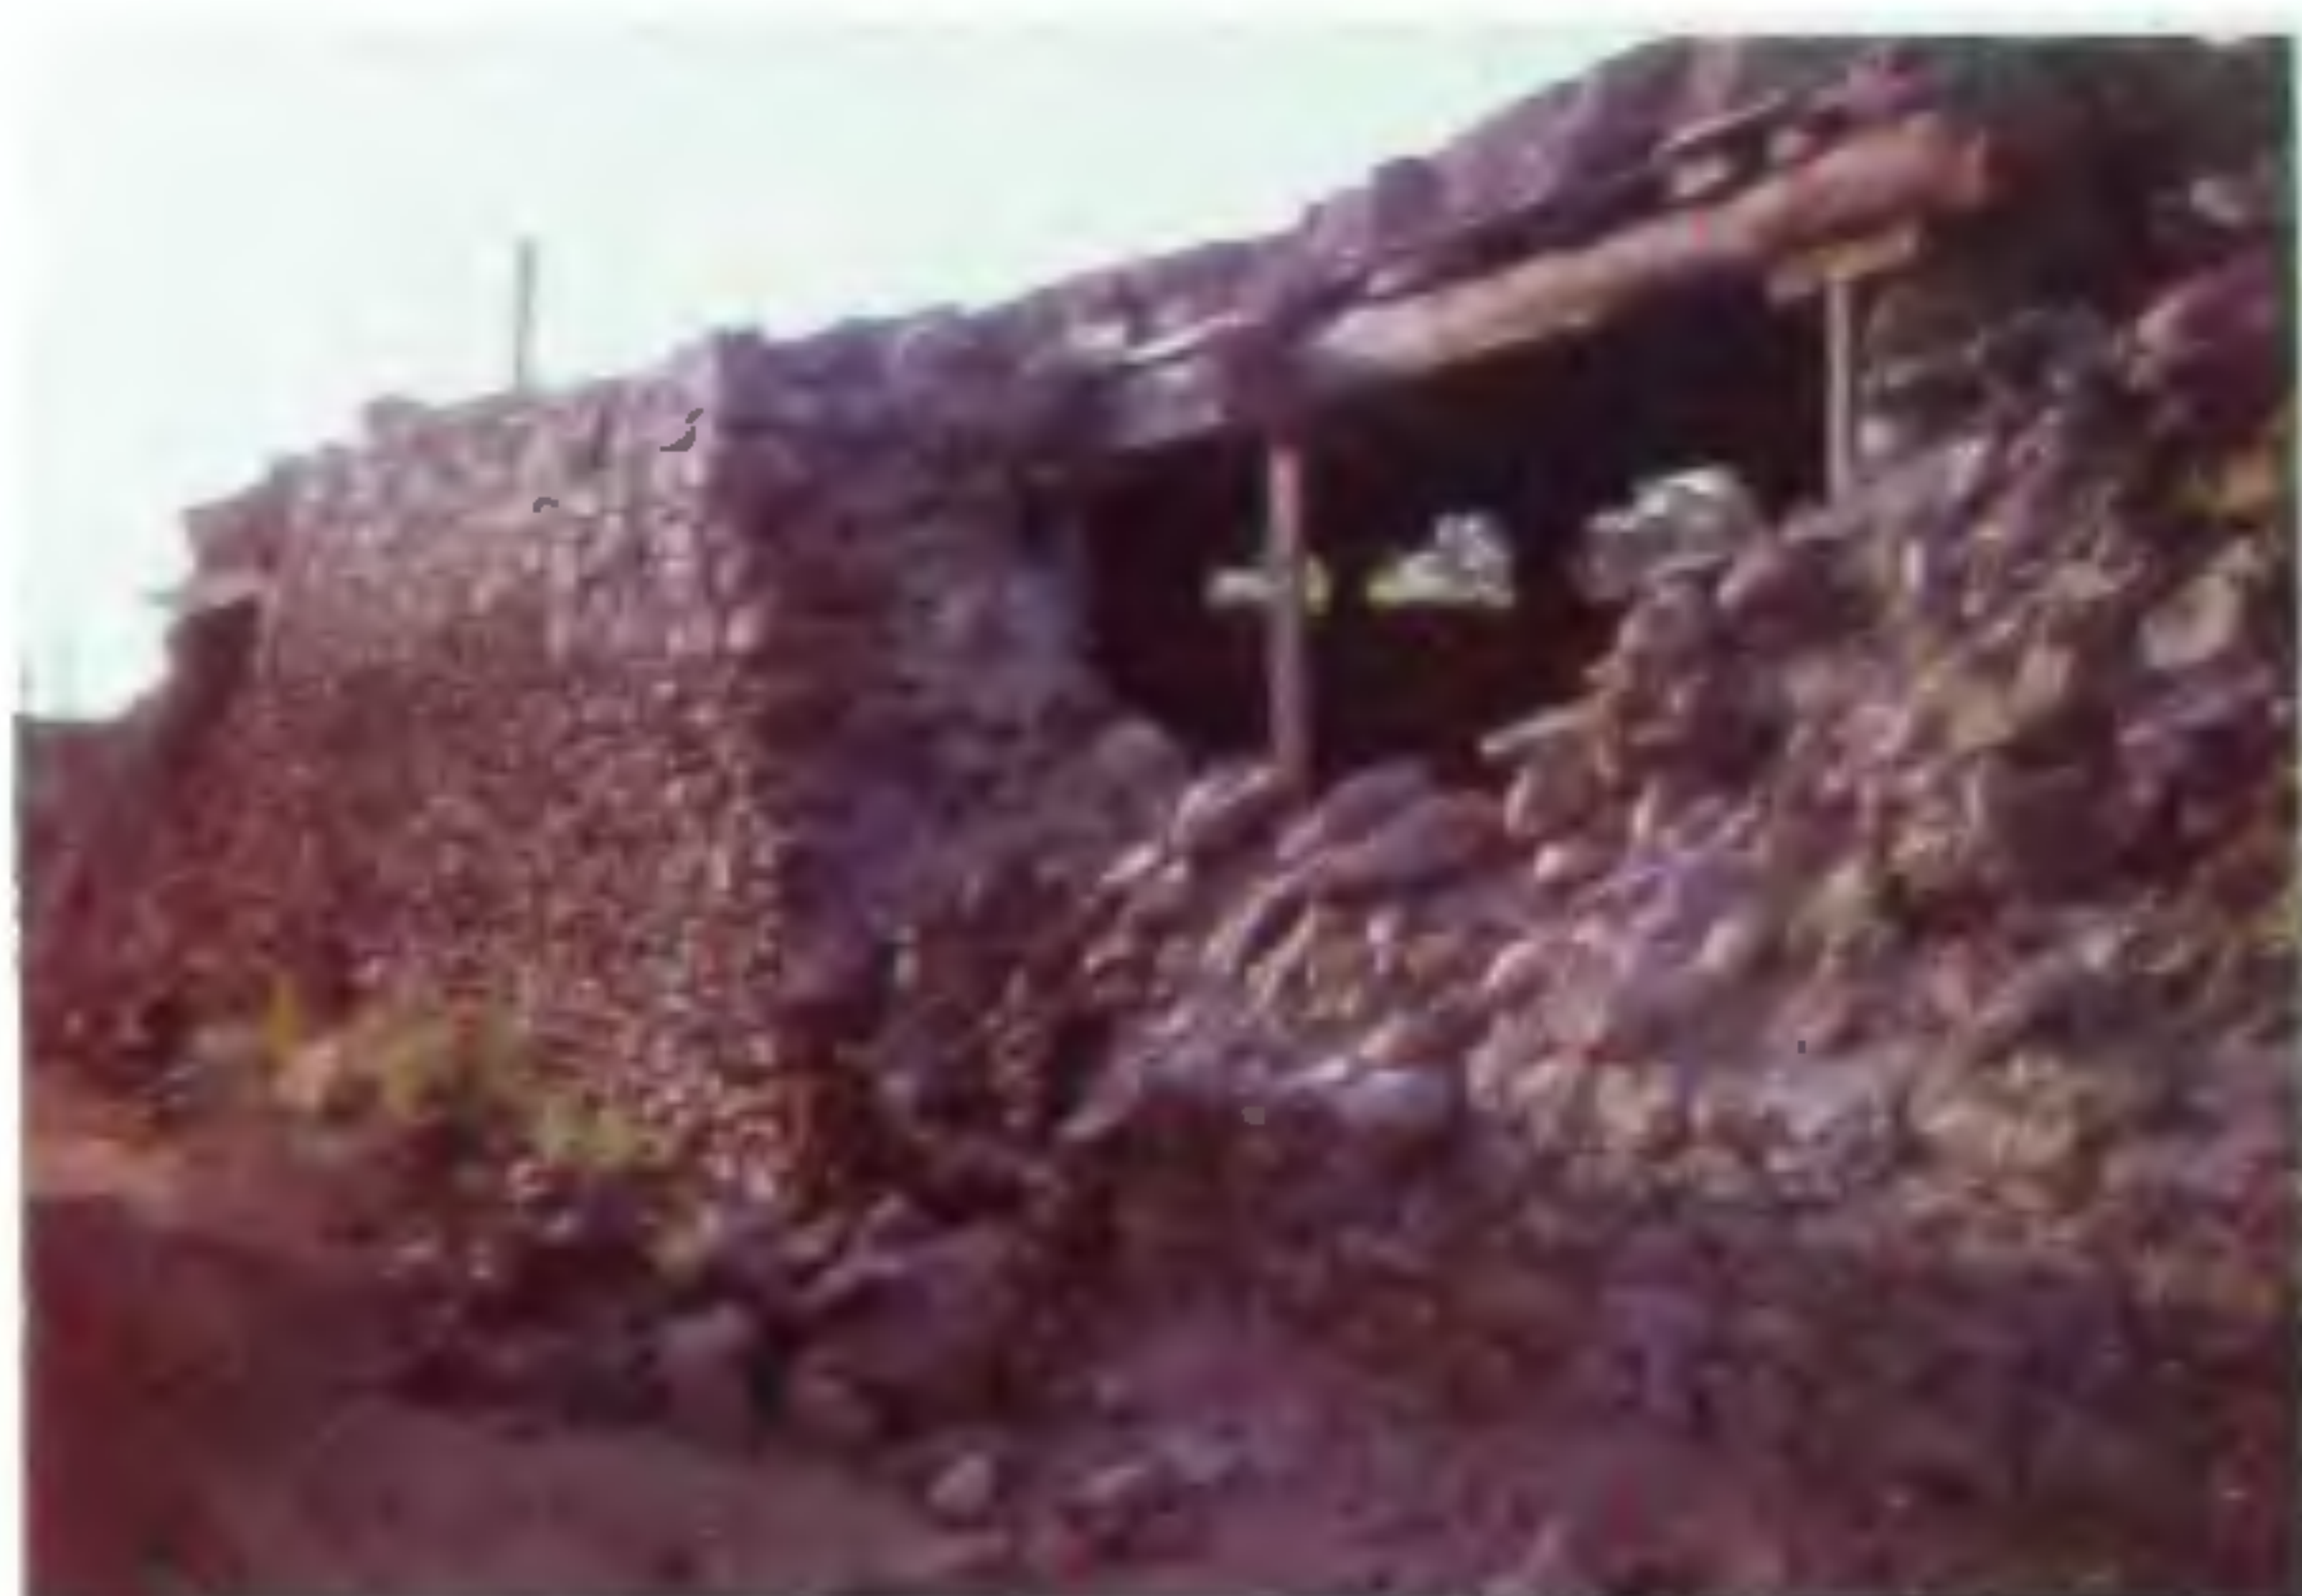
Figure 5. Khilari, Type A structure, grade 4 damage.

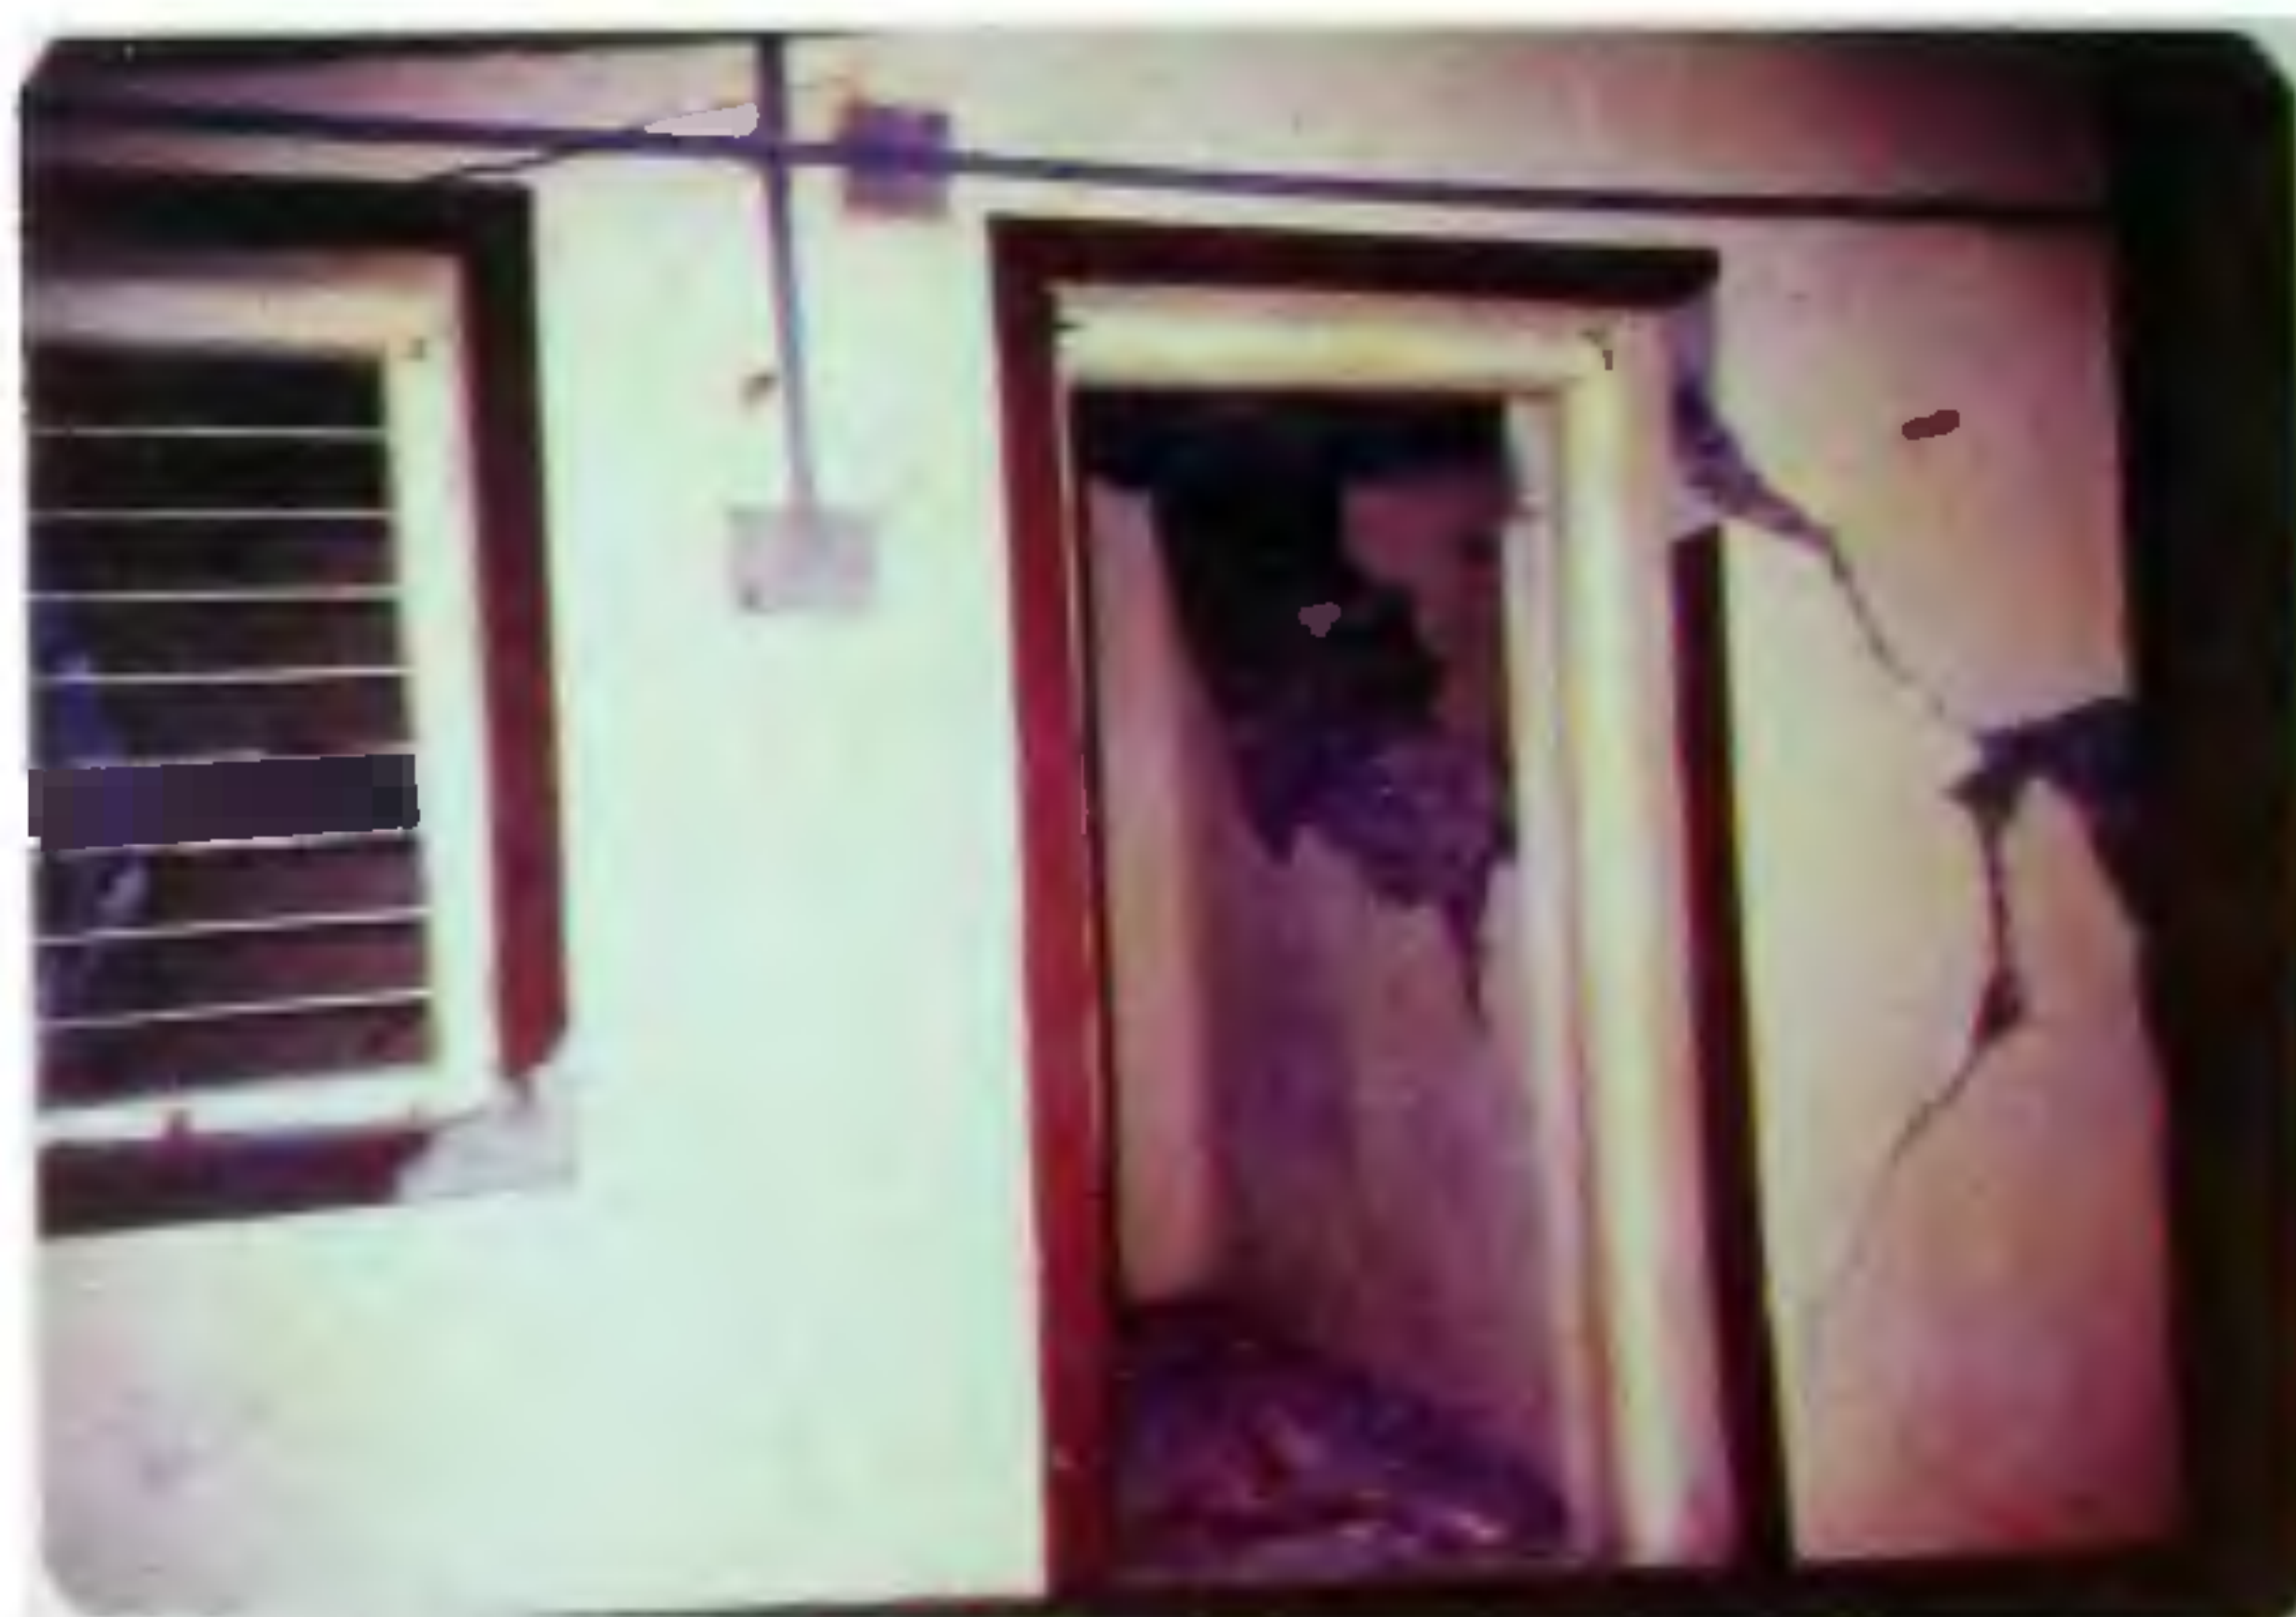
Figure 8. Khilari; Type C structure, grade 3 damage.

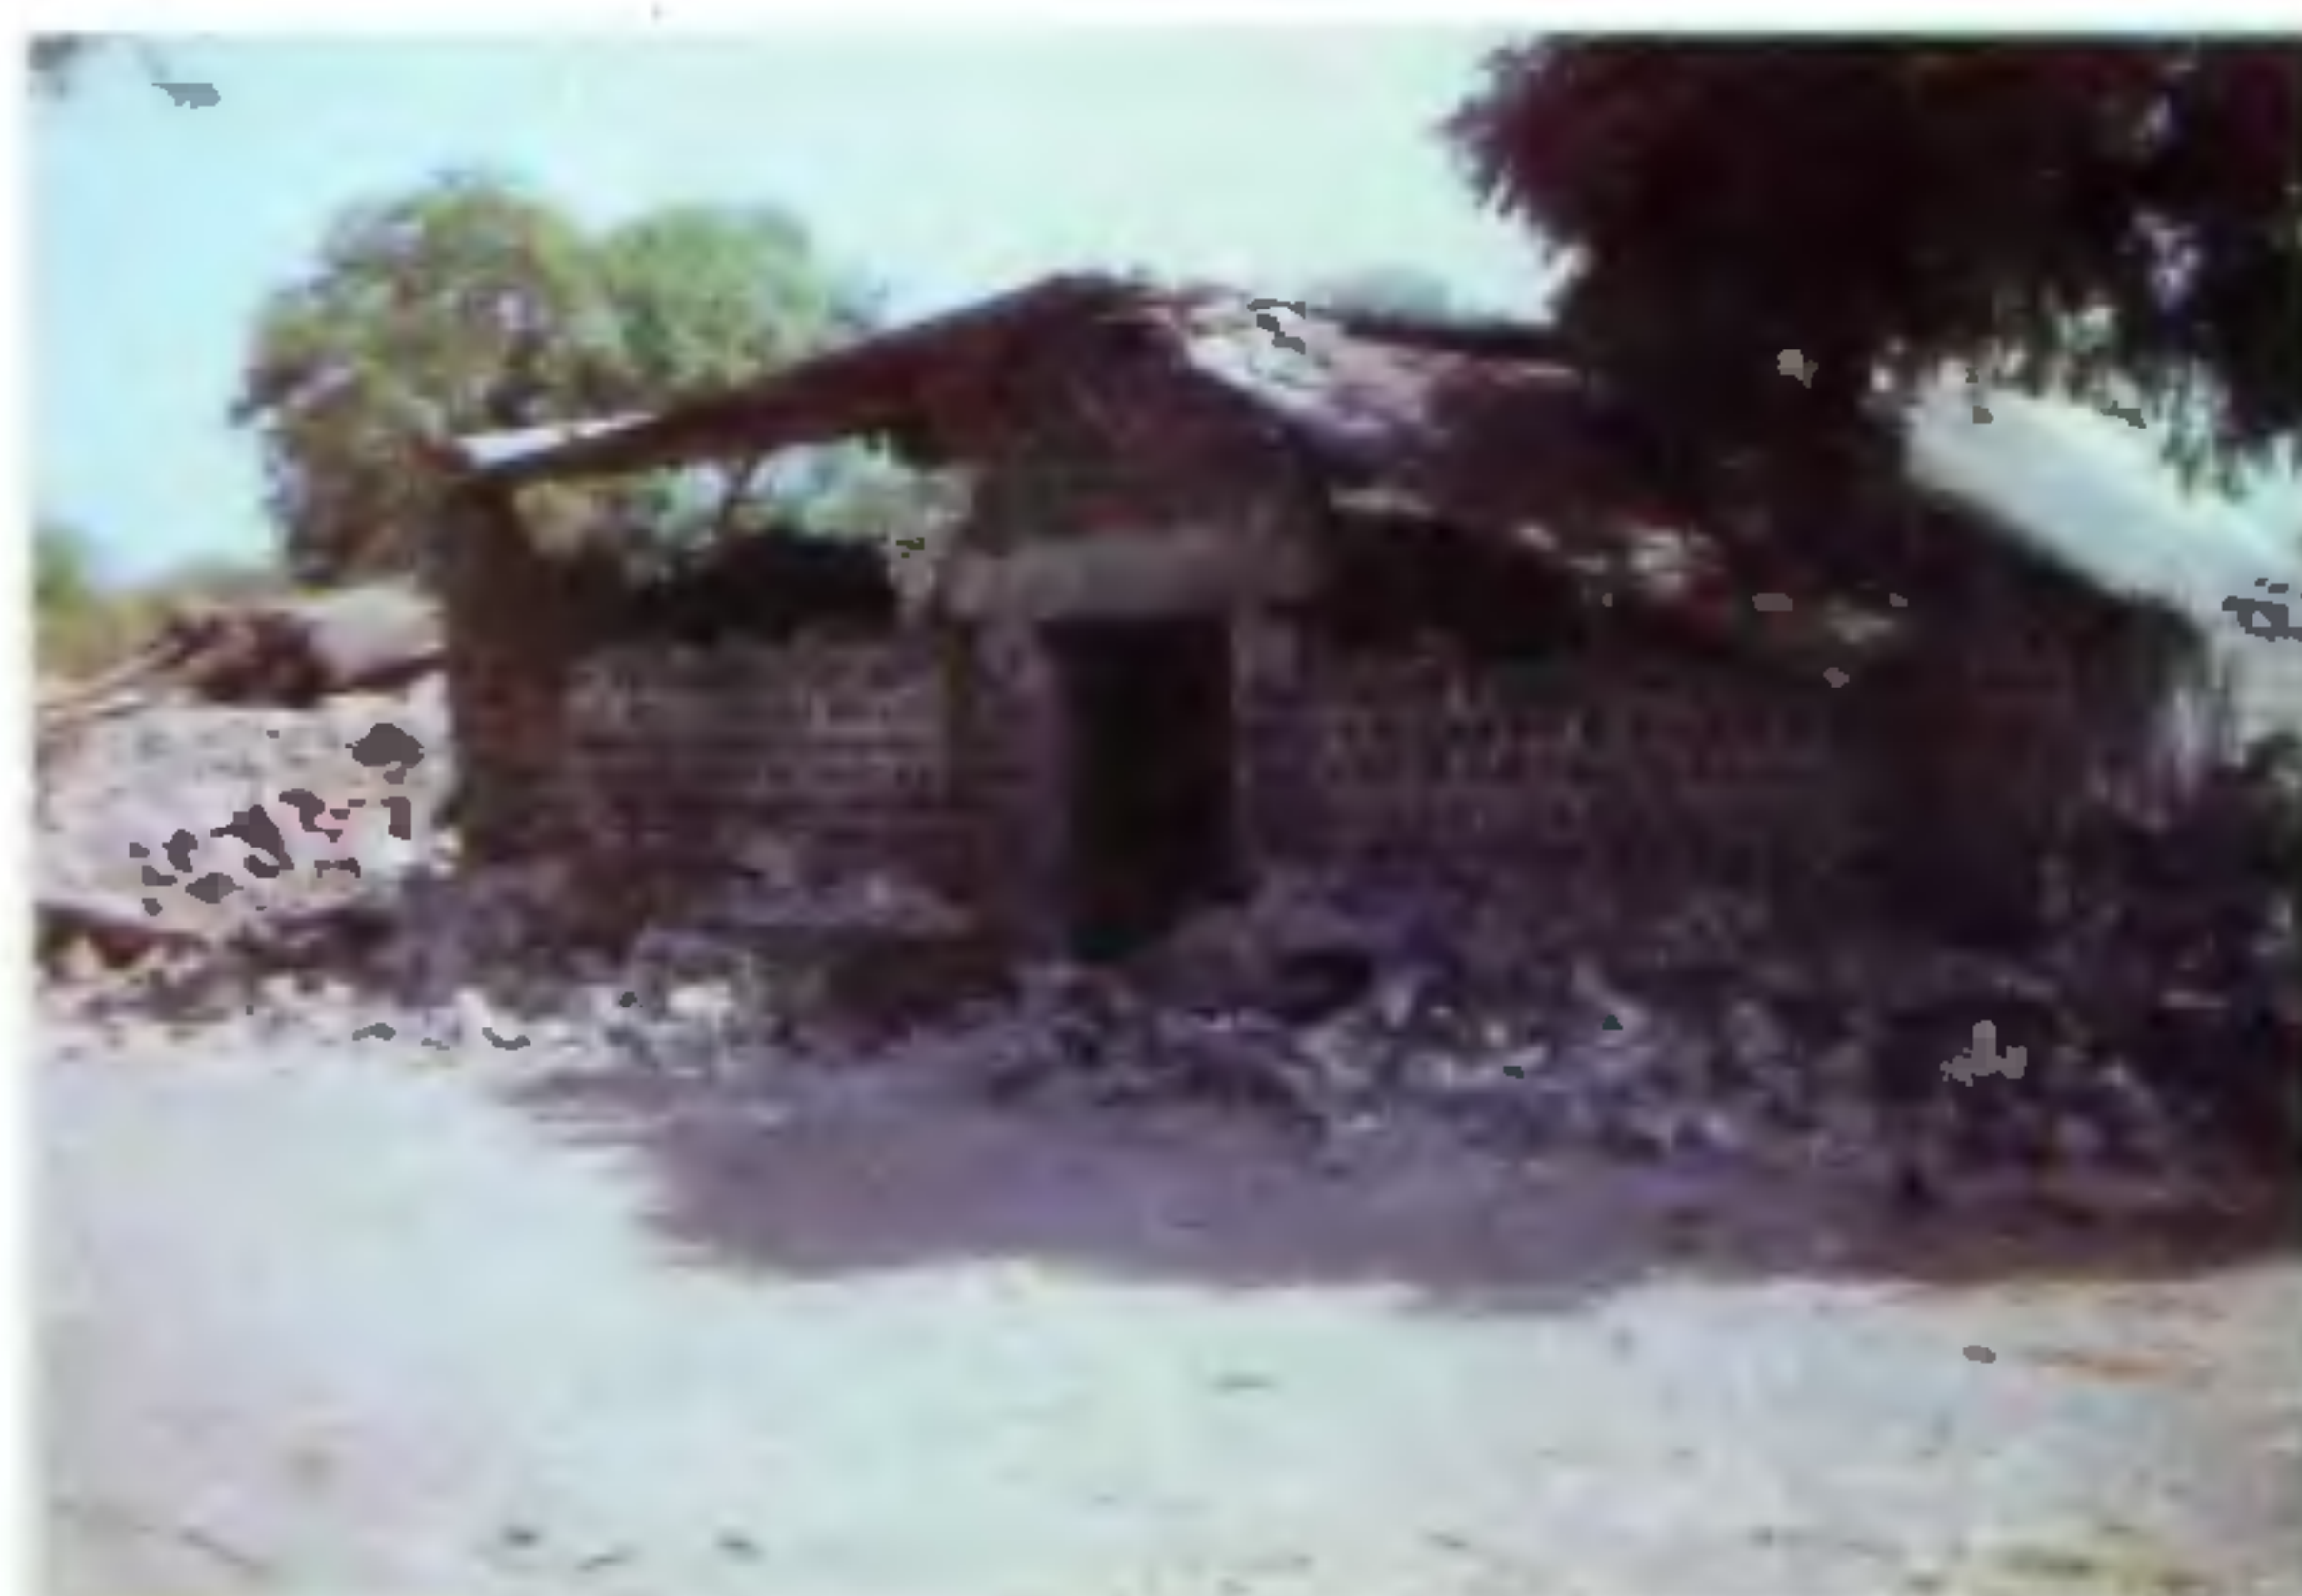
Figure 6. Rajegaon, Type B structure, grade 4 damage.
