Field investigation of the 30 September 1993 earthquake in Maharashtra

R. N. Iyengar*, C. S. Manohar and O. R. Jaiswal

Department of Civil Engineering, Indian Institute of Science, Bangalore 560 012, India

An engineering field study of the 30 September Marathwada earthquake is reported. The study covered Osmanabad, Latur, Sholapur, Bijapur, Gulbarga and Bidar districts. The level of ground acceleration was estimated based on tilting of free standing objects. The study shows that the epicentral intensity has been VIII on the UNESCO scale. The horizontal ground acceleration near the epicentre has been estimated to be about 0.2 g.

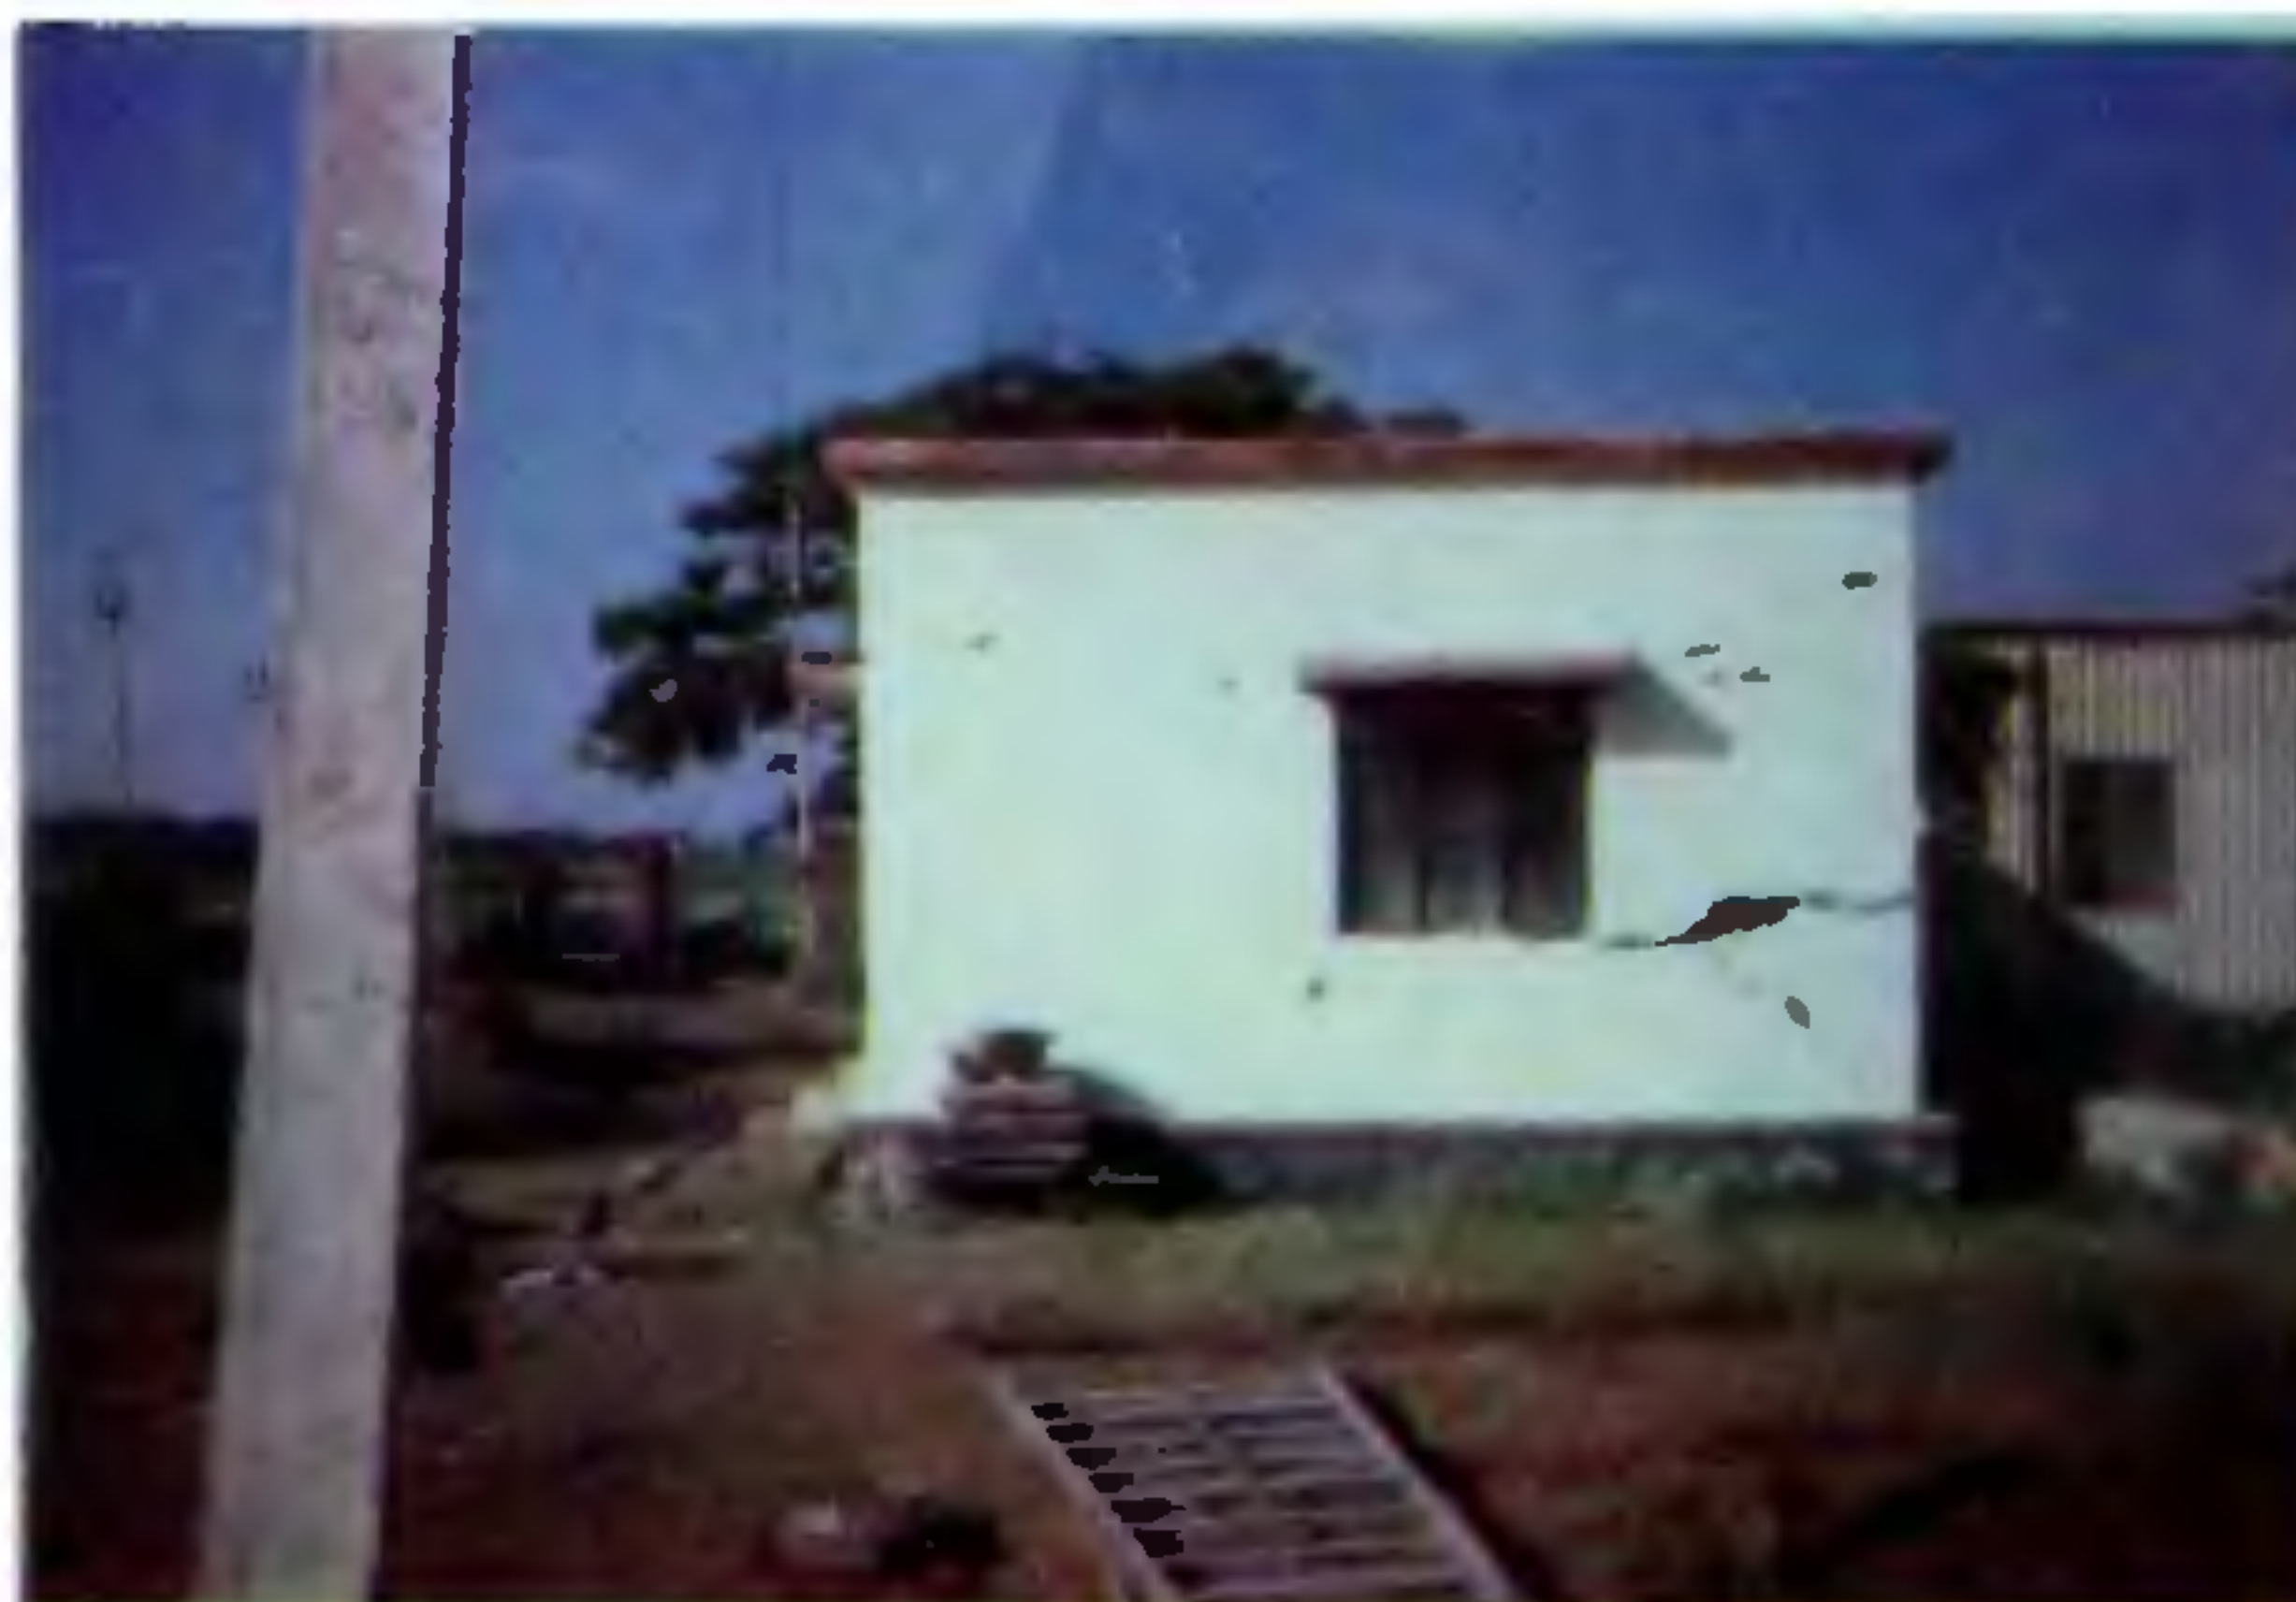
Figure 9. Sastur; Type C structure, grade 3 damage.

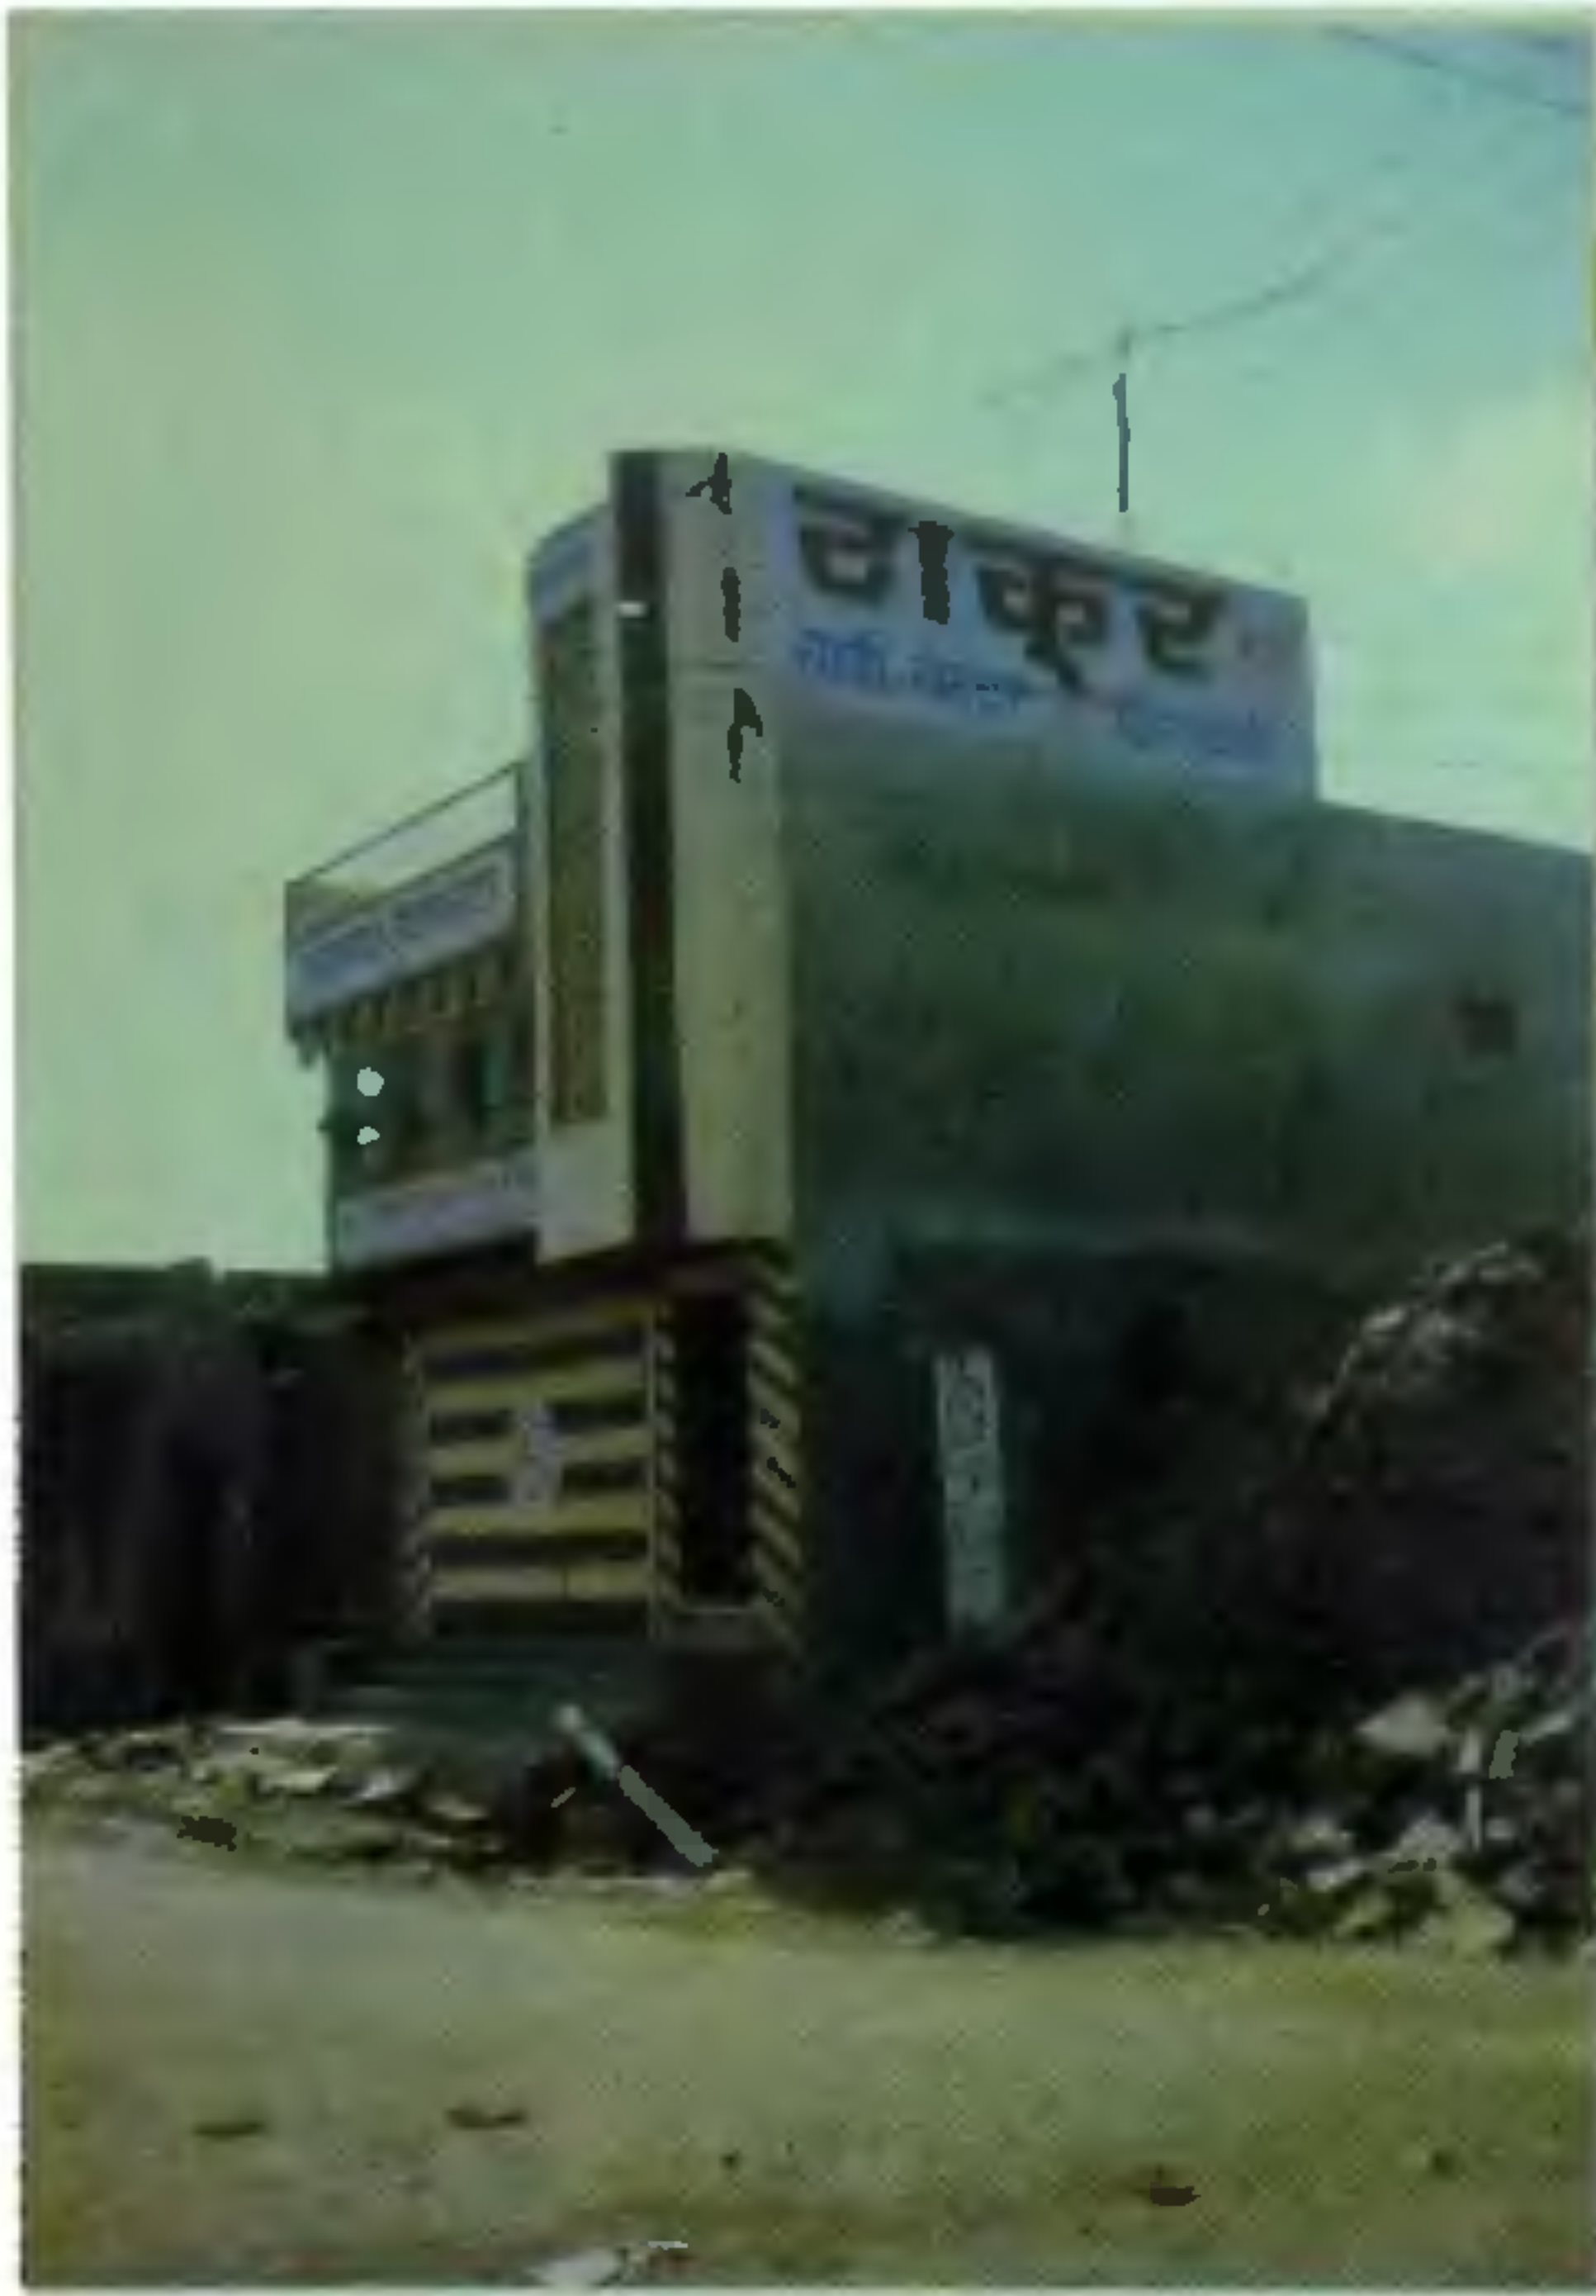
Figure 10. Khilari; Type C structure, grade 2 damage.

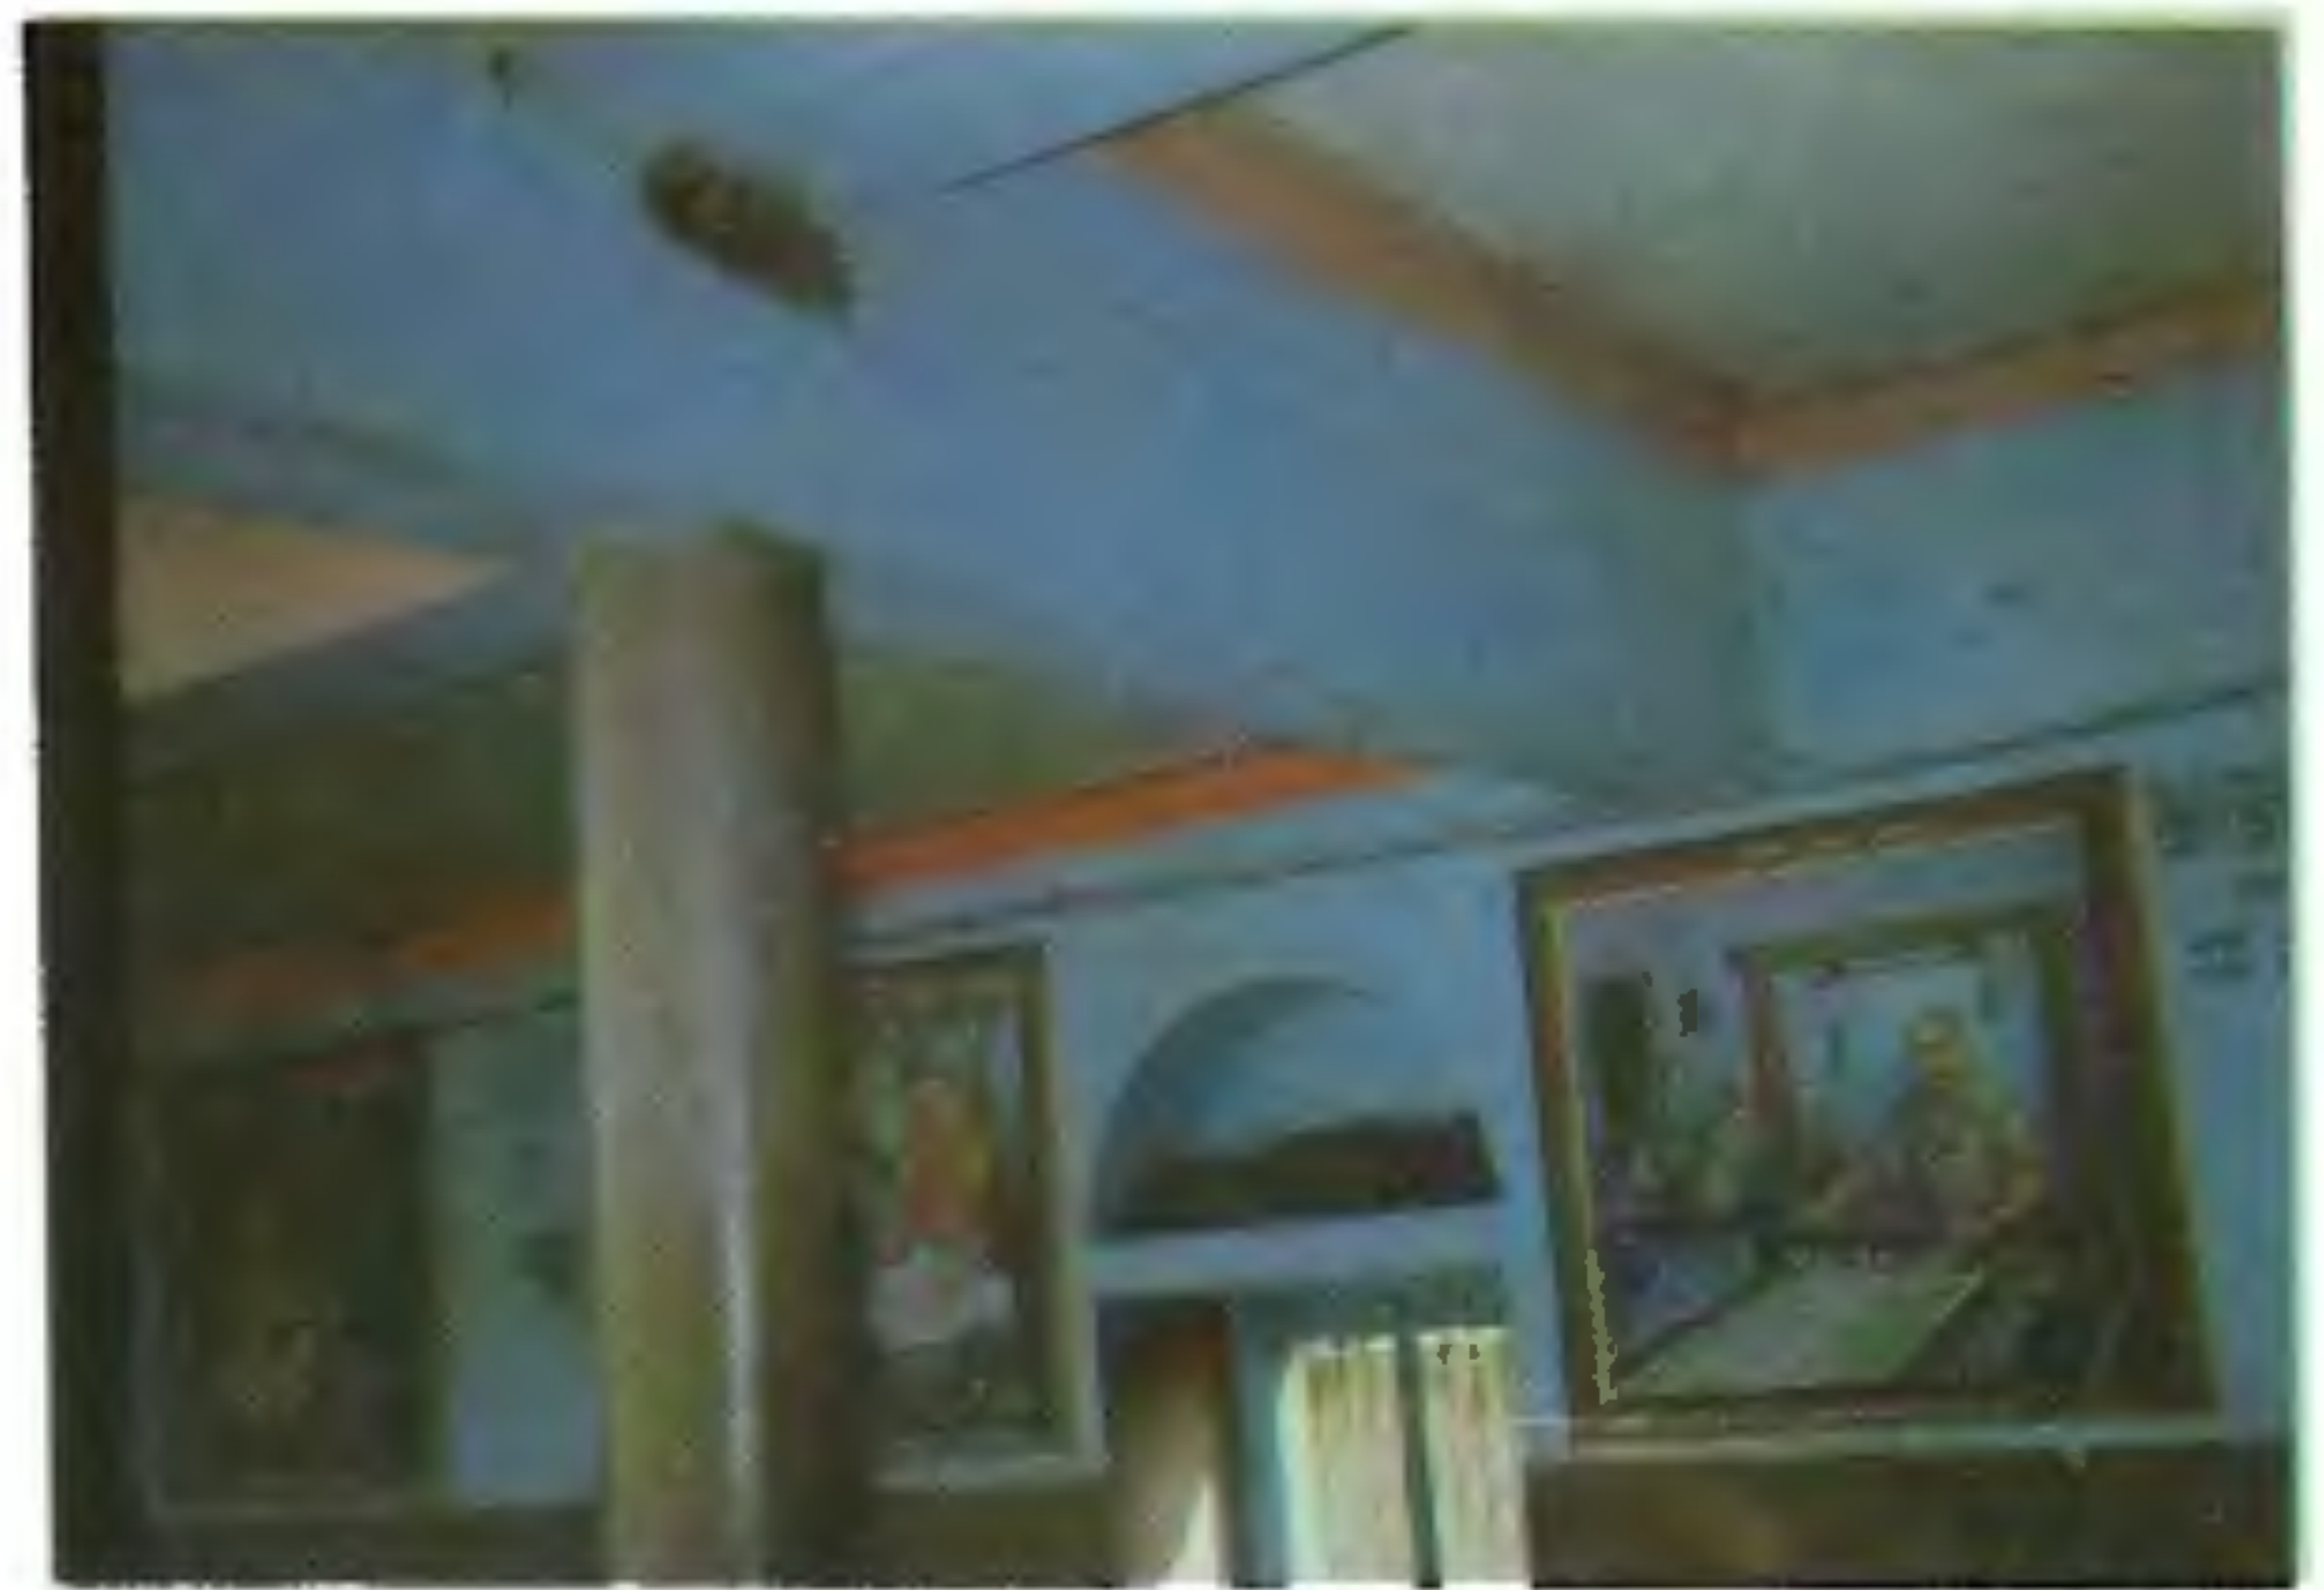
Figure 12. Basavakalyan, Type C structure, grade 1 damage

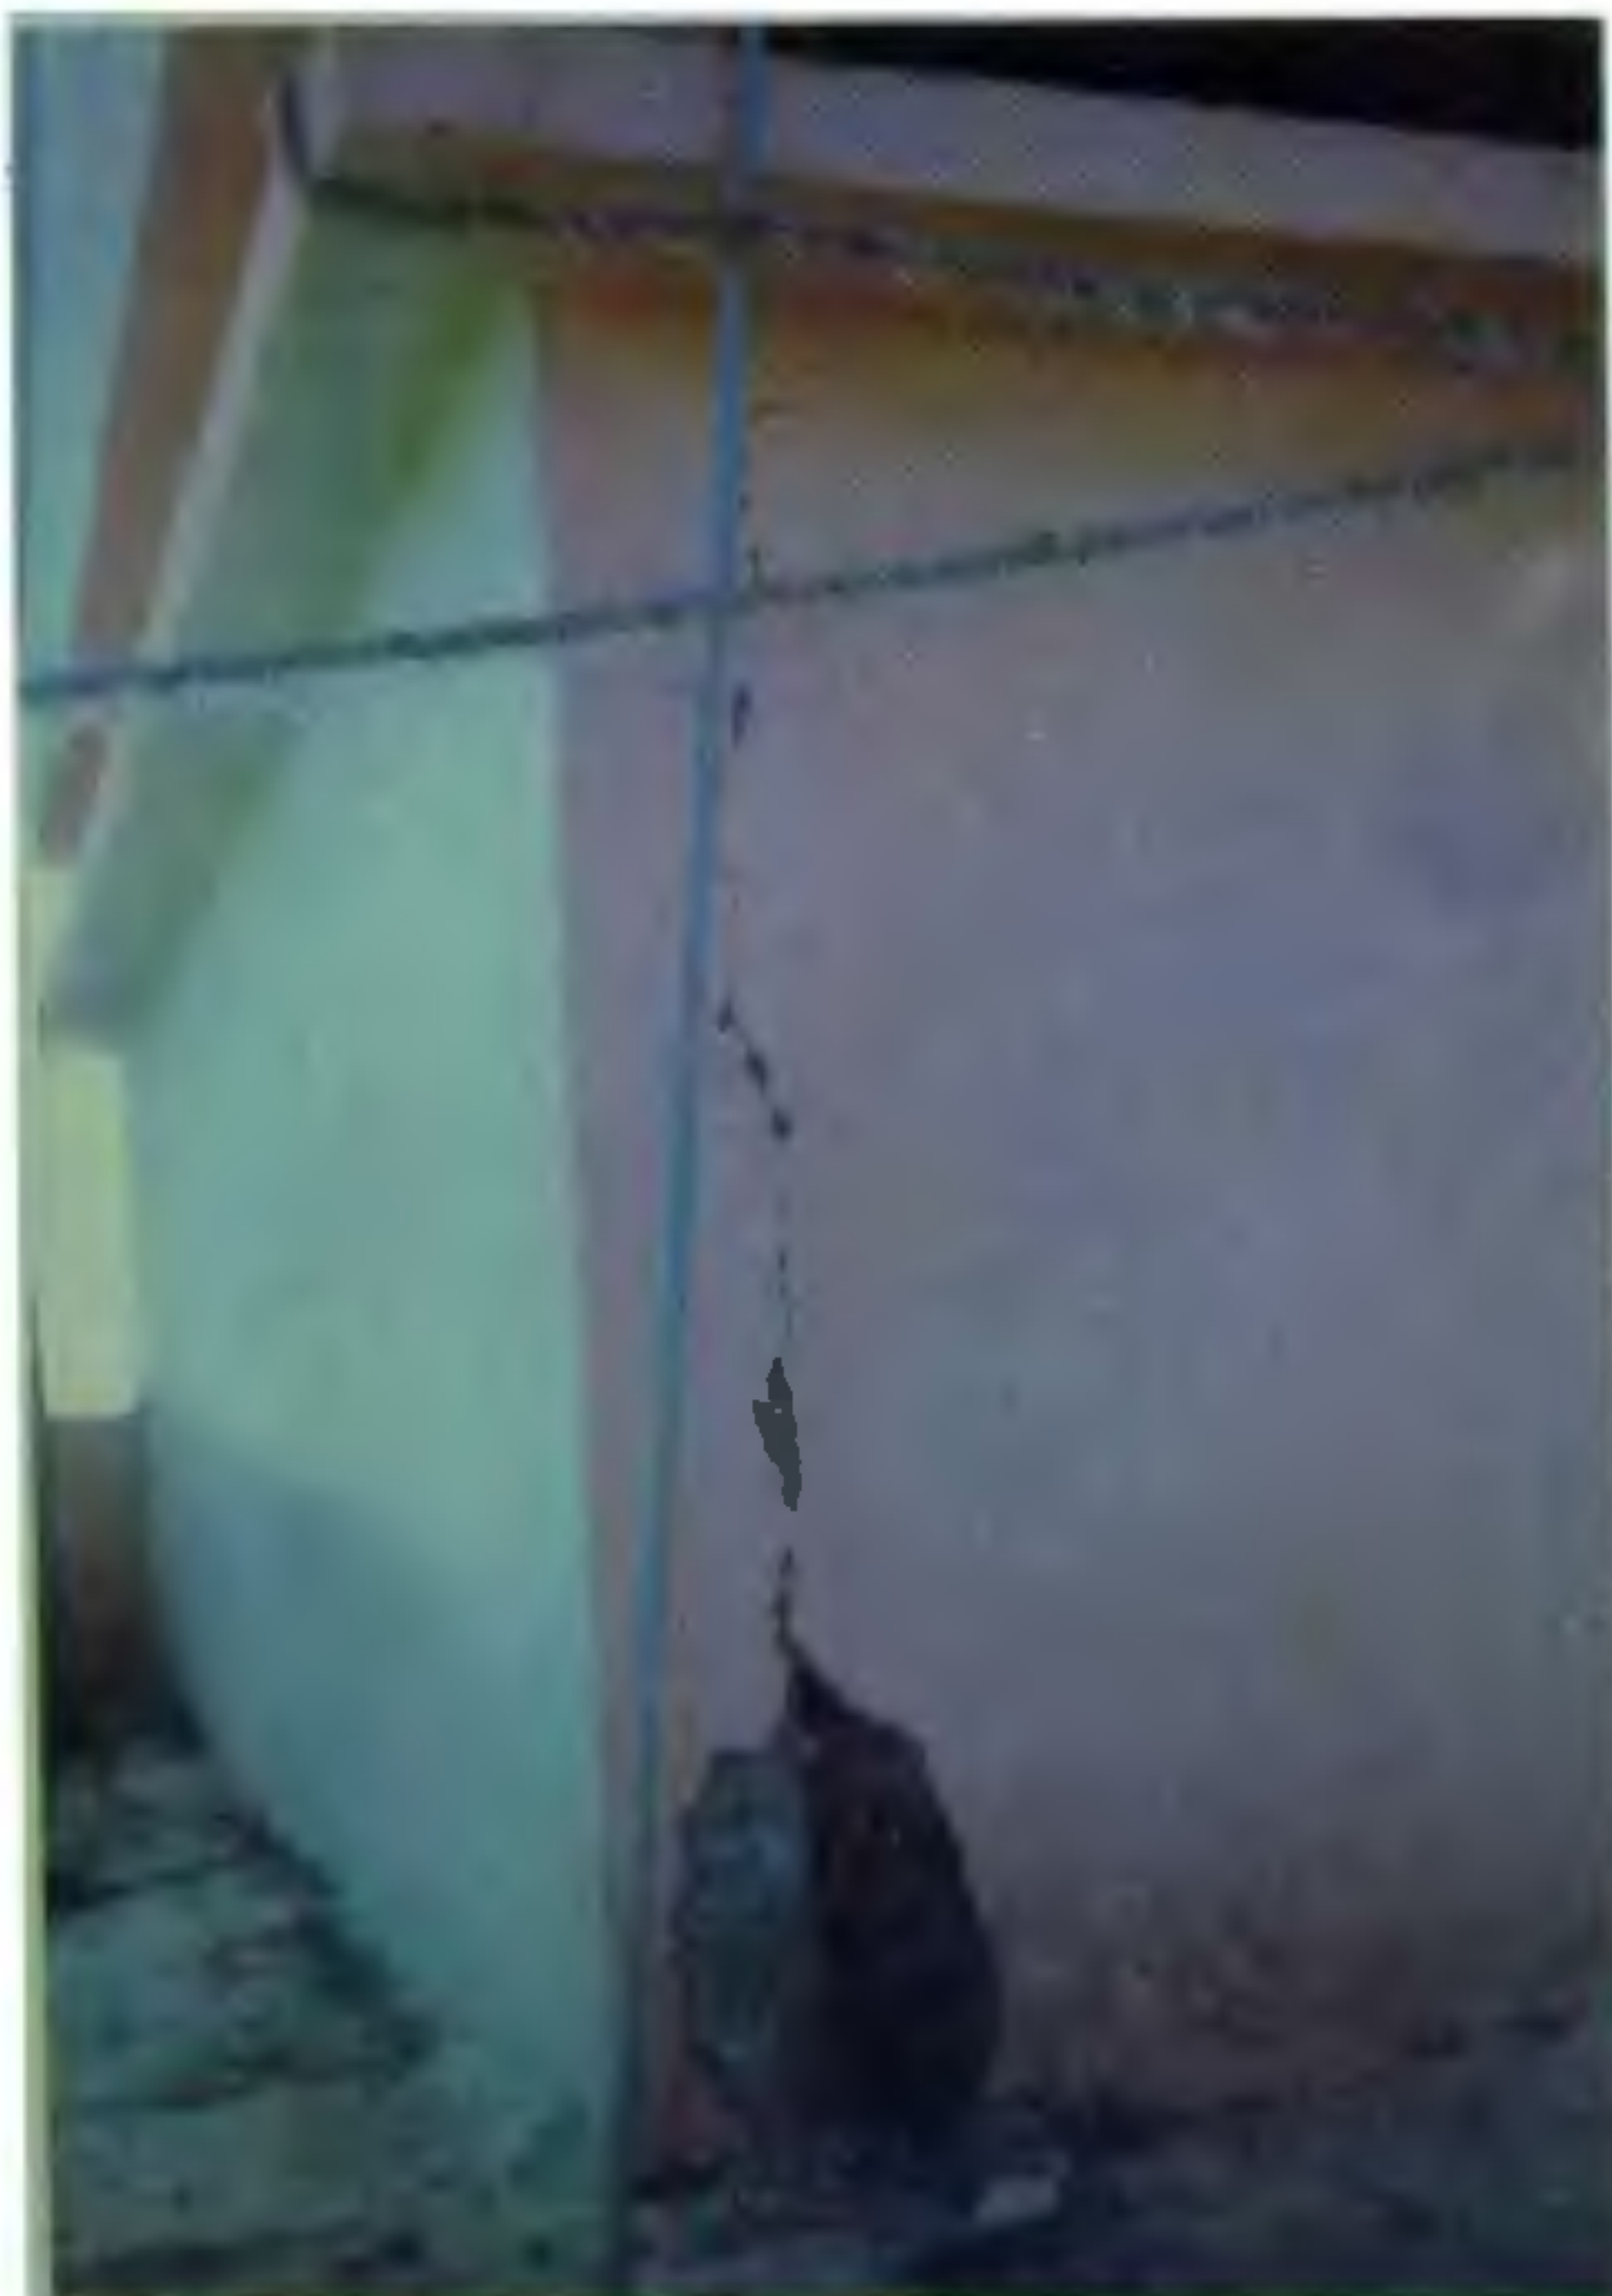
Figure 11. Umerga; Type C structure, grade 1 damage

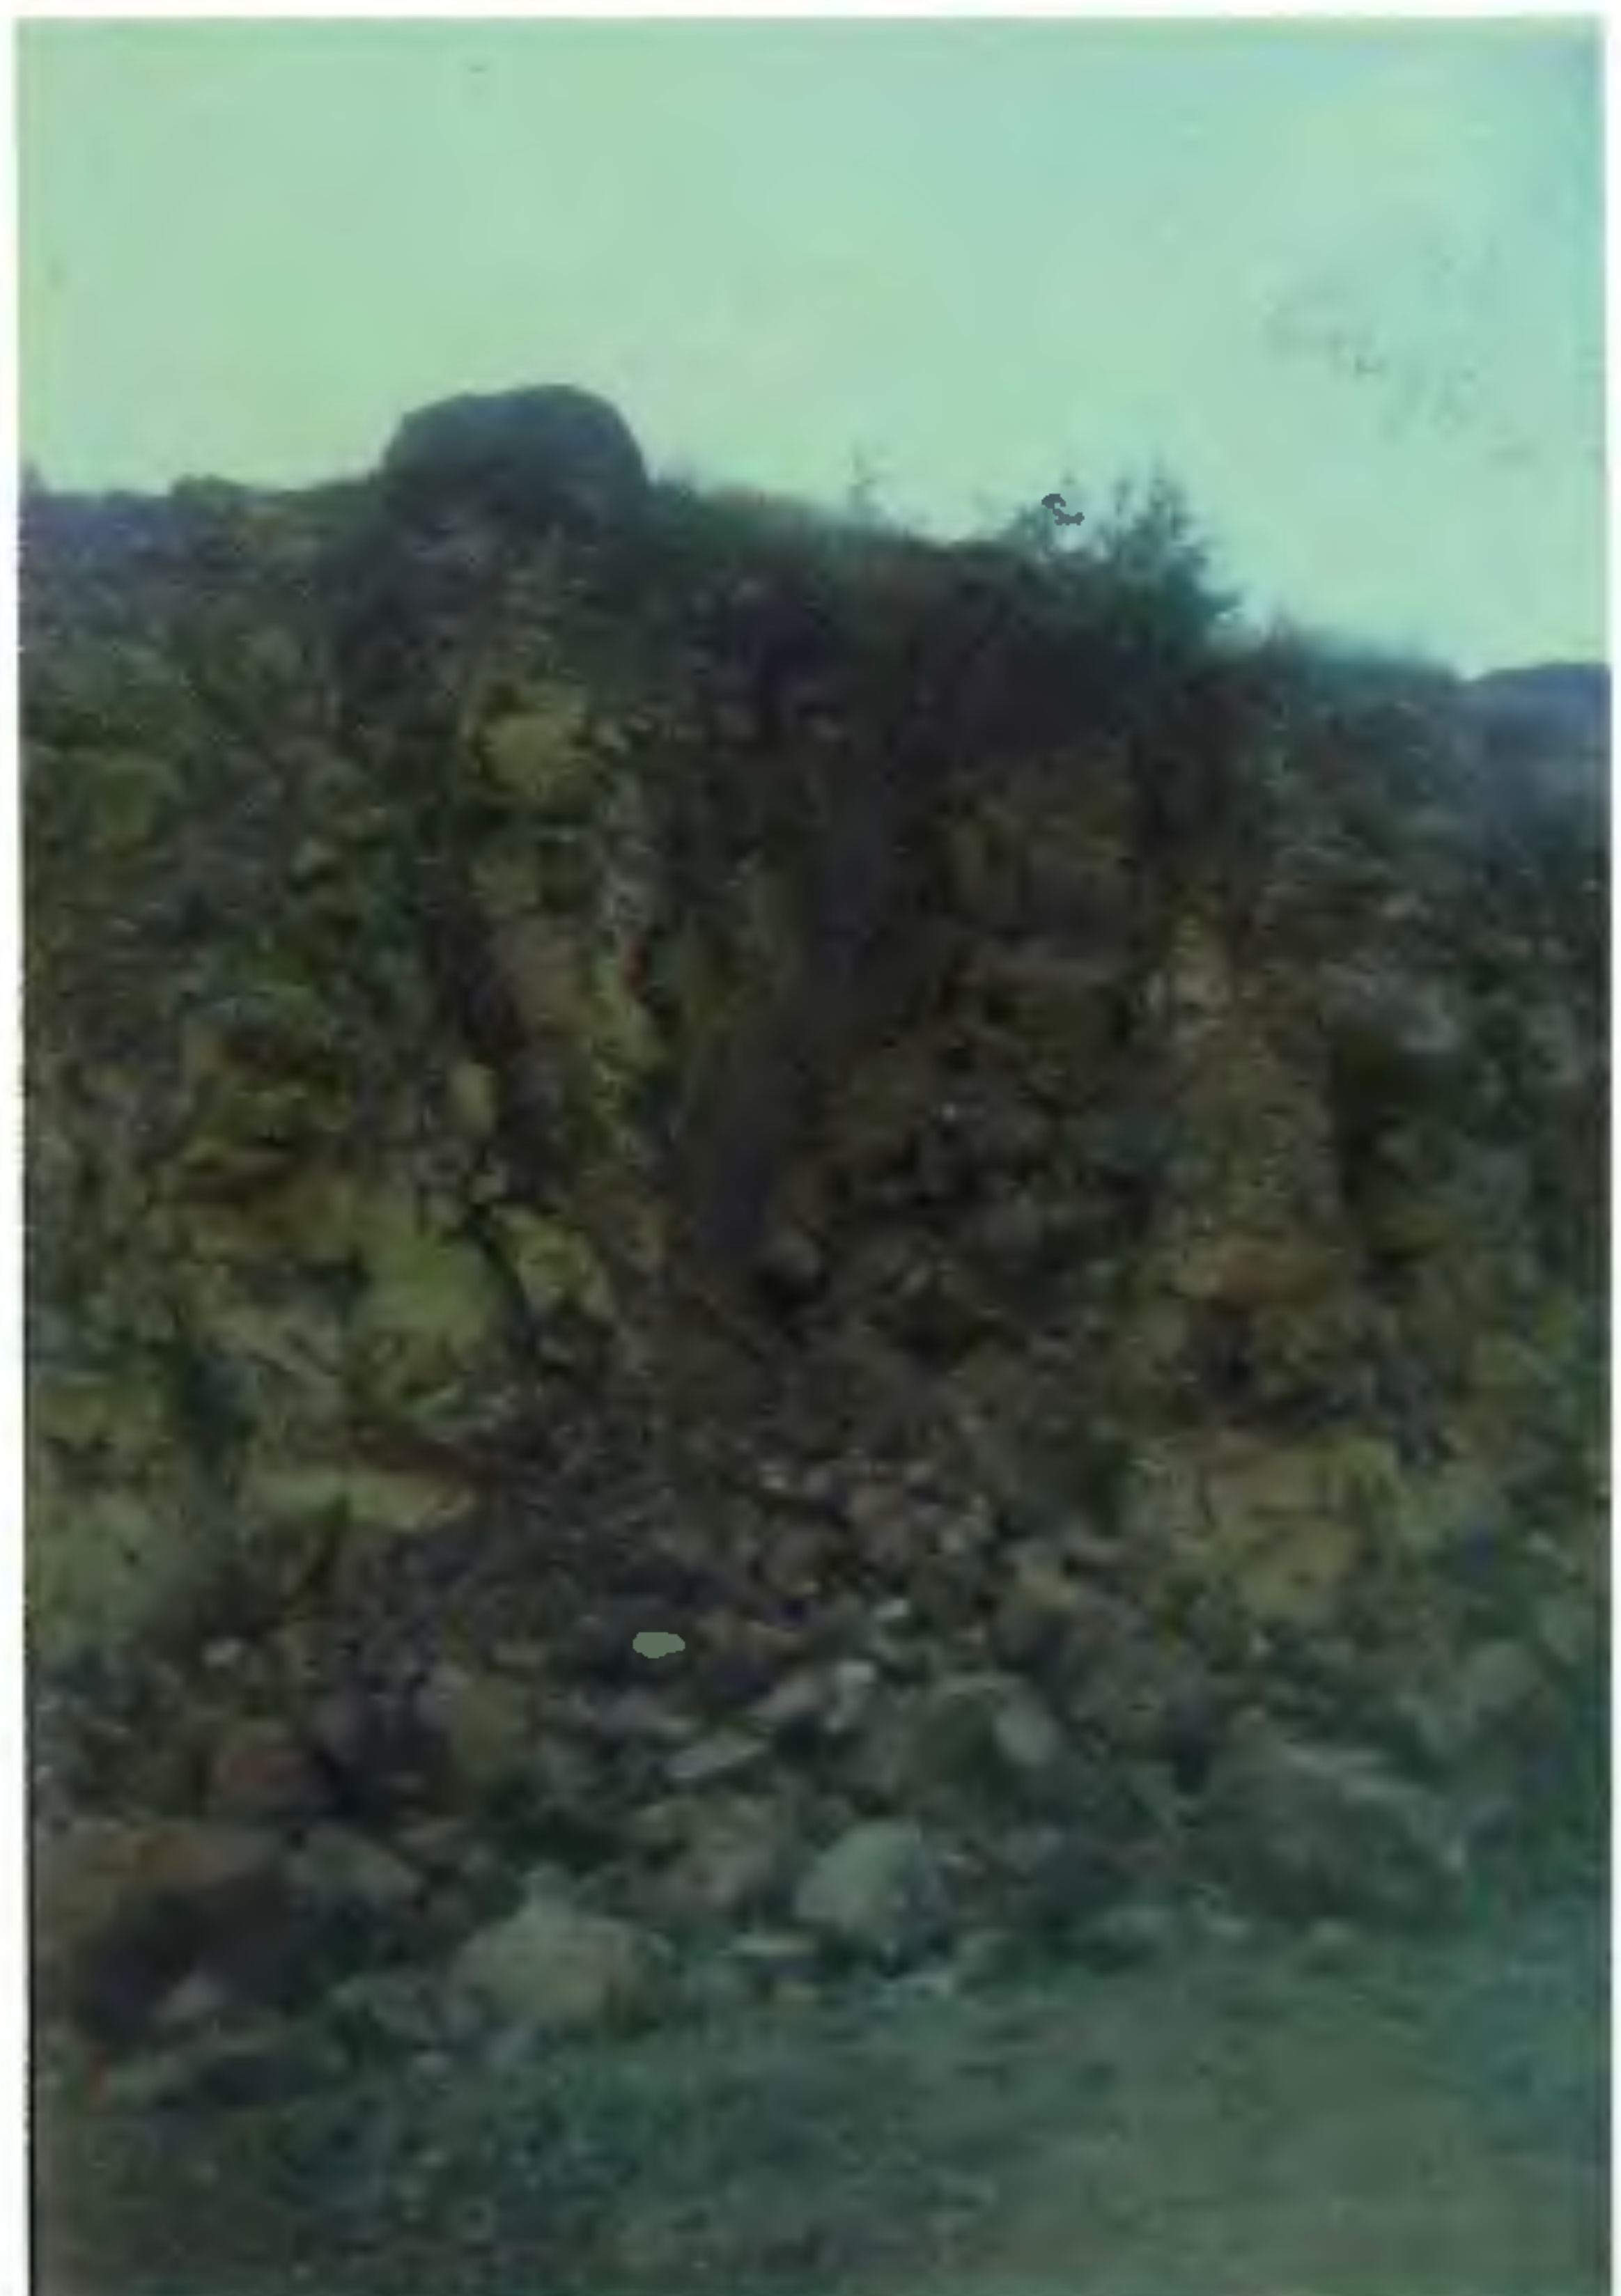
Figure 13. Landslide near Basavakalyan

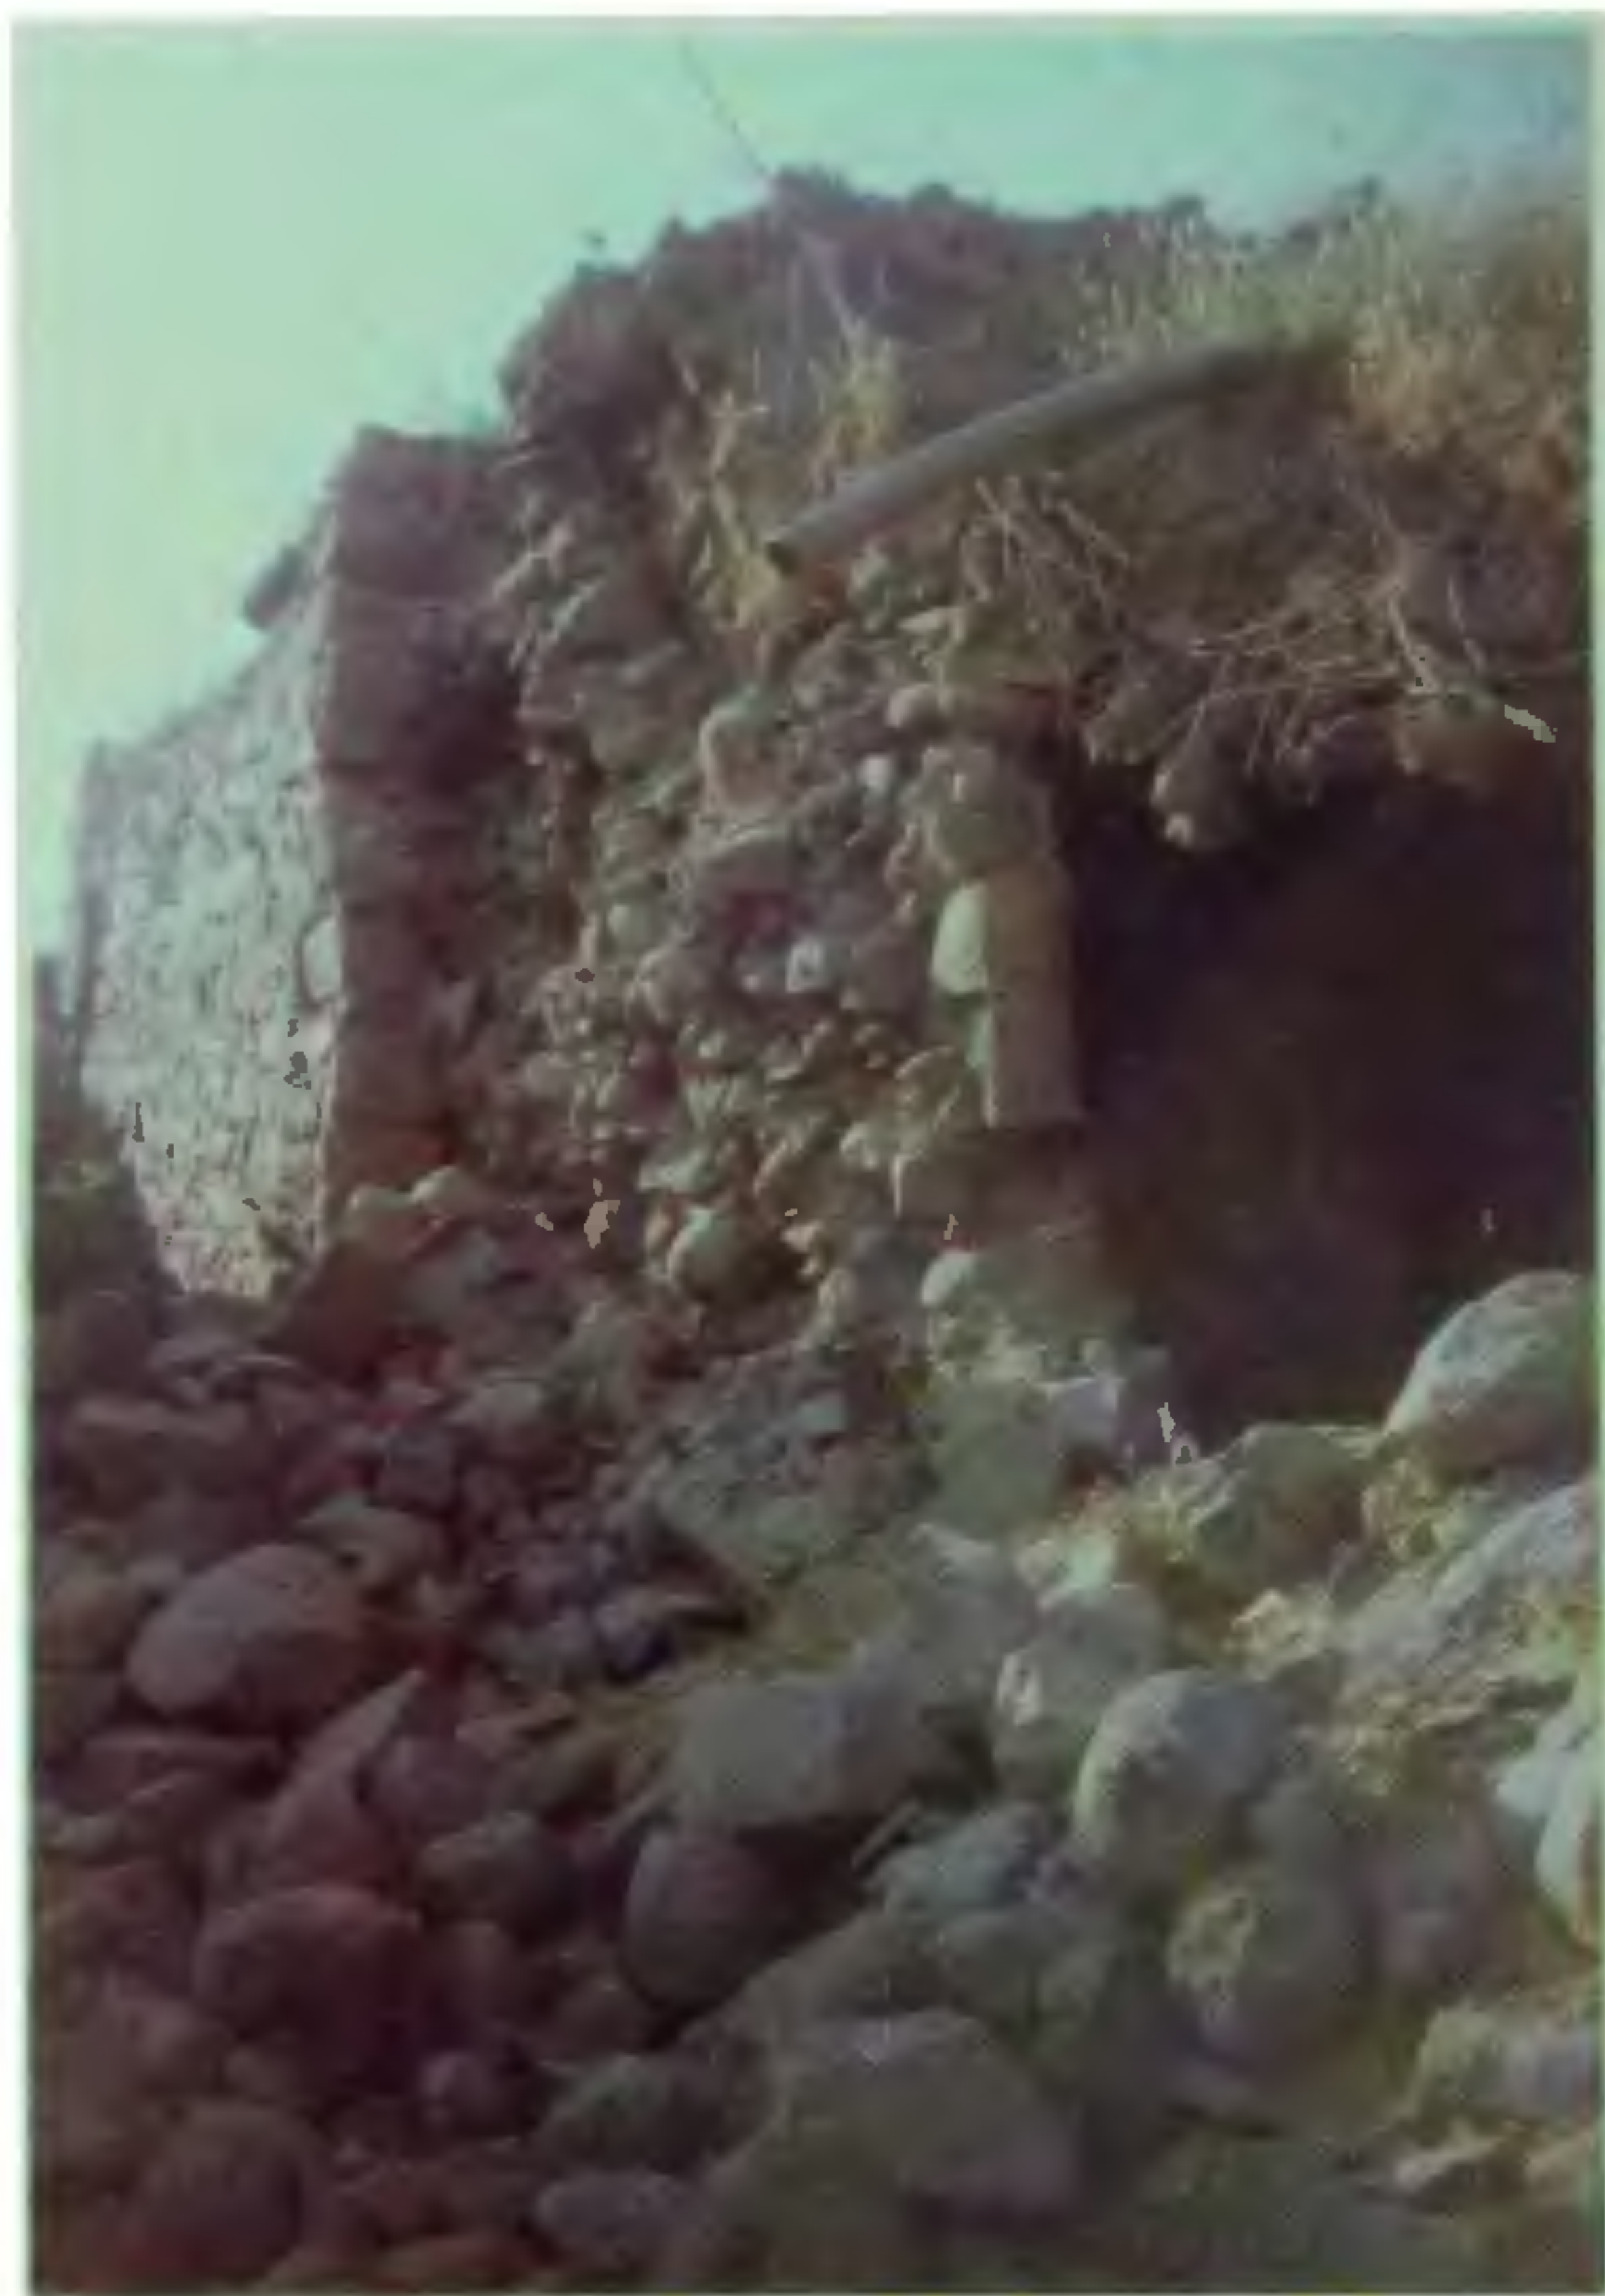
Figure 14. Bhosga-K, Type A structure, grade 4 damage.
