Field investigation of the 30 September 1993 earthquake in Maharashtra

R. N. Iyengar*, C. S. Manohar and O. R. Jaiswal

Department of Civil Engineering, Indian Institute of Science, Bangalore 560 012, India

An engineering field study of the 30 September Marathwada earthquake is reported. The study covered Osmanabad, Latur, Sholapur, Bijapur, Gulbarga and Bidar districts. The level of ground acceleration was estimated based on tilting of free standing objects. The study shows that the epicentral intensity has been VIII on the UNESCO scale. The horizontal ground acceleration near the epicentre has been estimated to be about 0.2 g.

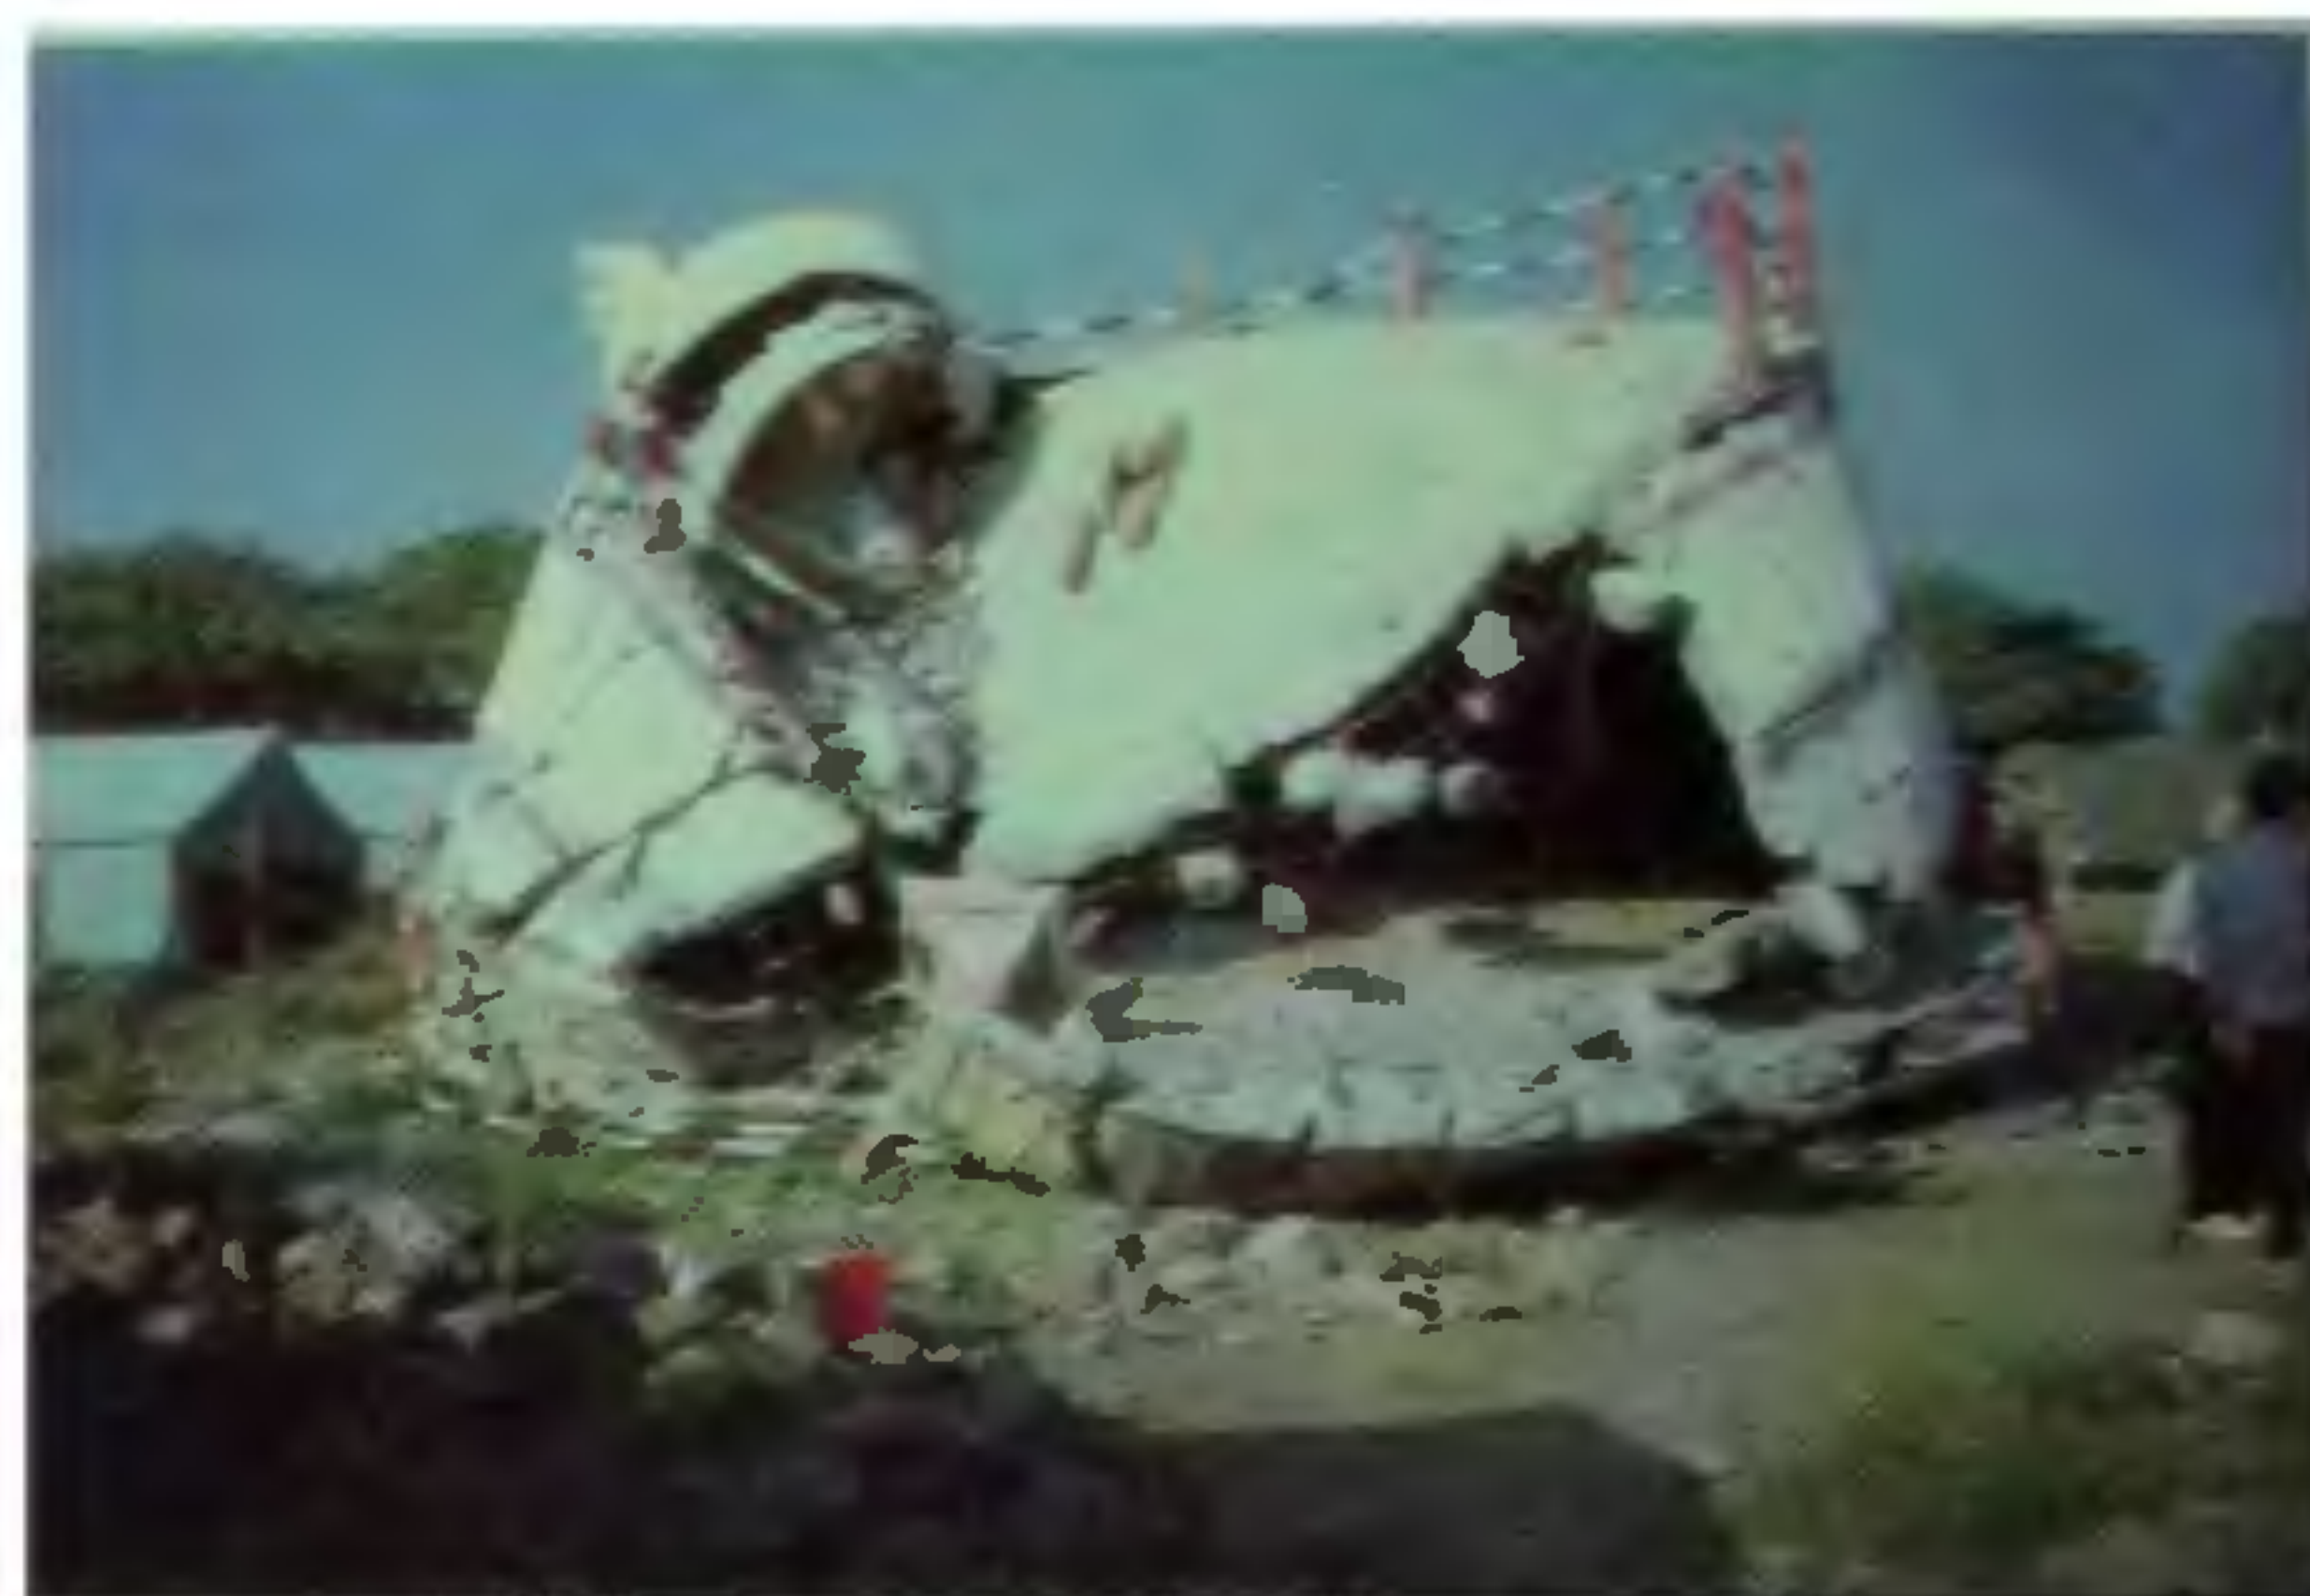
Figure 16. Circular water tank at Kavatha.

We inspected several engineered structures such as water tanks, earthen dams, hydraulic works, bridges, industrial structures and electric substations in the affected area. Figures 16–19 show some of the conspicuous scenes of damage observed. Among these, the catastrophic failure of the overhead water tank at the epicentral village of Kavatha is the most striking (Figure 16). This structure had a spiral staircase adjoining the circular tank portion which made the structure asymmetric in plan. Further, the tank was reportedly partially filled at the time of the earthquake. It is of interest to note that a water

tank of similar design has survived the earthquake in the town of Umerga 20 km away. Also, rectangular overhead water tanks in the epicentral villages of Khilari and Sastur are still safe. The earthen dam at Makni, about 15 km away from Khilari, developed a 15 m long, 1.2 m deep and 10 to 15 cm wide longitudinal crack at the top (Figure 17). This dam is about 15 m tall, 1.5 km long and has a central concrete masonry control structure of about 400 m long flanked by earth sections. In the top portion of the dam, junctions between the masonry and earth parts showed signs of severe distress. The earthen dam at the Upper Mullamari project near Hallikhed-K, in Bidar district, about 70 km away from the epicentre has remained unaffected. On the other hand, a 200-year-old stone masonry earth-retaining structure collapsed in the village of Kohinoor Pahad, Bidar district, at an epicentral distance of 50 km (Figure 18).

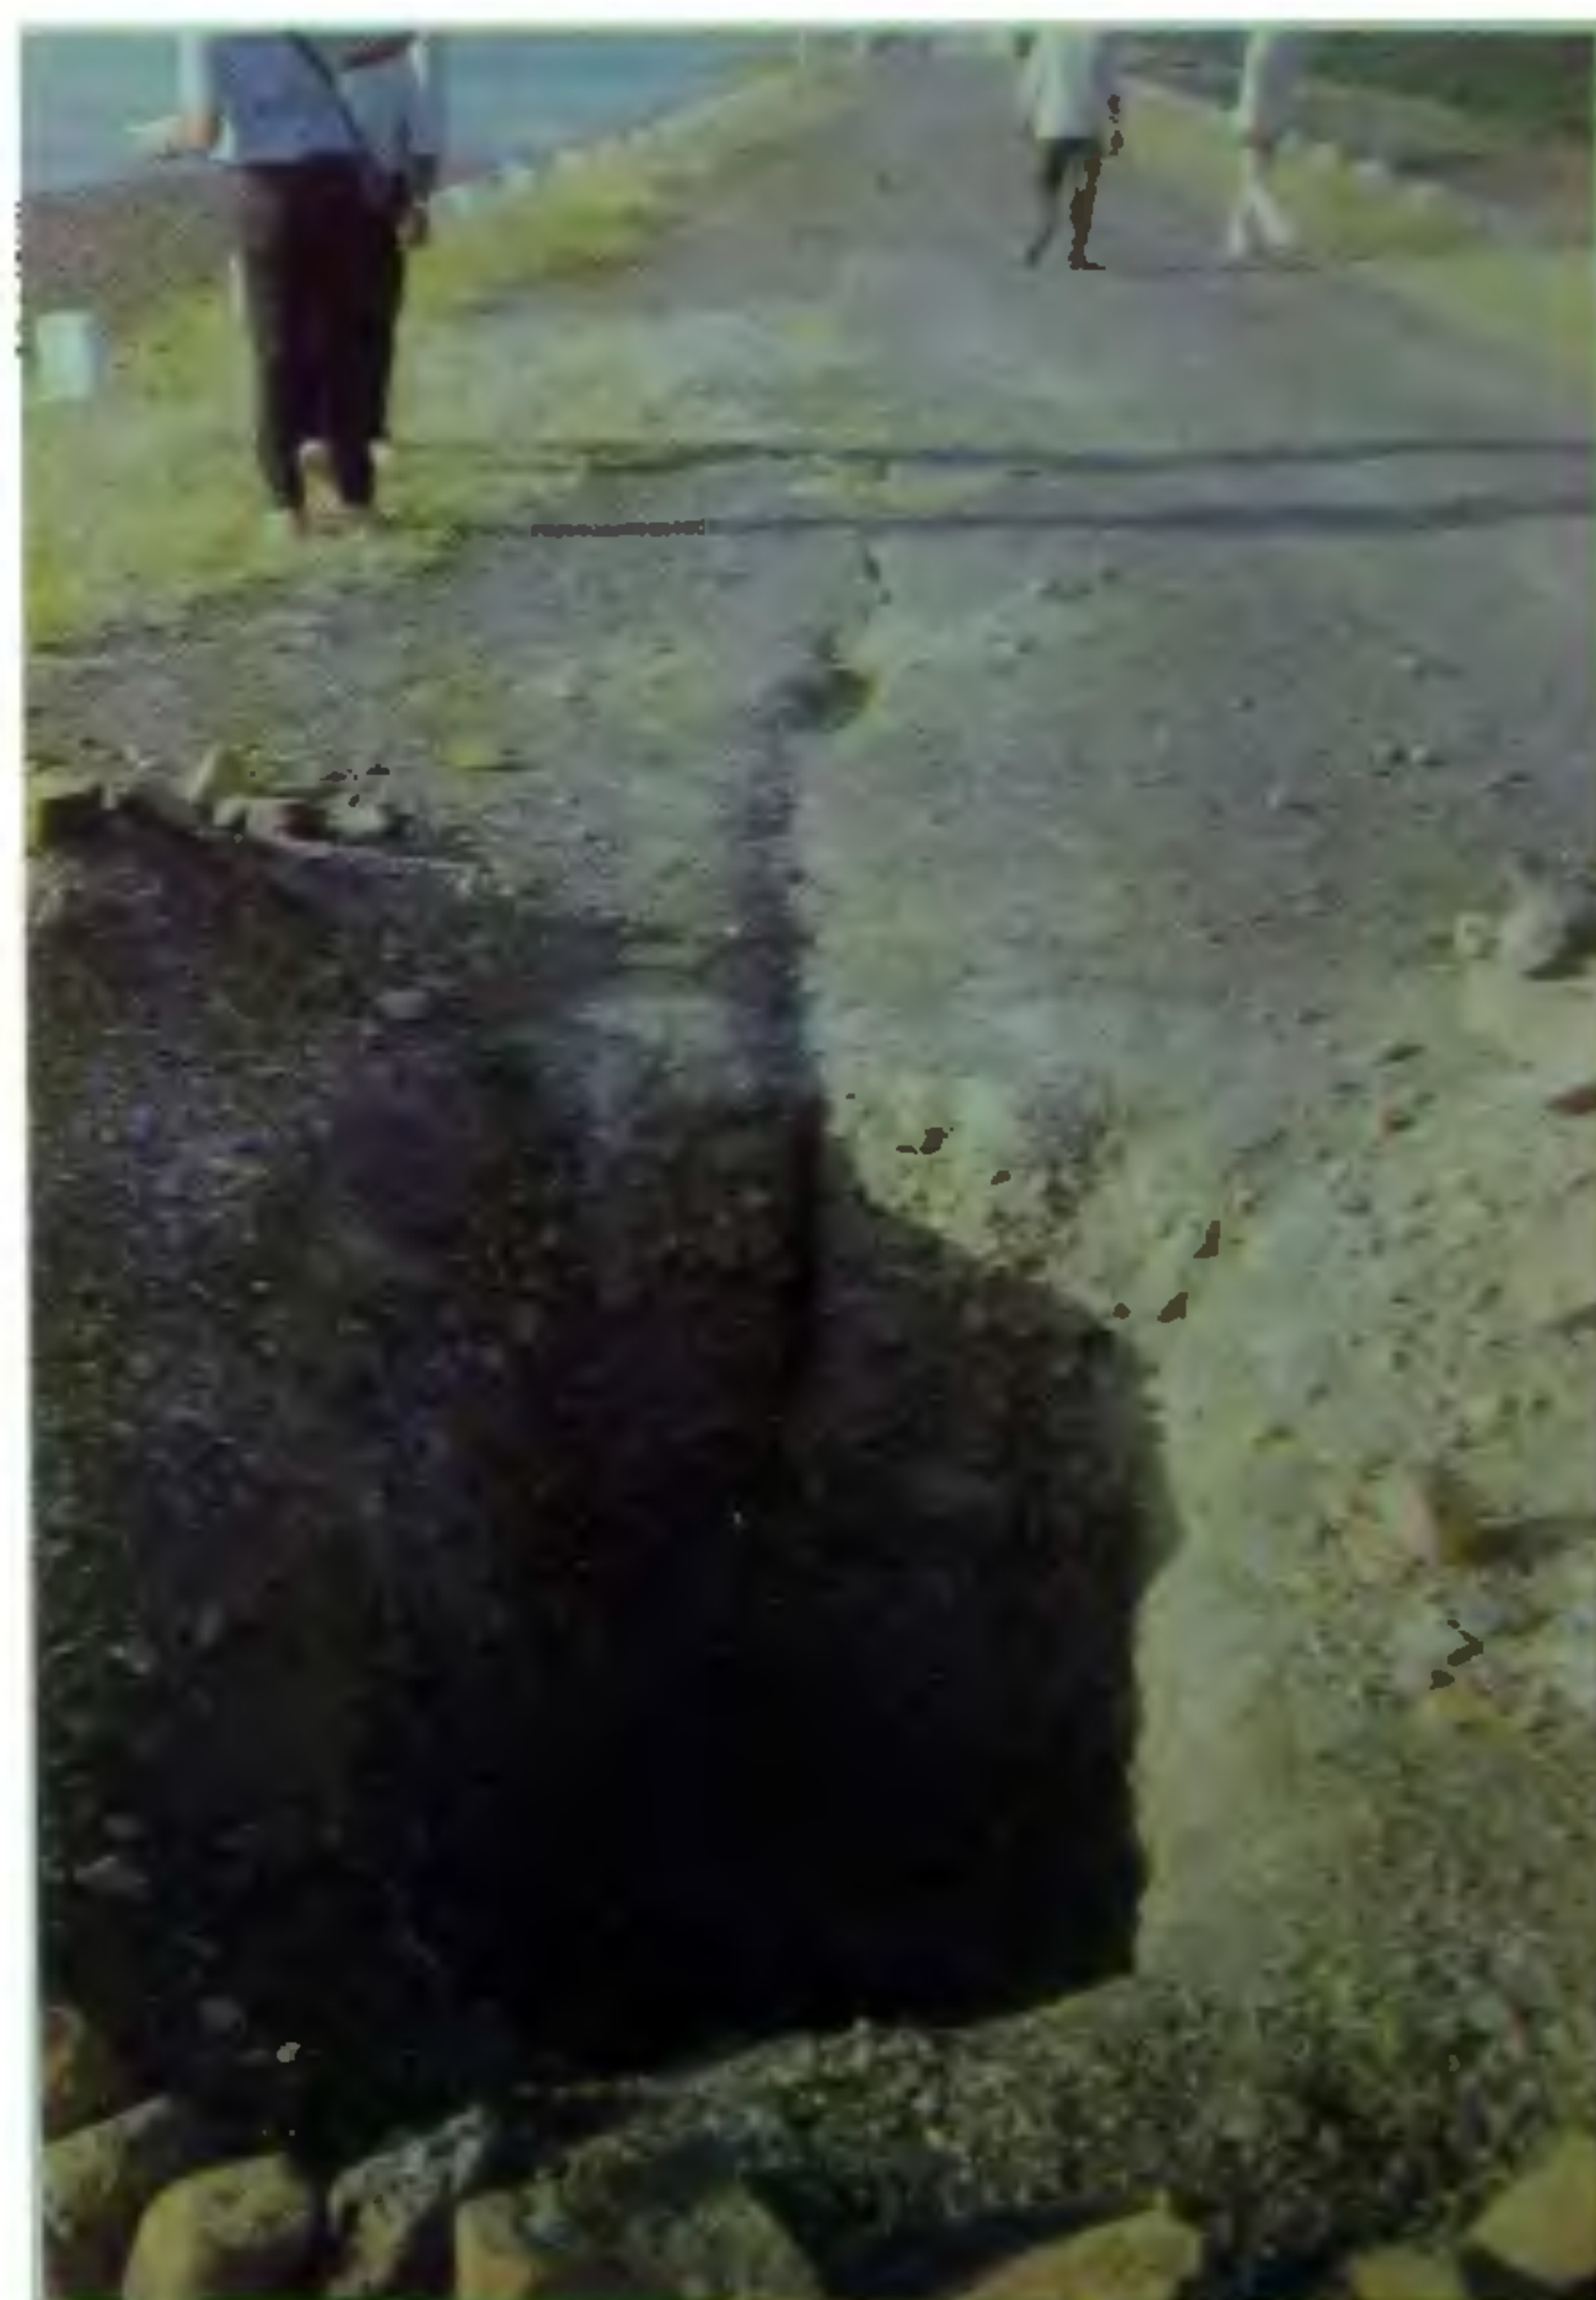
Figure 17. Crack on the top of the Makmi dam (pit was dug for inspection).

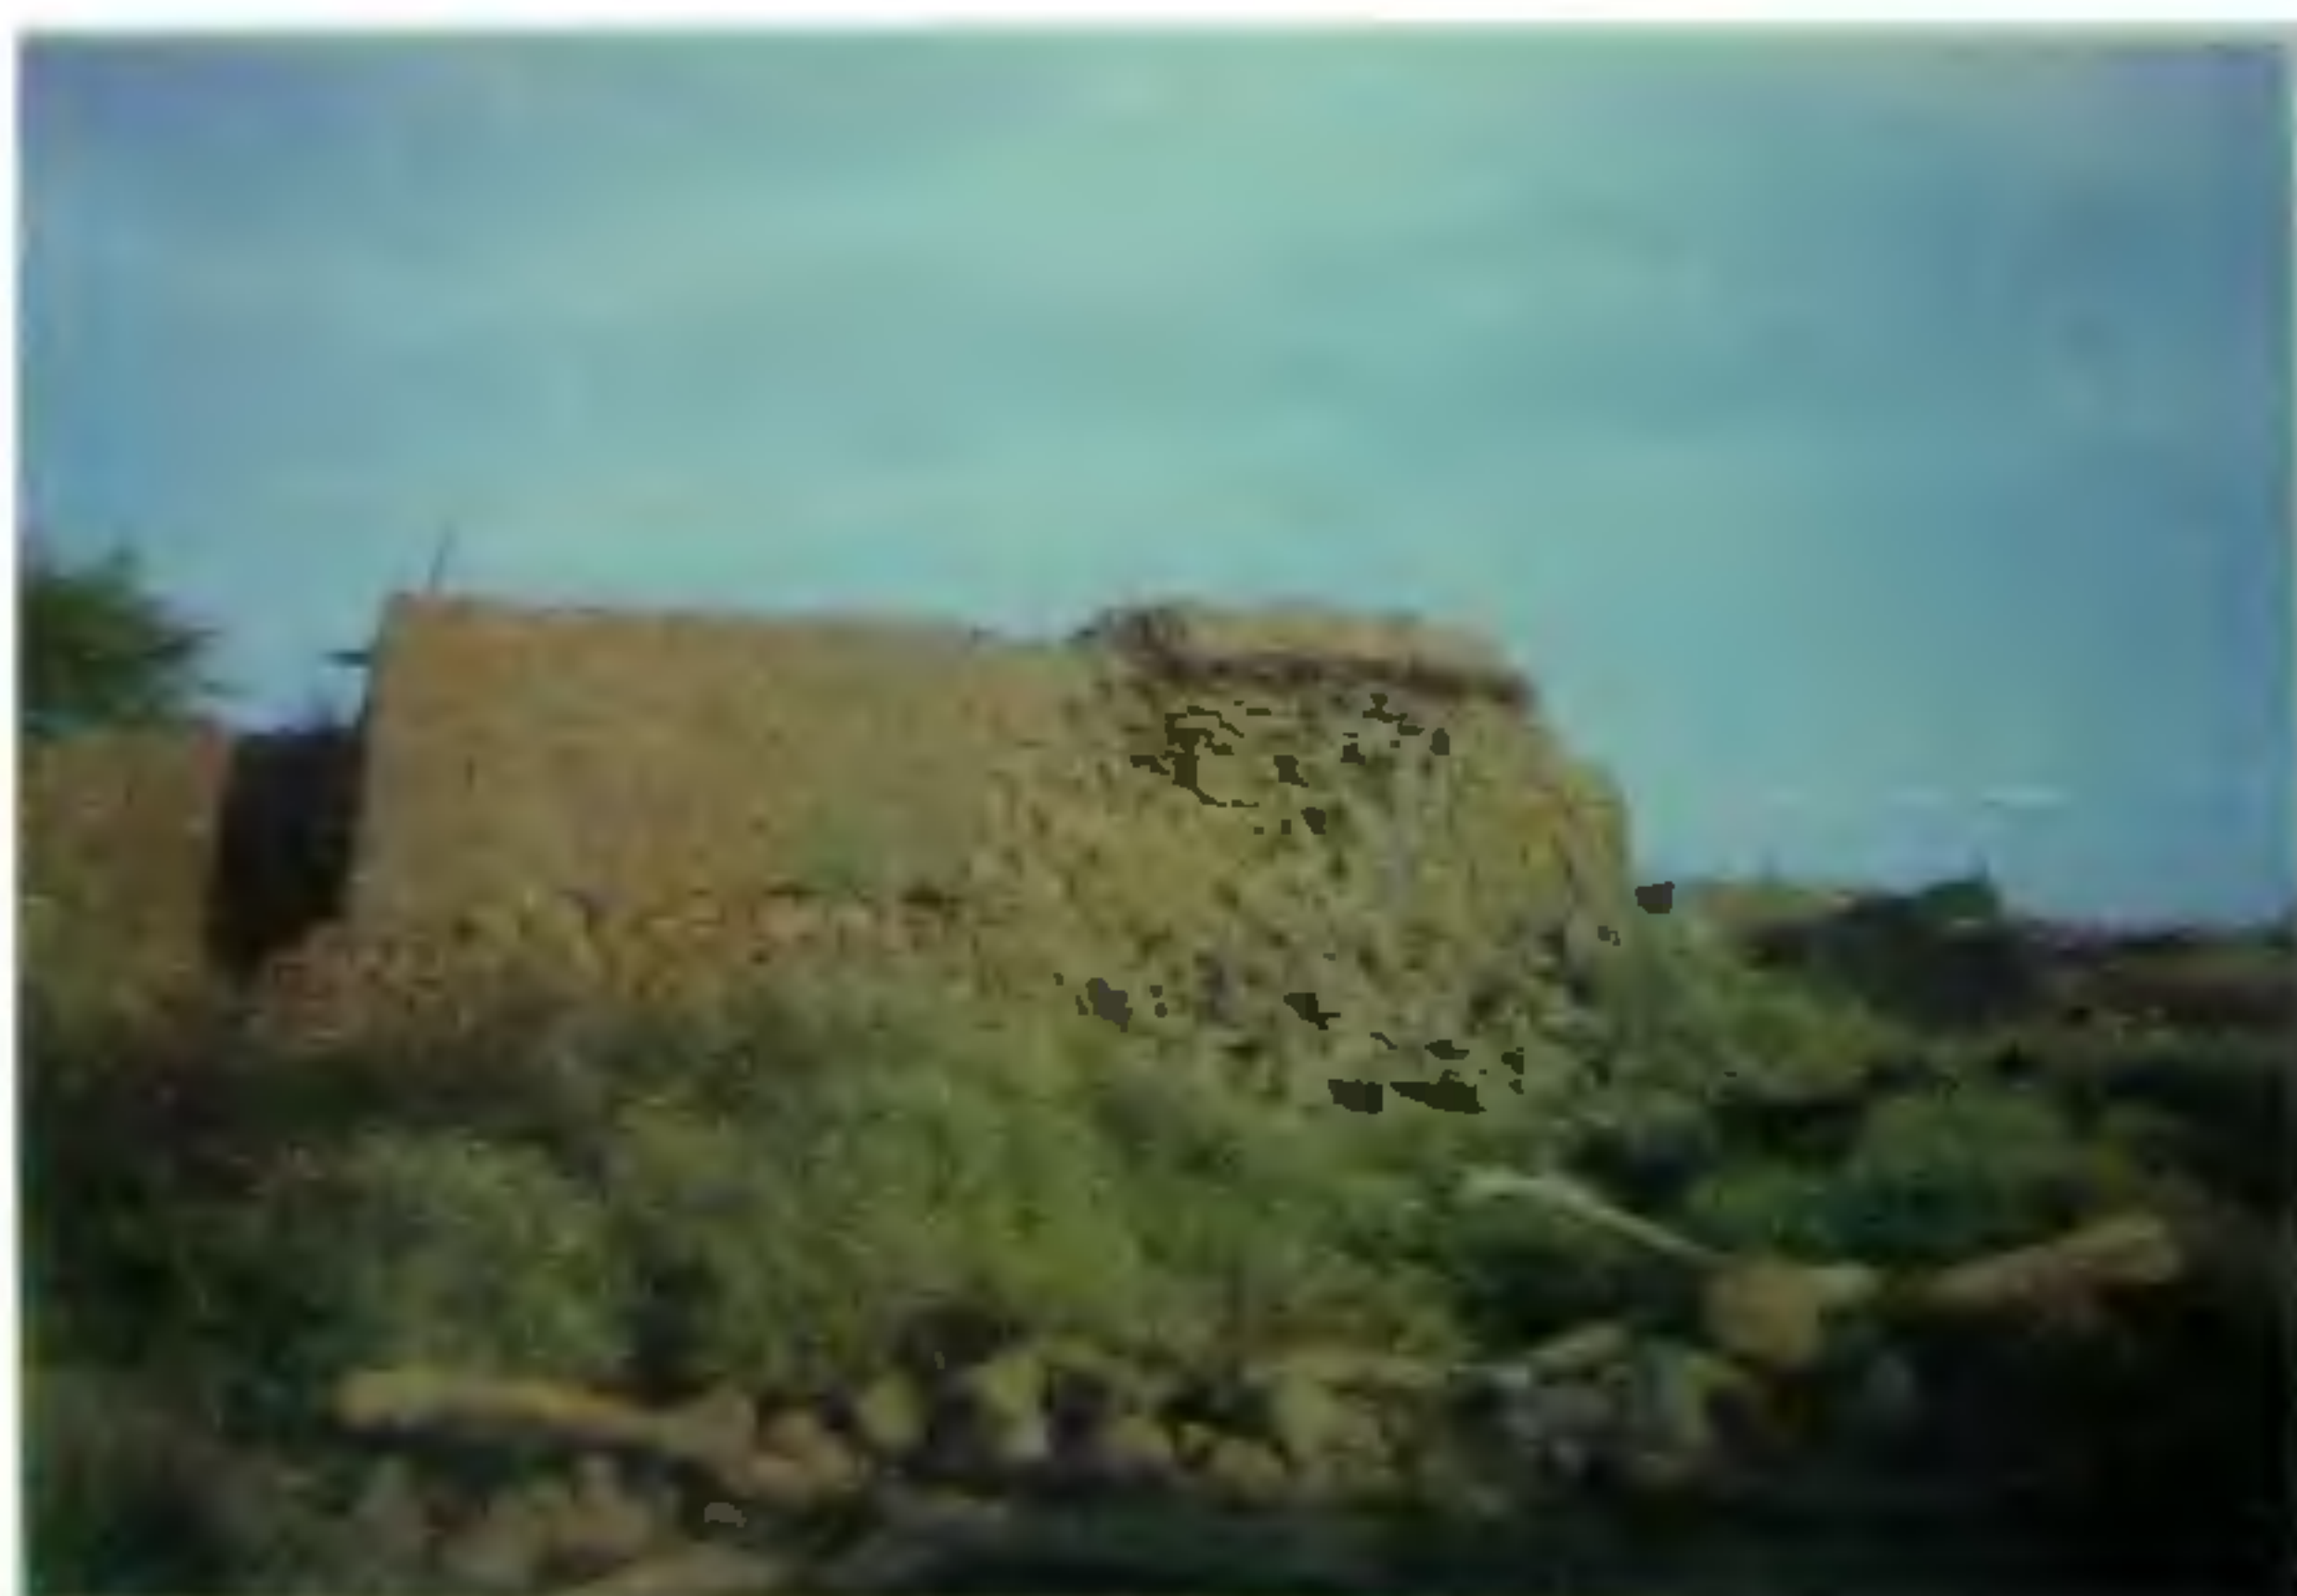
Figure 15. Bhosga-K, Type A structure, grade 3 damage.

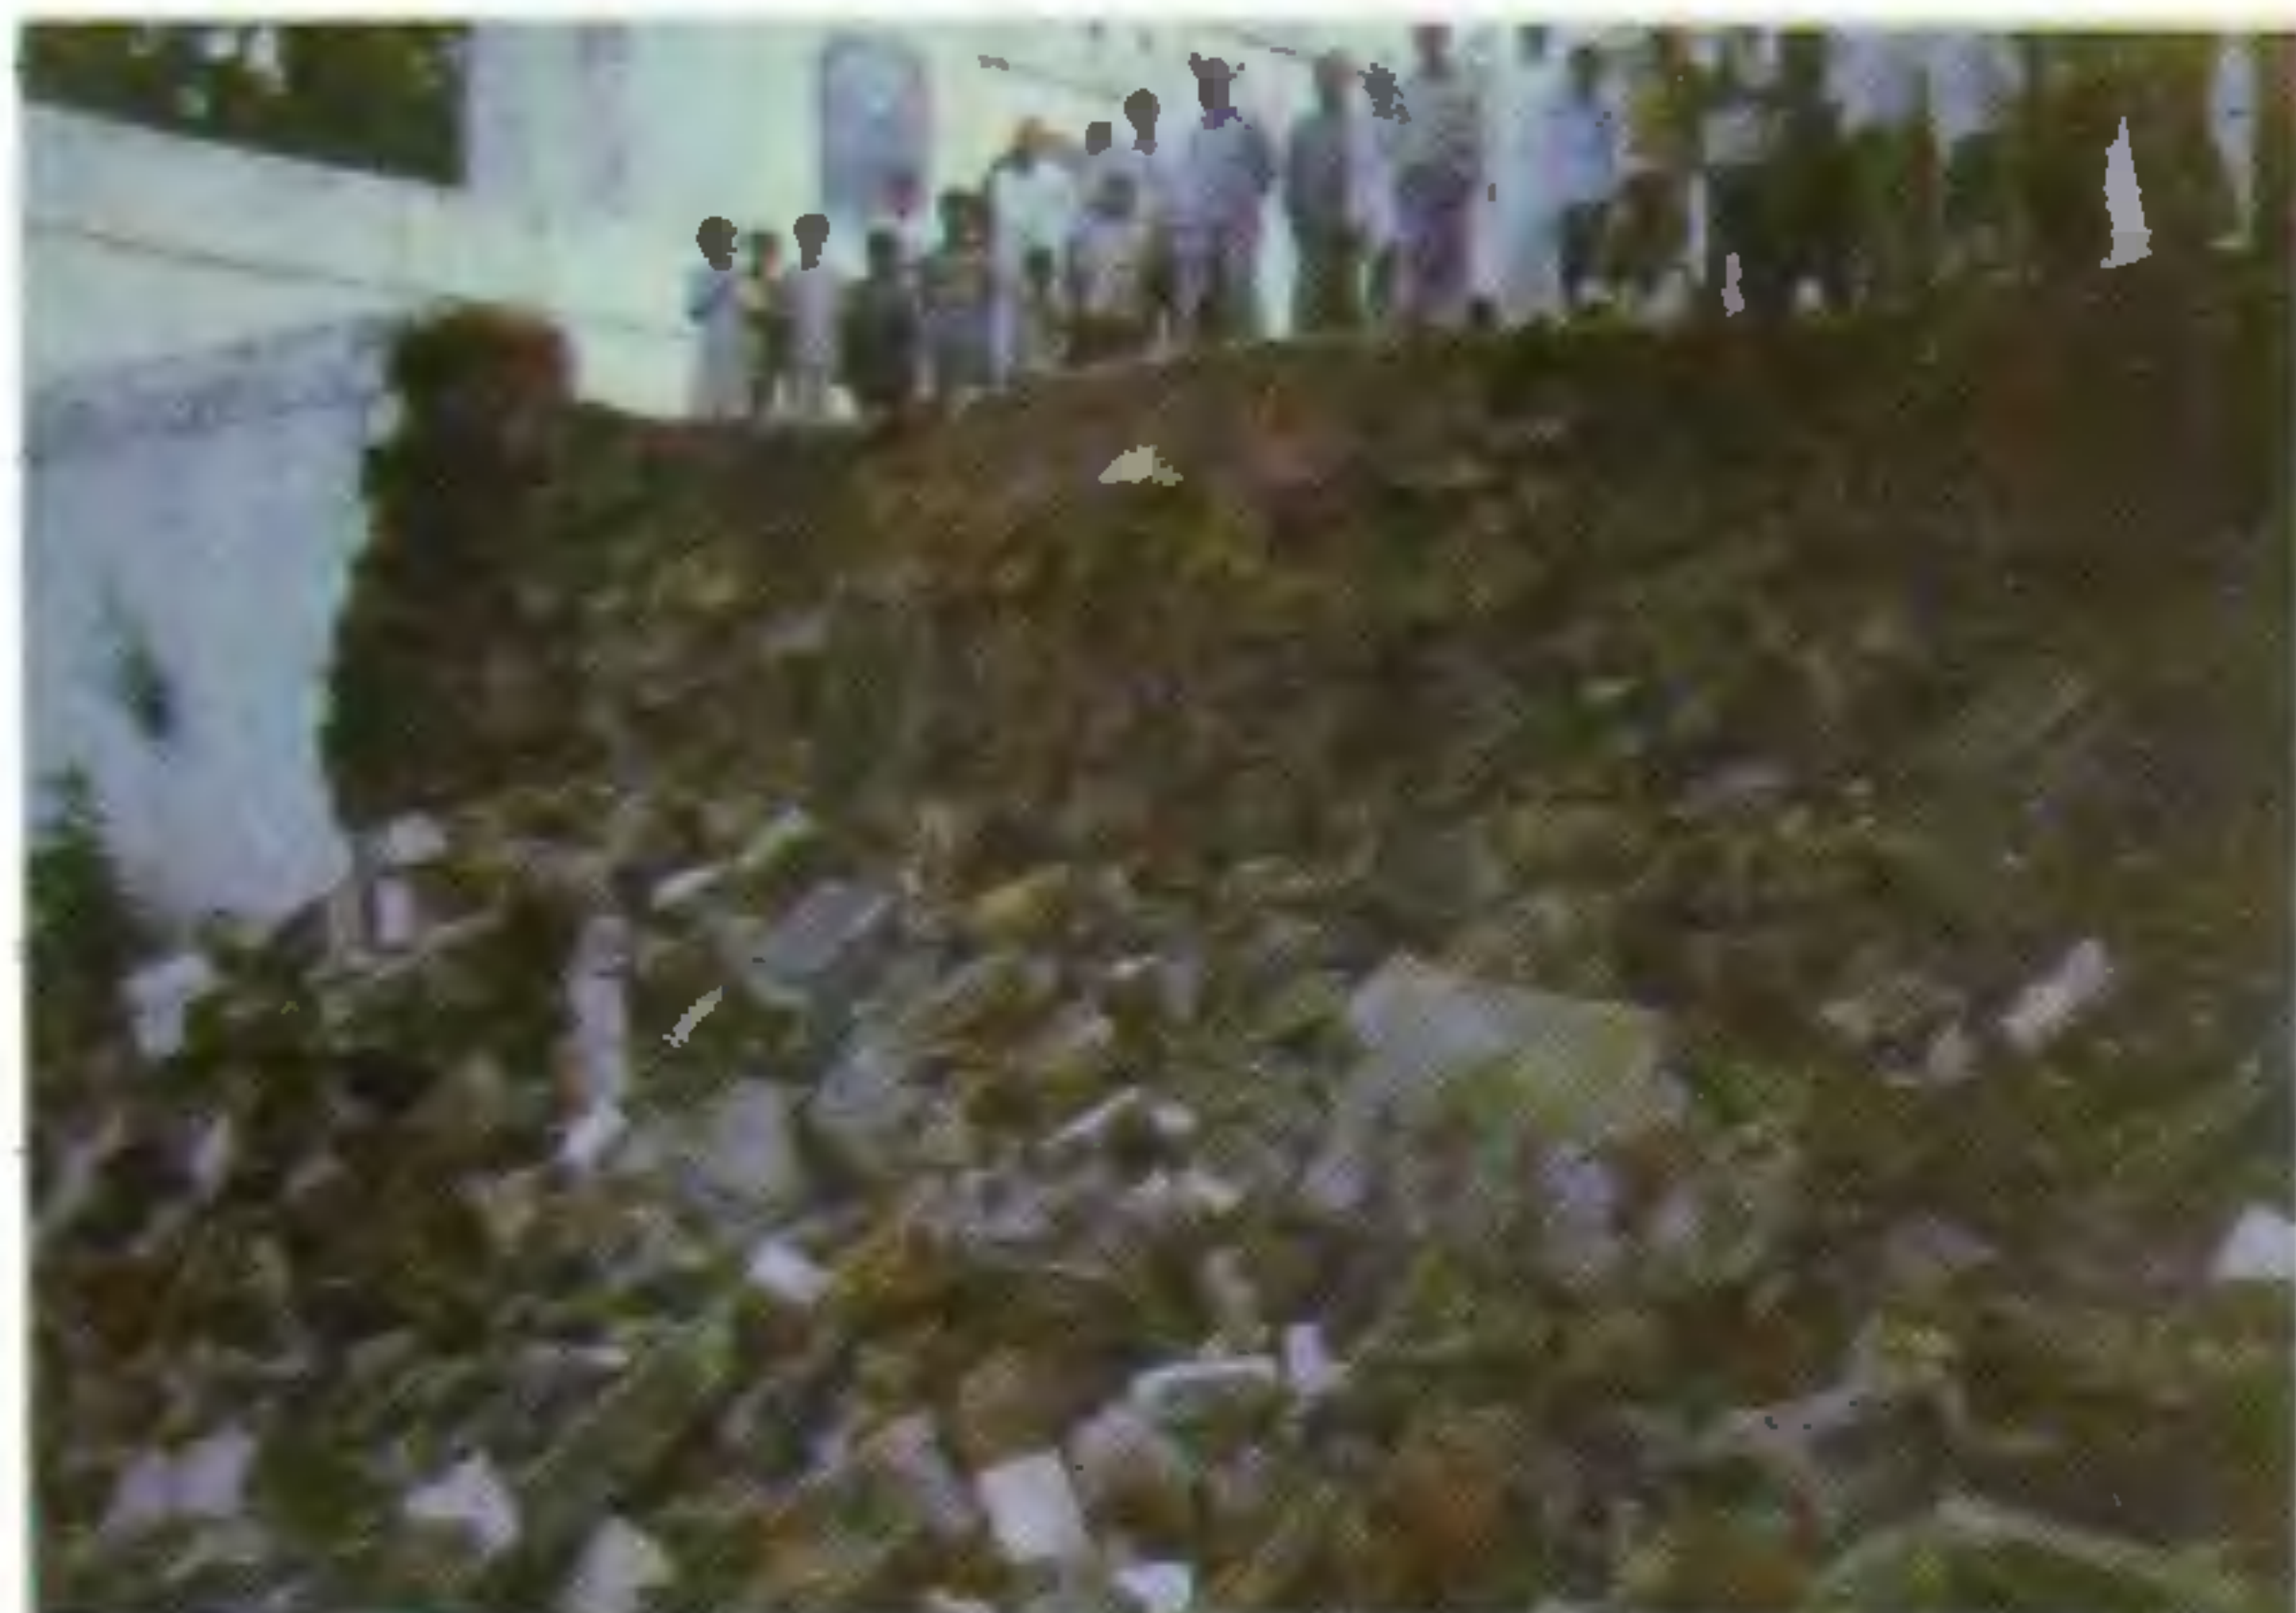
Figure 18. Retaining wall failure at Kohinoor Pahad near Basavakalyan, Bidar district.

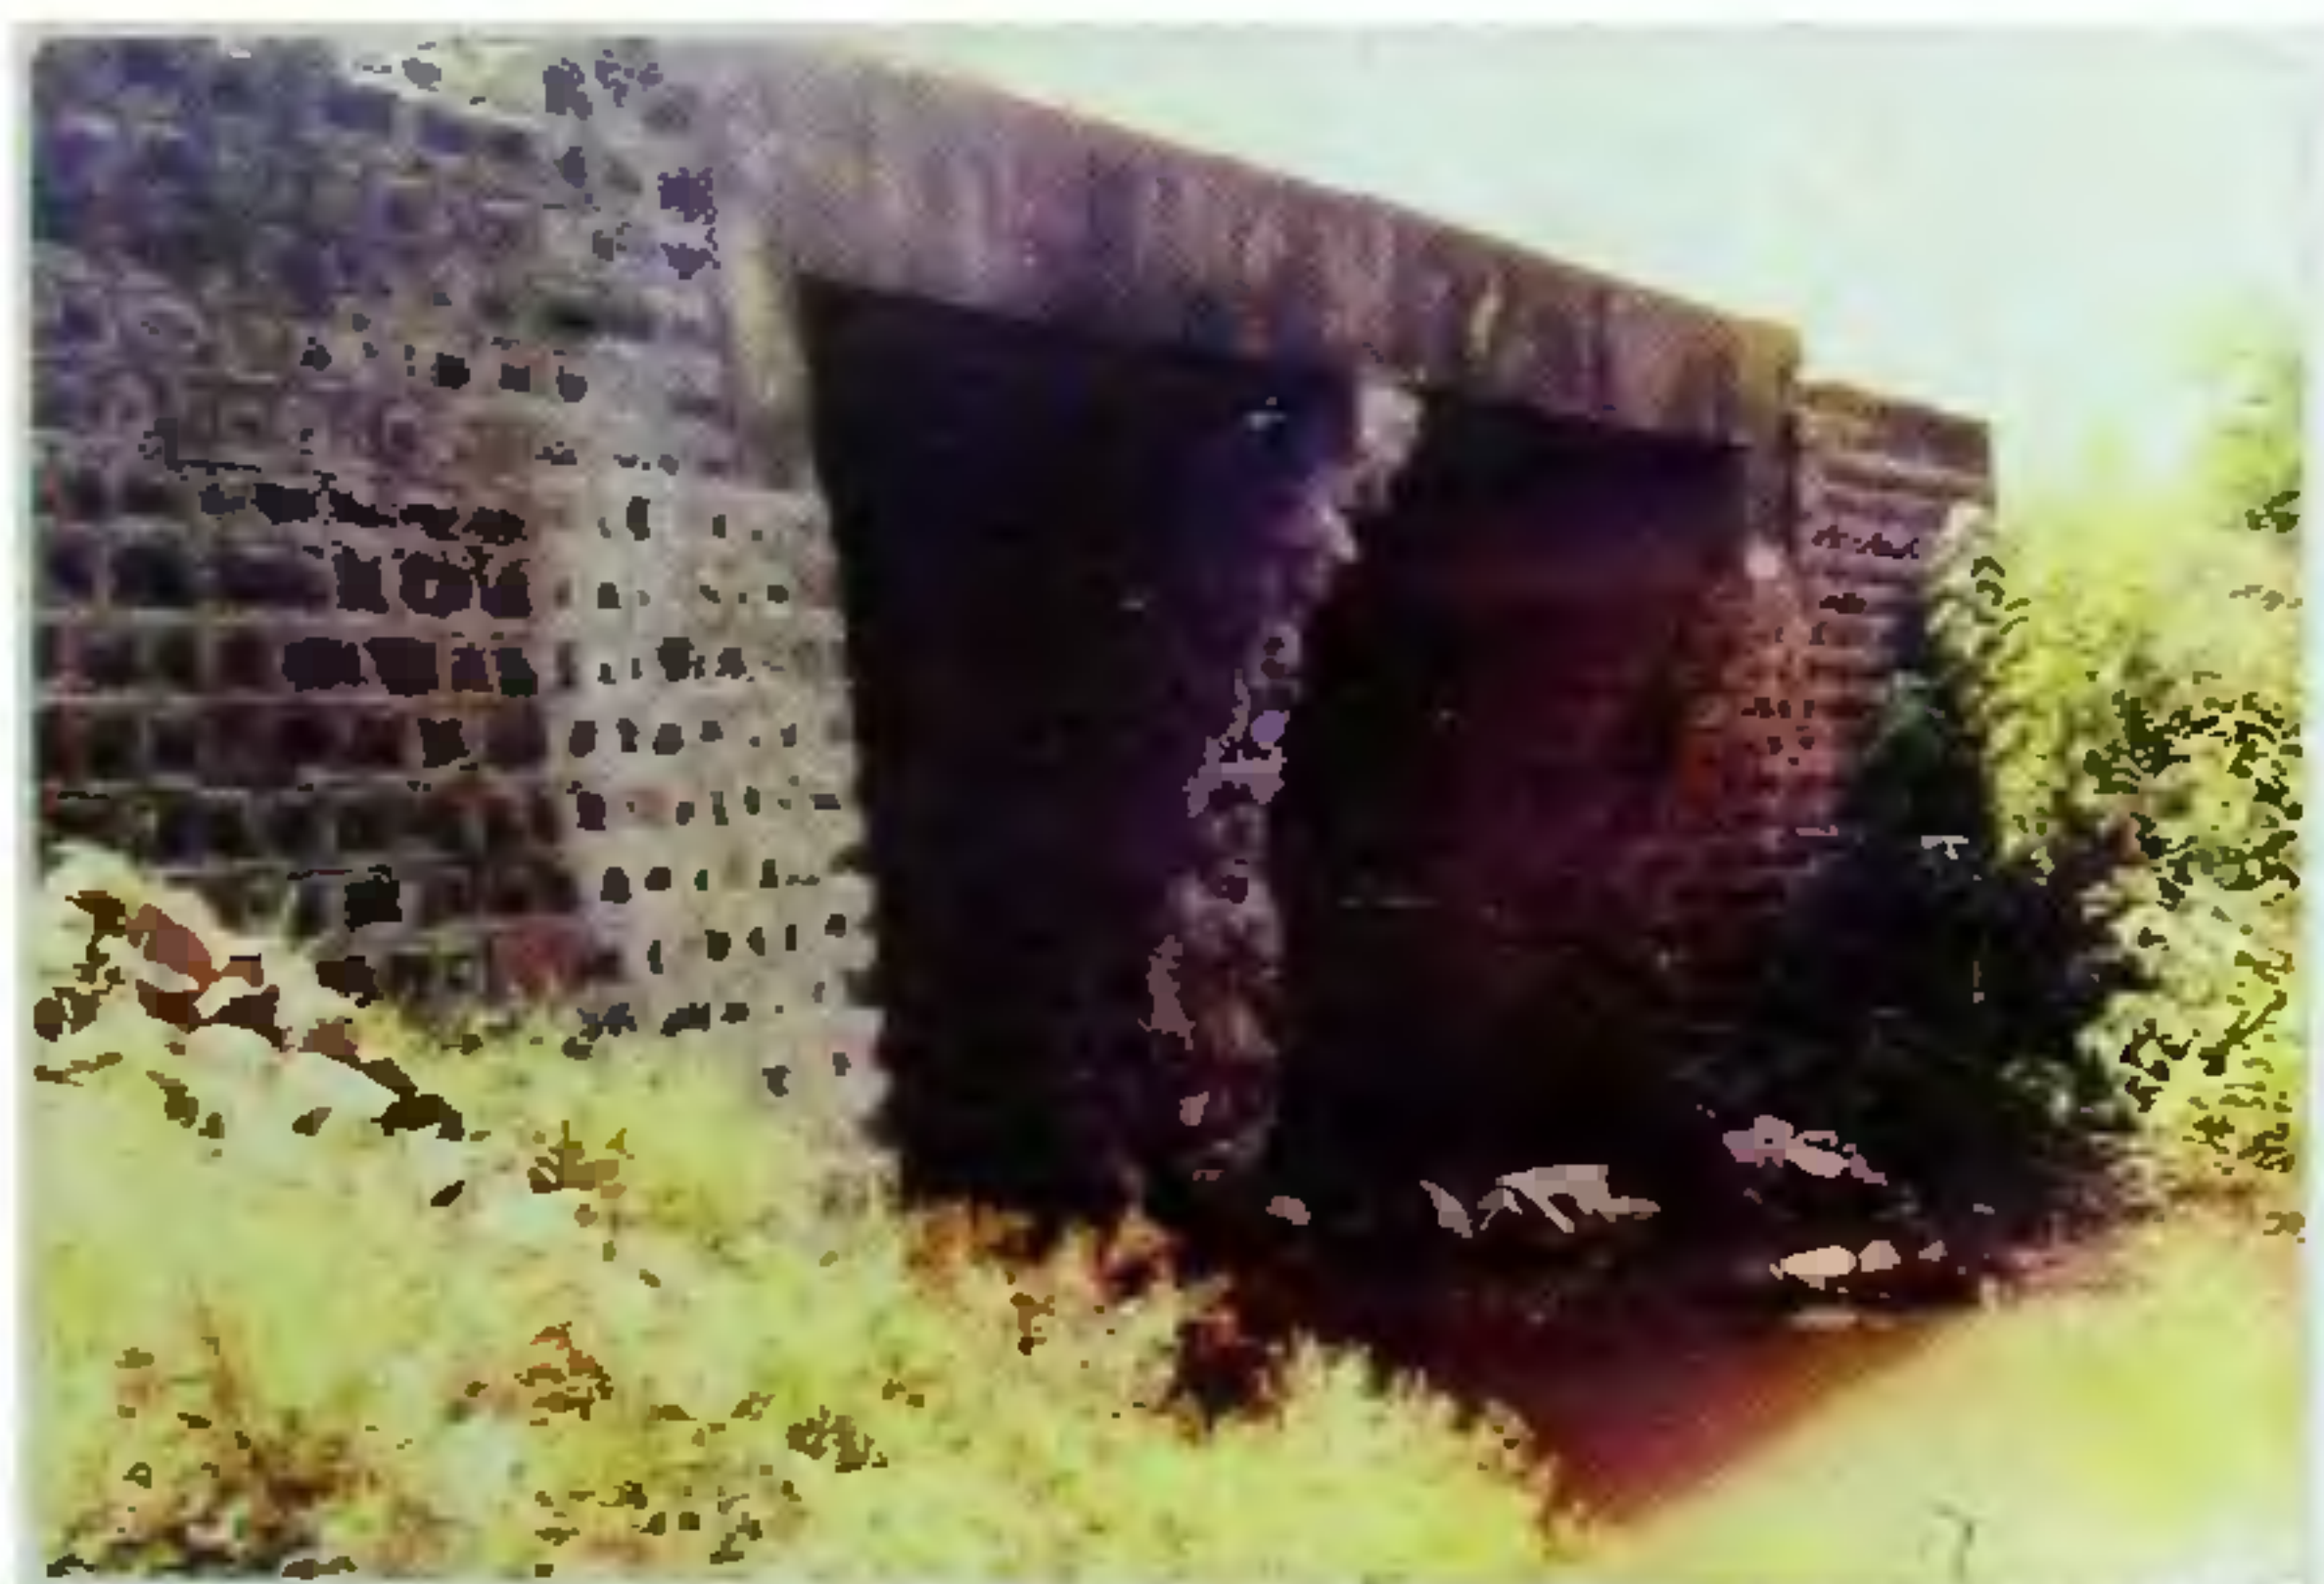
Figure 19. Damaged pier of Rudrawadi culvert near Aland, Gulbarga district.

Cracks were observed at the abutments of a few bridges on the national highway between Humnabad and Umerga. The central pier of the Rudrawadi culvert near Aland, about 55 km away from Khilari was considerably damaged (Figure 19). Several culverts and parapets of small bridges in the epicentral region have also suffered damage. Near Khilari, cement concrete pipes of small culverts were damaged. The piers of a stone masonry hydraulic control structure, which was under construction near Rajegaon, have extensively cracked at about mid-height (Figure 20). The RC pads on the top of some of the piers have also cracked exposing the reinforcement at a few places. About 50 km away from the epicentre, RC aqueducts of the Upper Mullamari irrigation works near Hallikhed-K have cracked leaving open the steel at a few places. Some minor distress was also observed at aqueduct canal junctions.
