Field investigation of the 30 September 1993 earthquake in Maharashtra

R. N. Iyengar*, C. S. Manohar and O. R. Jaiswal

Department of Civil Engineering, Indian Institute of Science, Bangalore 560 012, India

An engineering field study of the 30 September Marathwada earthquake is reported. The study covered Osmanabad, Latur, Sholapur, Bijapur, Gulbarga and Bidar districts. The level of ground acceleration was estimated based on tilting of free standing objects. The study shows that the epicentral intensity has been VIII on the UNESCO scale. The horizontal ground acceleration near the epicentre has been estimated to be about 0.2 g.

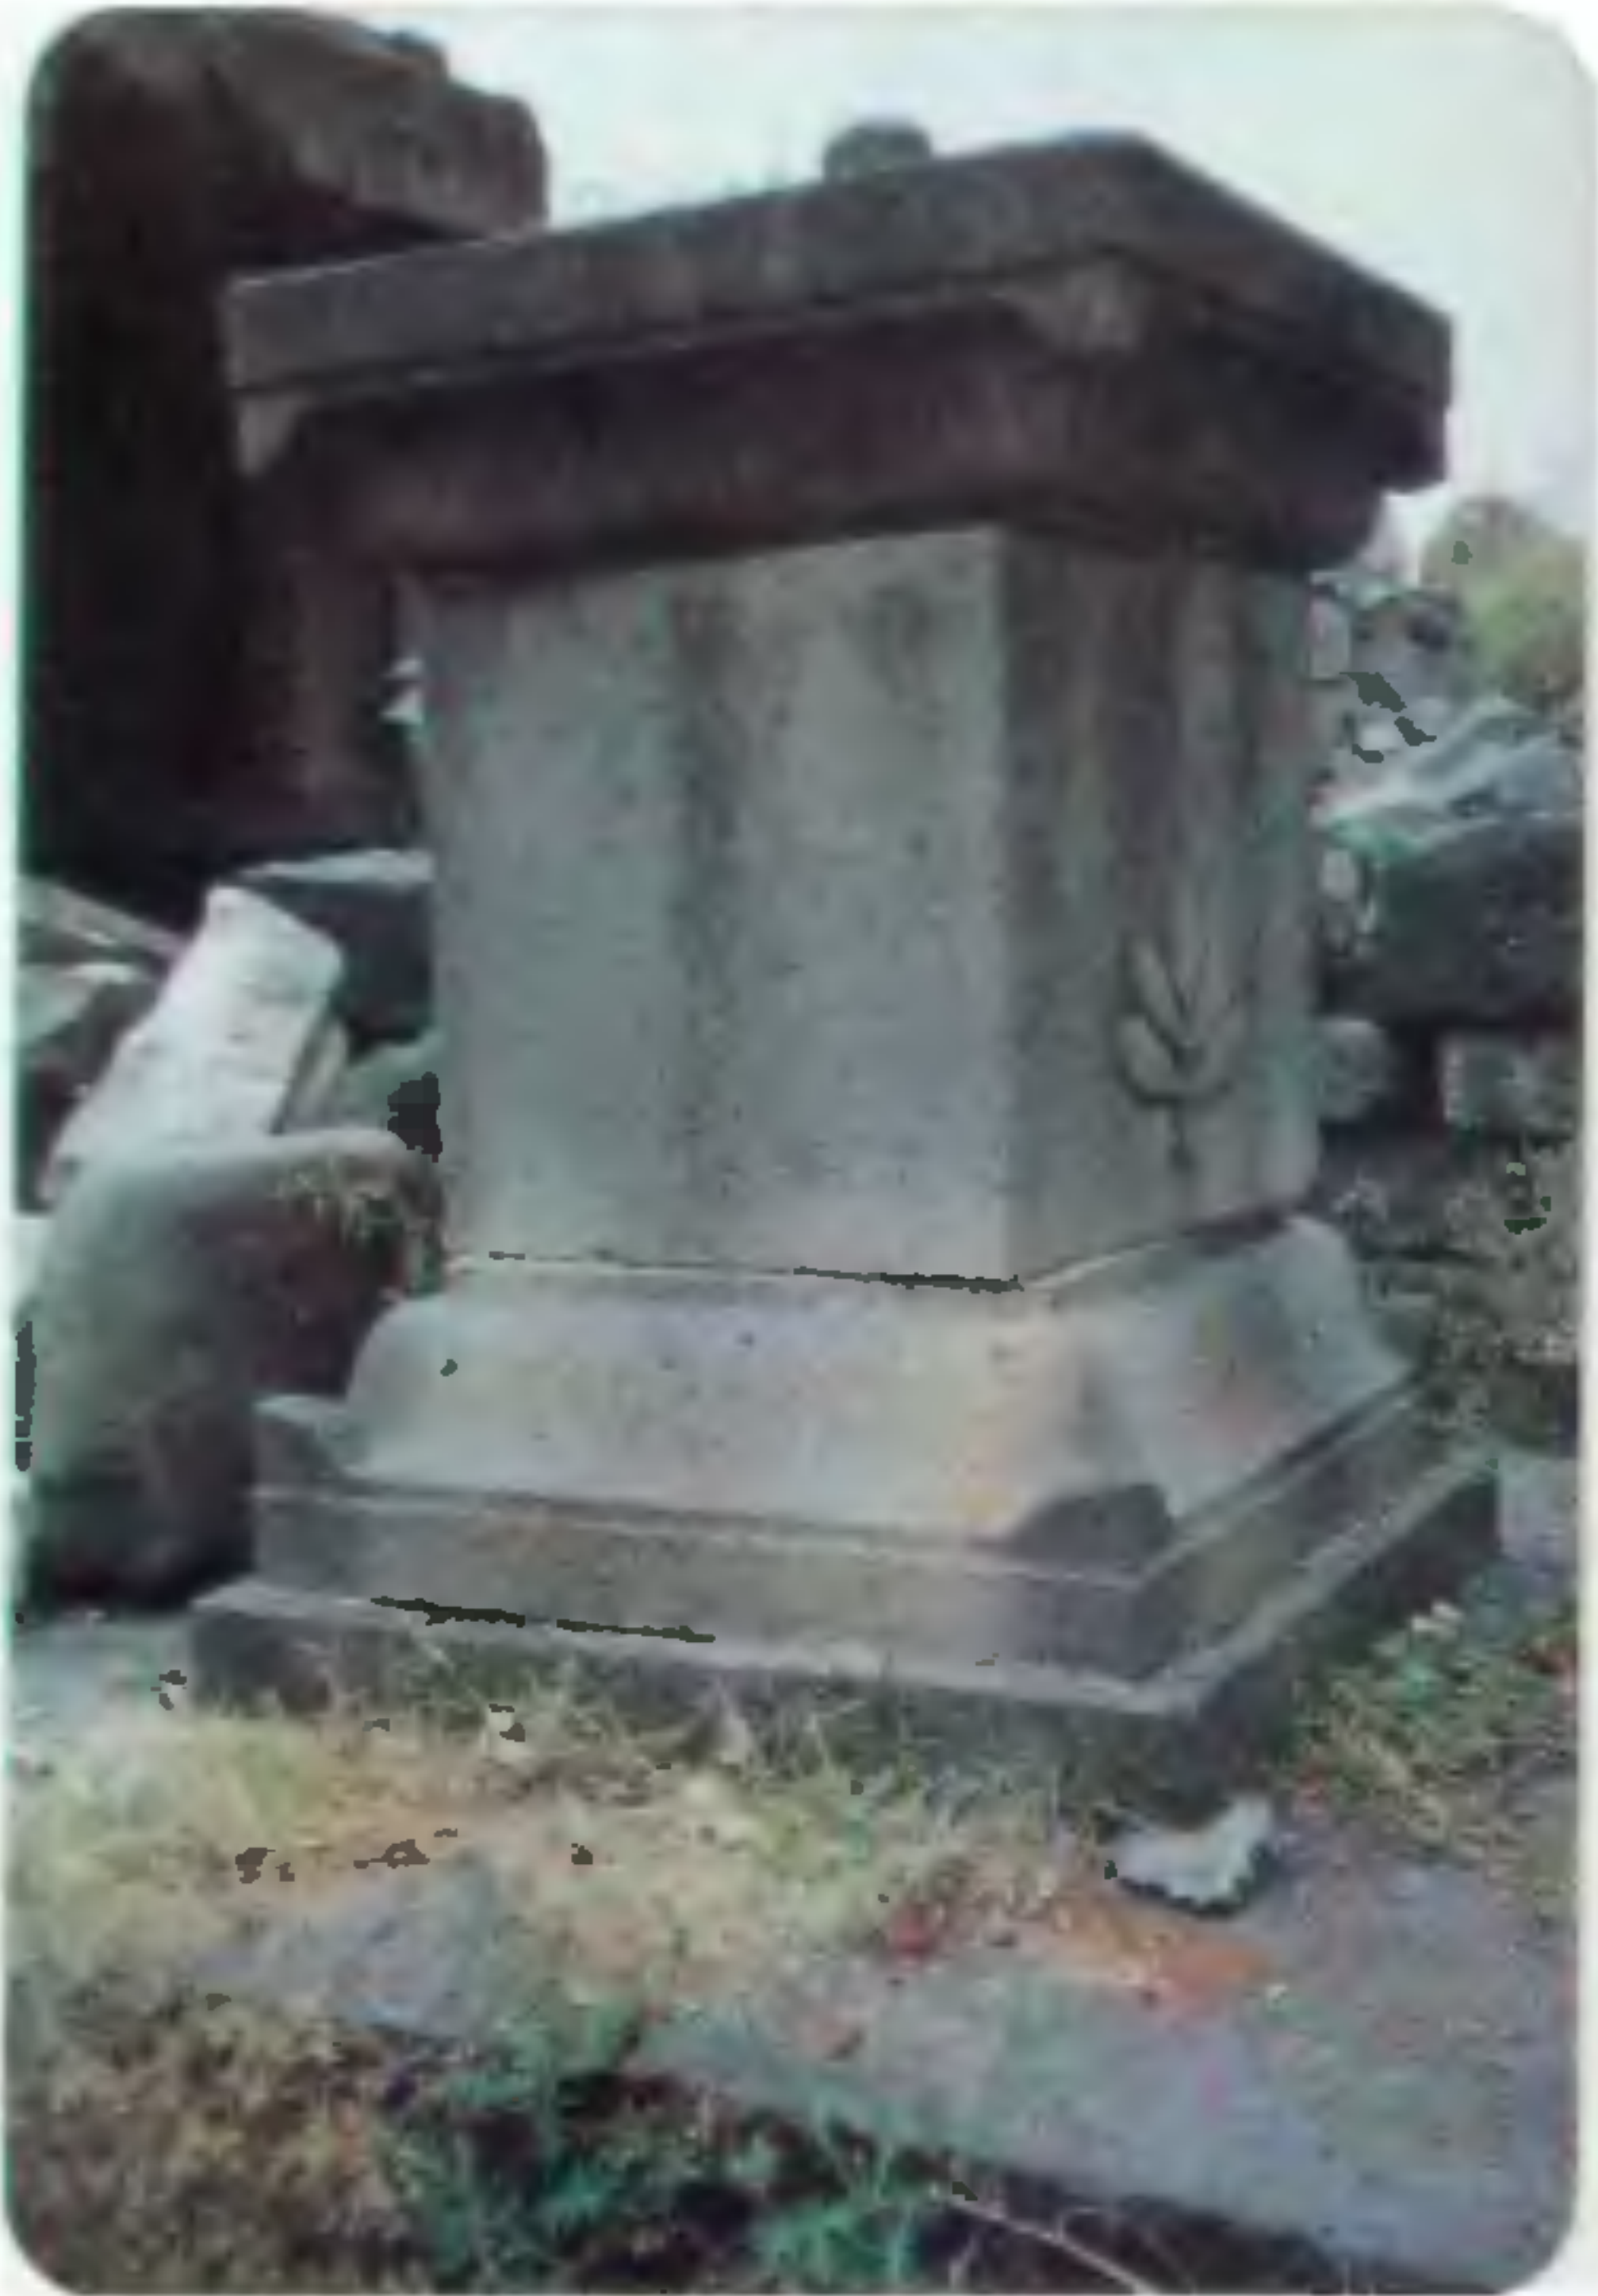
Figure 24. Clockwise rotation of stone block in Kavatha temple.

We also made a few observations on rotations of rigid blocks. Figure 24 shows a 3° to 4° clockwise yaw motion of a stone block in the Chalukyan temple complex in Kavatha village. About 200 m away in the same village, another stone block of a later period has yawed in the same fashion. Similar clockwise rotation was also observed in a stone block in front of the Vitoba temple in the river bed near Rajegaon. From the sense of these observed rotations, it may be surmised that both Kavatha and Rajegaon are located on the same side of the rupture plane. If more objects which have rotated in plan can be reliably located, it may be possible to fix up approximately the location and direction of the rupture.

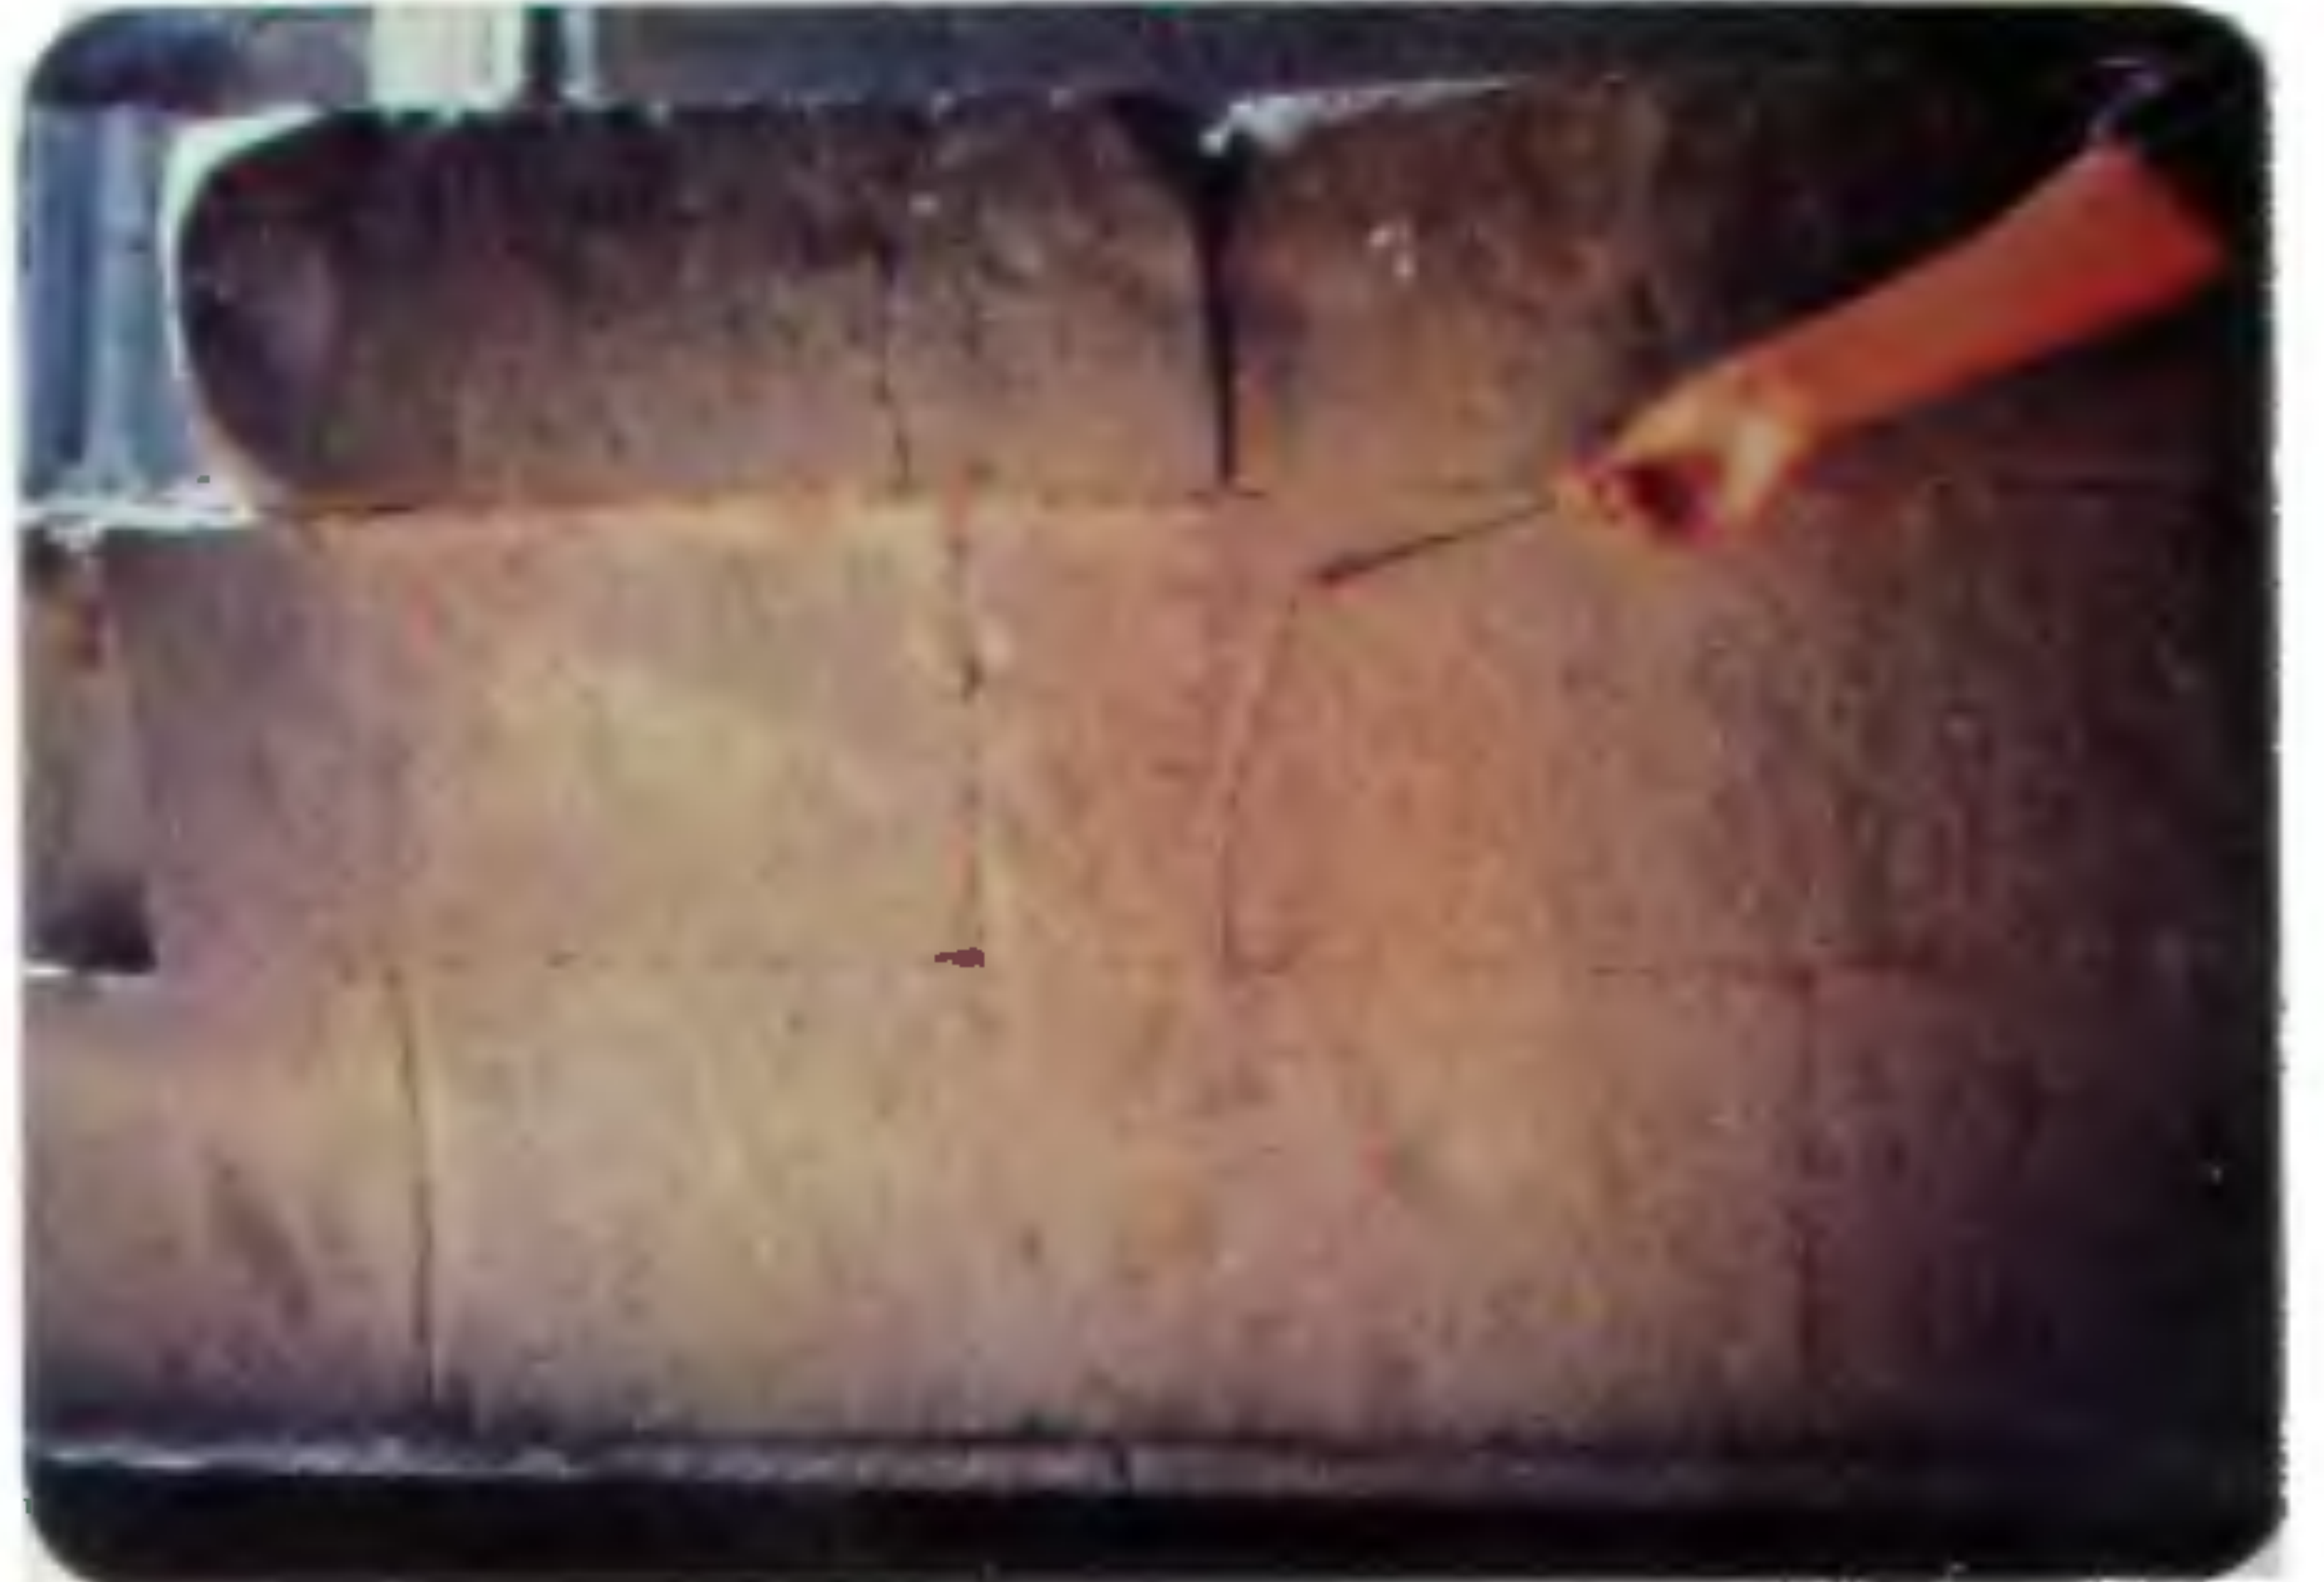
Figure 25. Cracked stone wall in Kavatha temple.

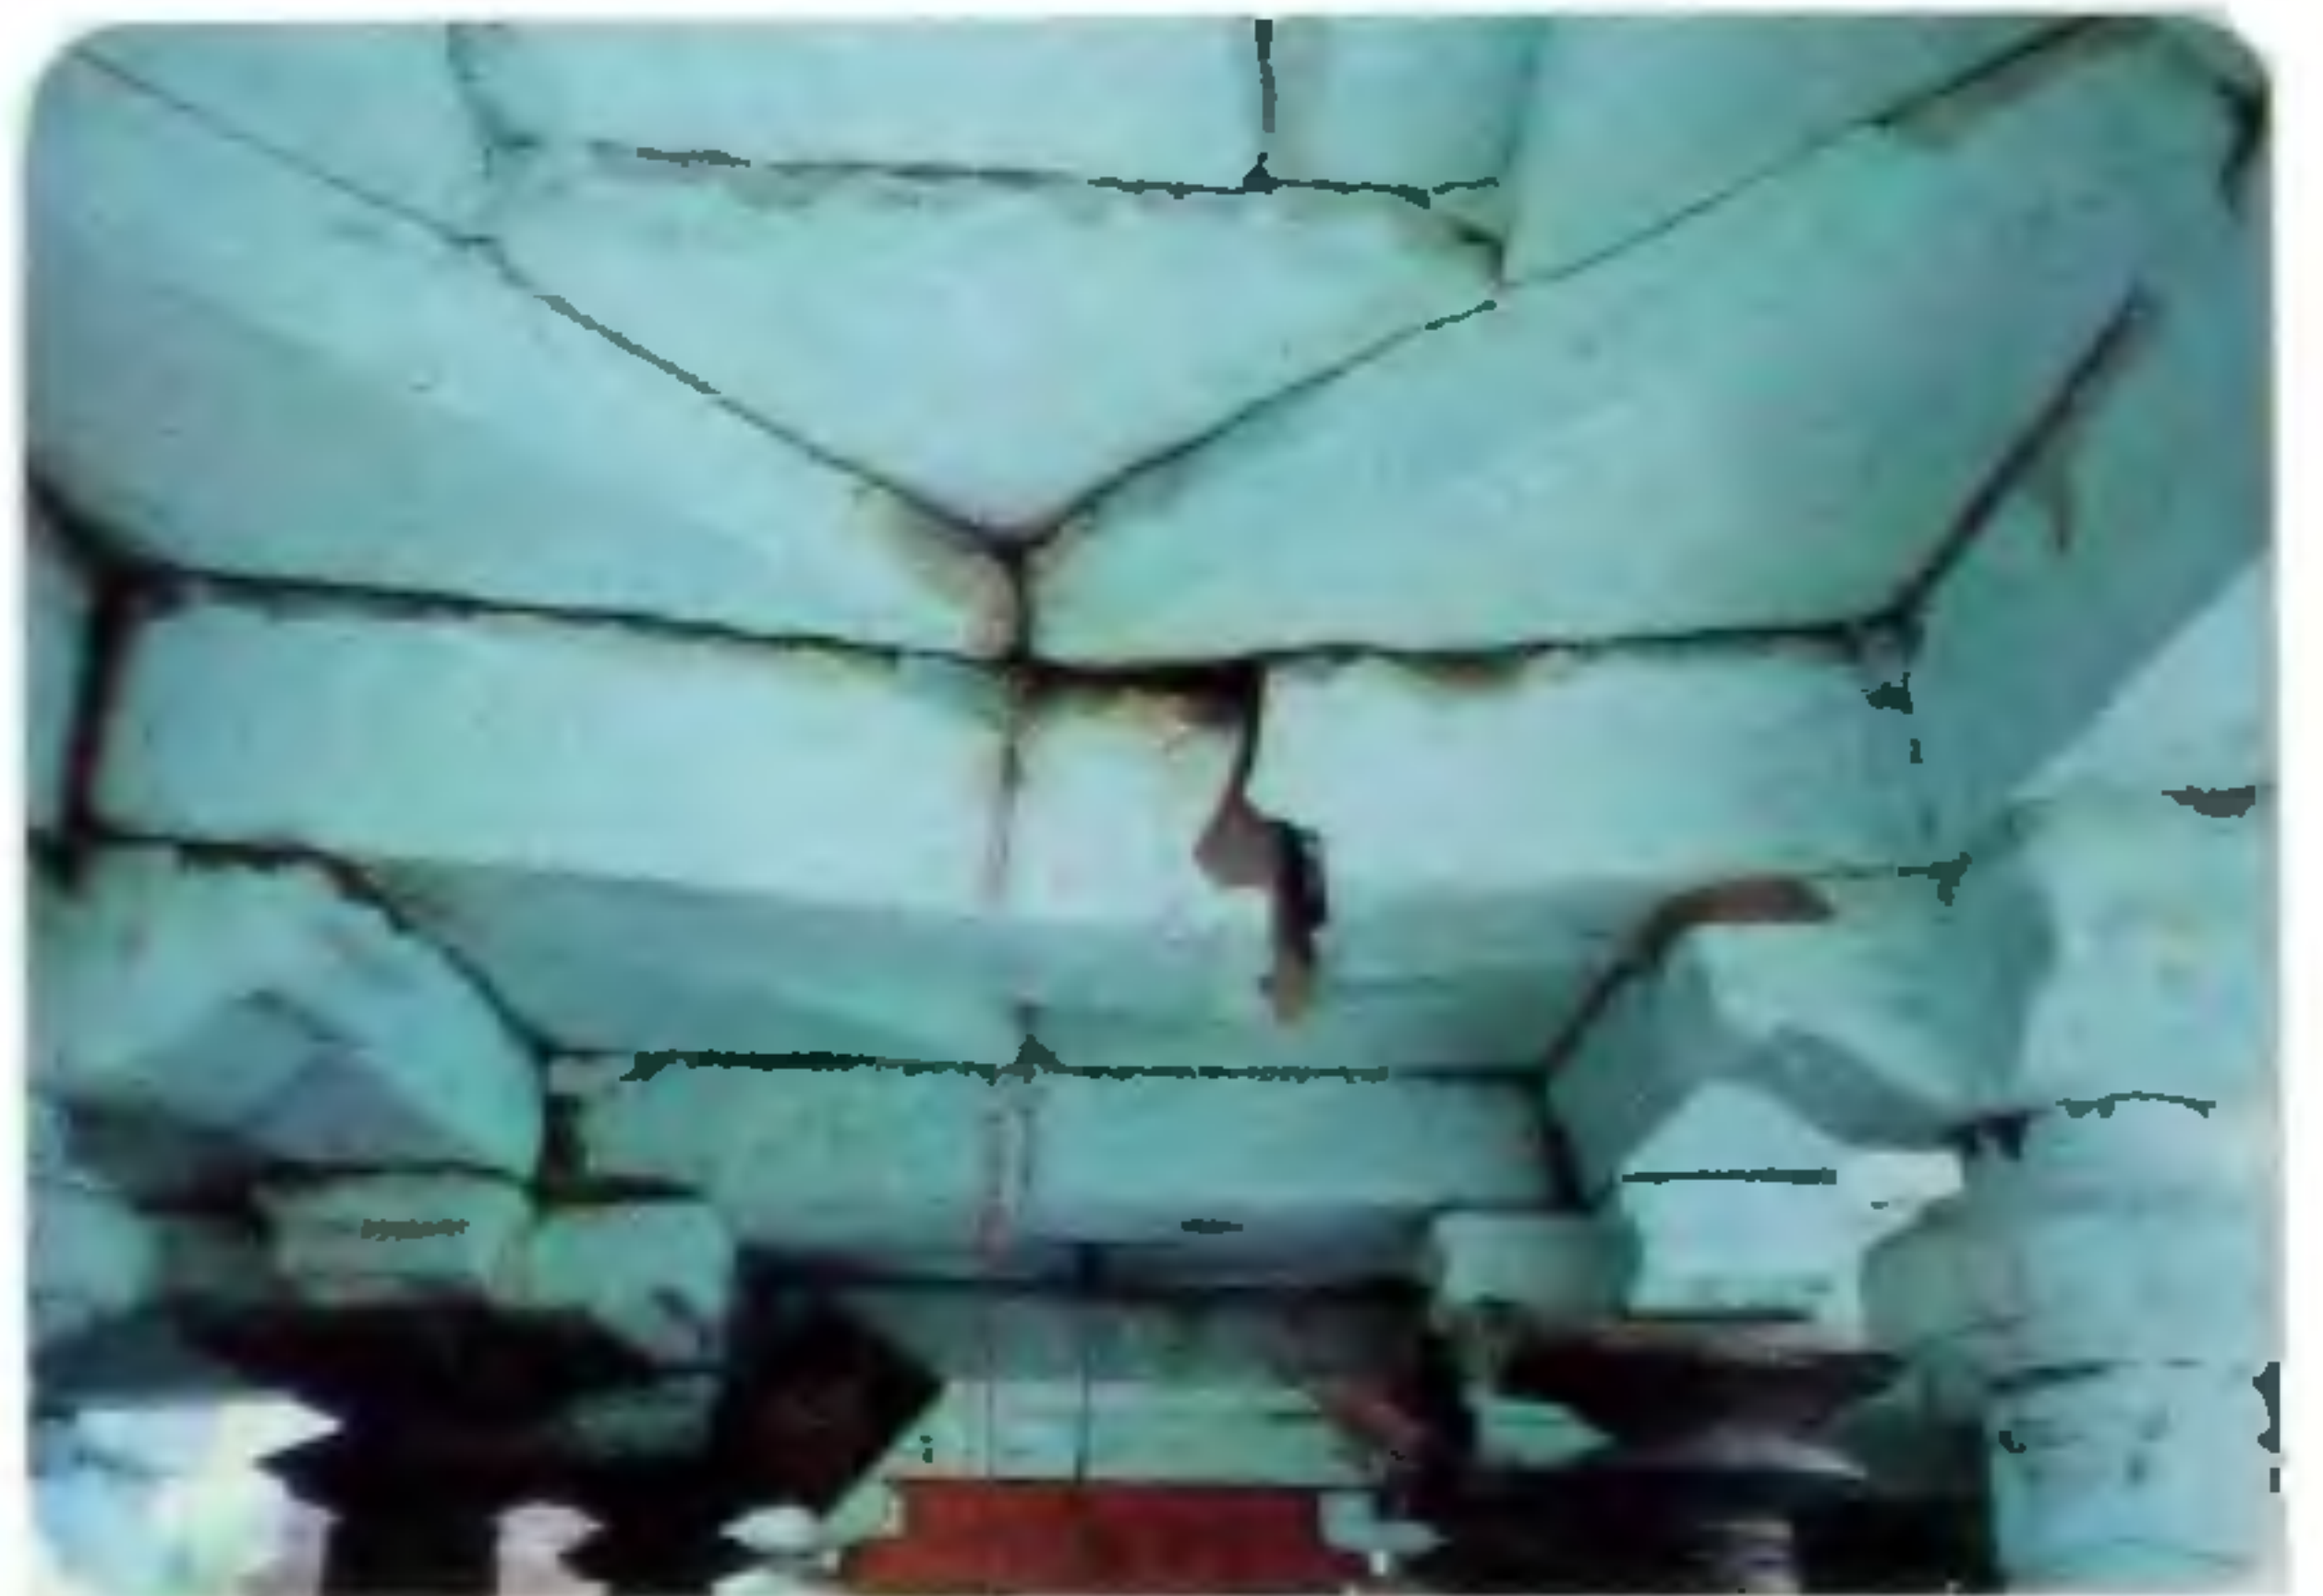
Figure 26. Broken stone beam, Ambabhavani temple, Khilari.

The monumental structures in and around Khilari are mostly temples built during the Chalukyan period. The exact dates of these temples, called locally Hemadpanthi temples, are not readily available. We have been able to gather from historians that these might have been built during 1000–1300 AD. Study of these temples was scientifically, and otherwise, quite revealing. The study of free standing objects such as lamps, idols and marking stones was useful in gaining some idea about the level of ground acceleration. The Chalukyan temple complex at Kavatha (Figure 23) with broken idols was also the site of rotation of a massive well dressed stone block (Figure 24). In the same temple complex, dressed rectangular stone blocks in three parallel walls got sliced between the joints (Figure 25). There is a huge stone inscription outside the temple wall in Kannada script. We have not been able to decipher whether any date is mentioned in this. However, based on the photographs, a few historians suggested that the temple could belong to 11–12 century AD. From local inquiries it was learnt that at least the southernmost shrine was functional and regularly visited by worshippers. The present earthquake left this structure badly damaged. The brick-in-mortar spire had collapsed along with the metal cap. The integrity of the outer walls is drastically lost, with the corners looking out of plumb. A few stone lintels are broken giving a feeling of precariousness to parts of the structure. There is a temple of similar style in Khilari town which perhaps belongs to the same period. This is called the Ambabhavani temple, where again the lintels are broken (Figure 26). The remarkably beautiful stone columns are fractured at the bottom due

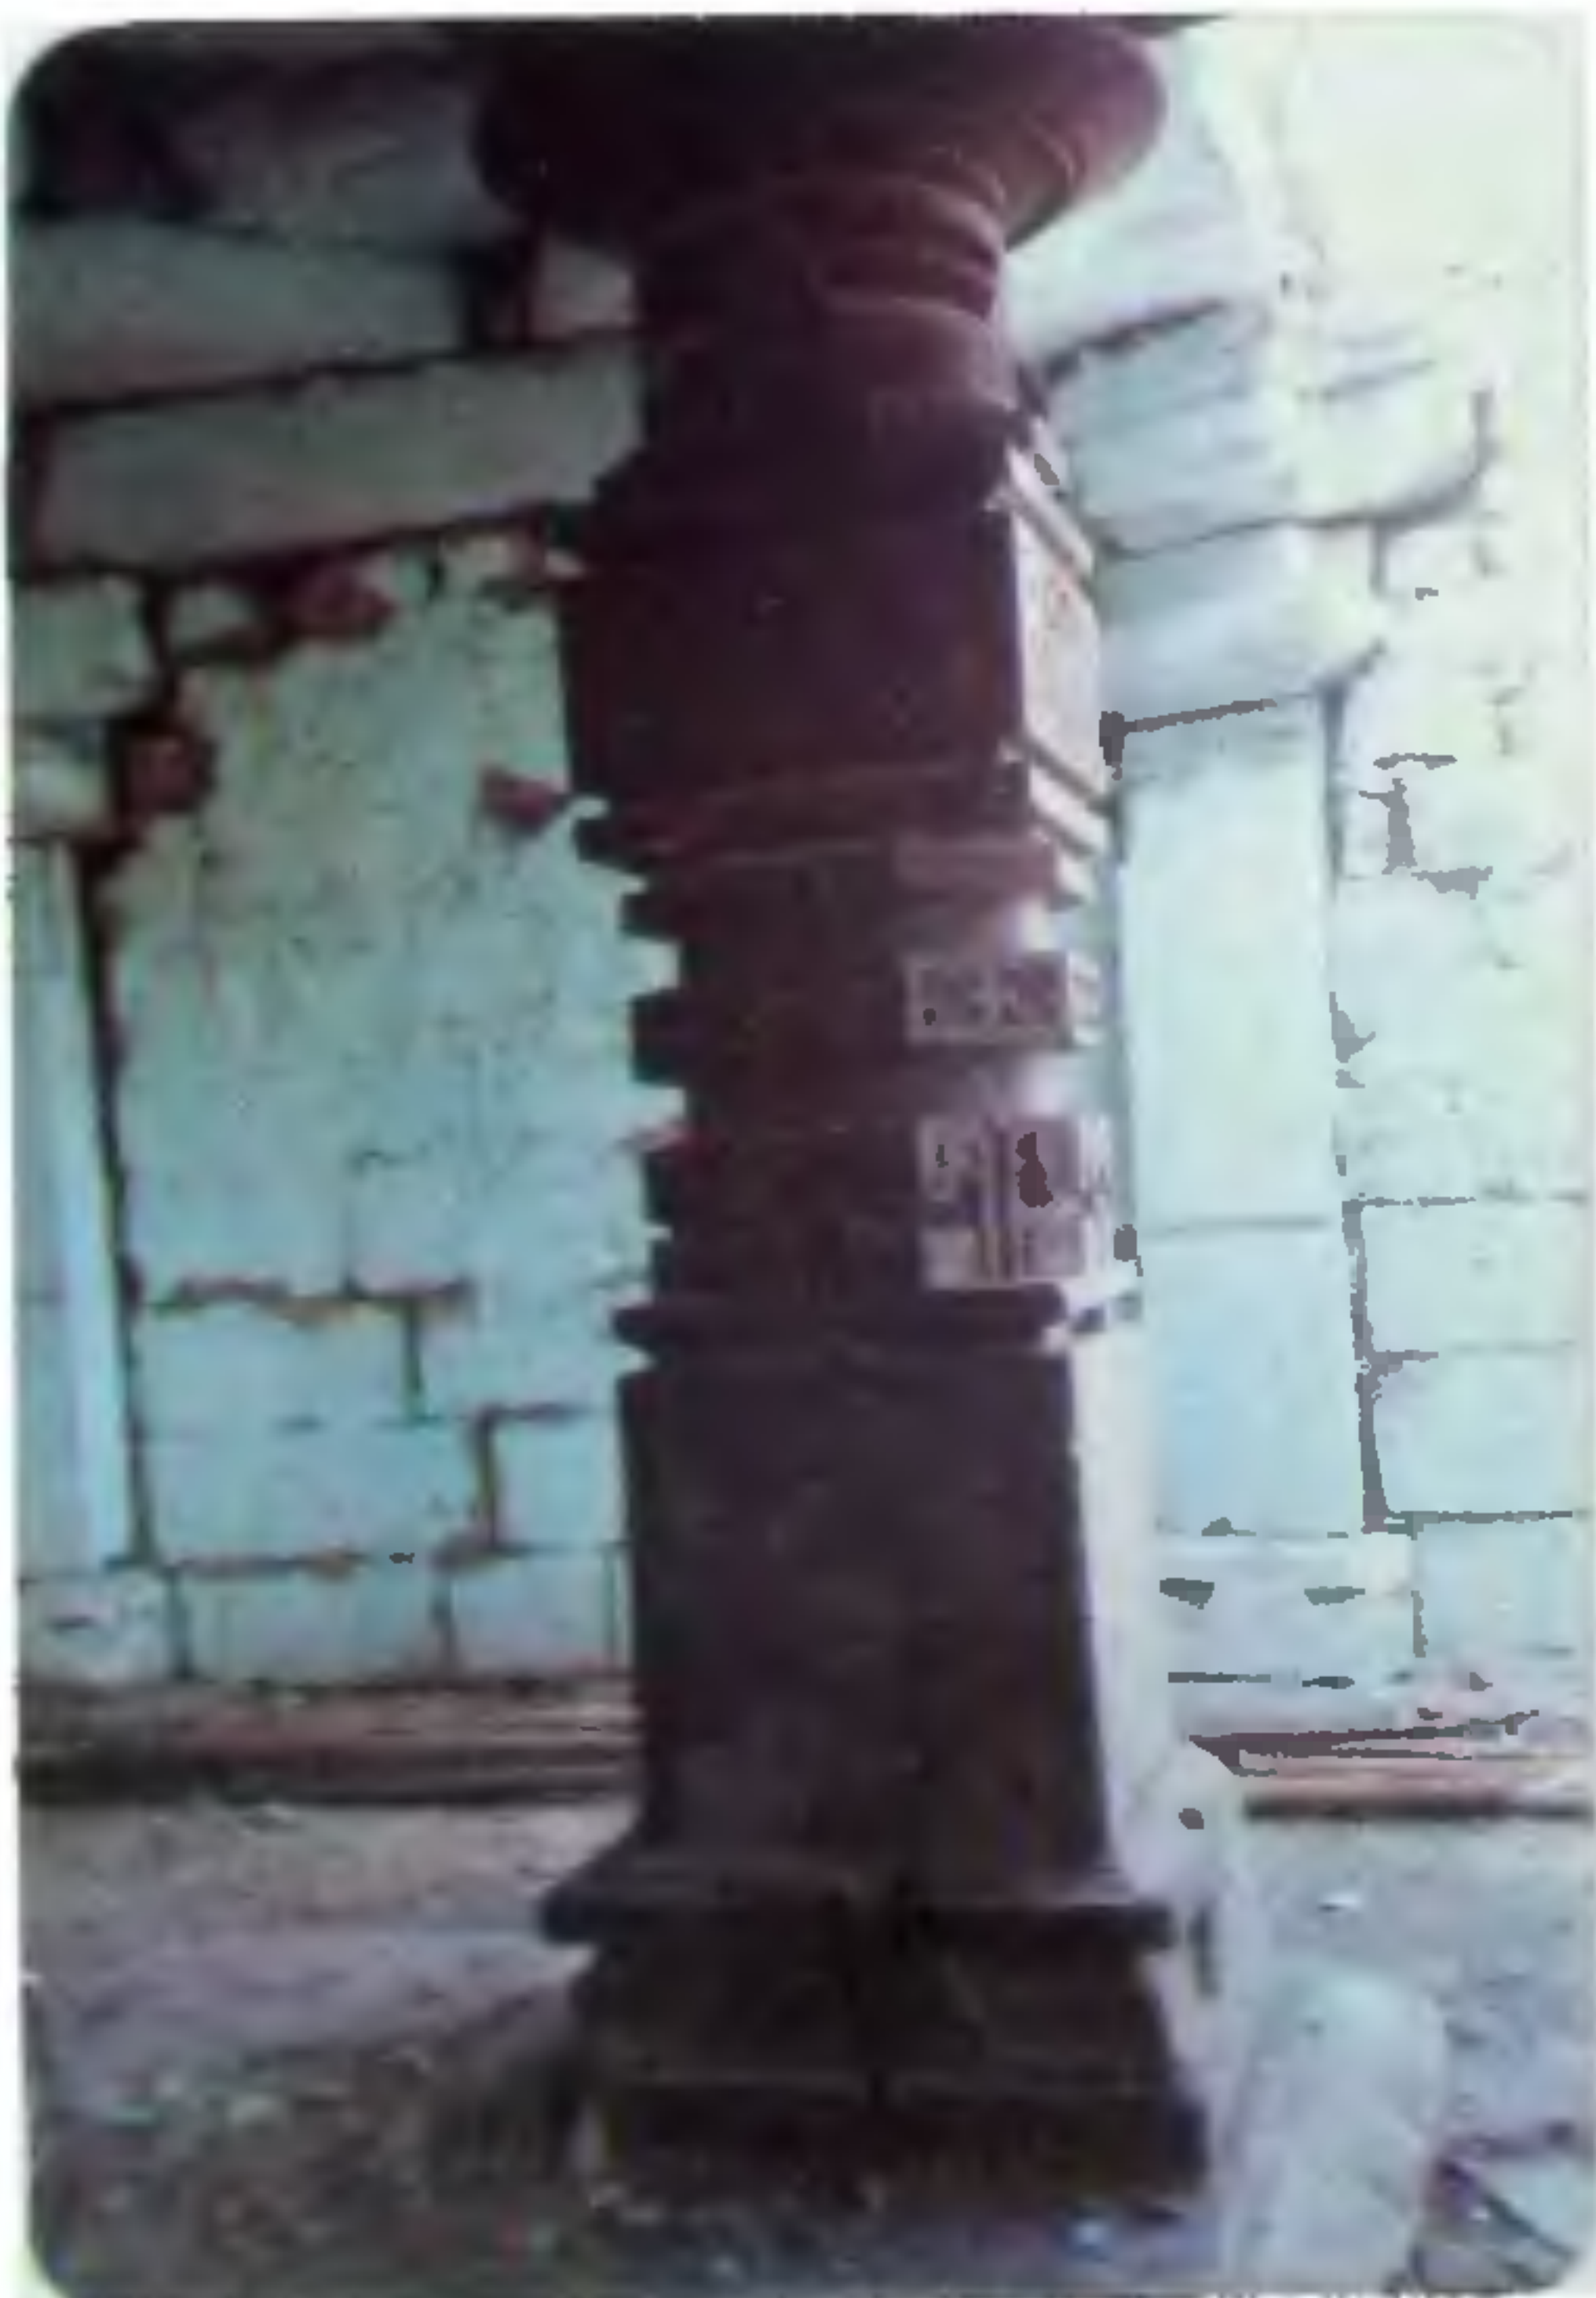
Figure 27. Fractured column, Ambabhavani temple, Khilari.

to the earthquake (Figure 27). Thus, even though it is not possible to say when a past earthquake of magnitude greater than 6 M occurred in this area, we may make an educated guess. Had an earthquake of the same or higher intensity visited this place in the past, it probably dates back to a period preceding the construction of these temples, which remained intact till the present earthquake occurred. If this argument is accepted, it follows that in the last 600–700 years no strong earthquake has visited, at least, the present epicentral tract of the Marathwada region. This, to some extent, explains the prevalence of local construction practices which do not take cognisance of possible seismic activity. However, this may not mean that there have been no strong earthquakes in historical times. For example, the village of Thair, which is 50 km NW of Khilari, is historically a most interesting place. Here, the damage from the present earthquake is not at all severe. Archaeological excavations have revealed that this place, formerly called Tagarpura, was a flourishing town some 2000 years ago, but then got ruined. Local villagers talk of earthquakes as being the cause of ruination. While this at present is merely speculation, palaeoseismic investigations are called for to ascertain this possibility.

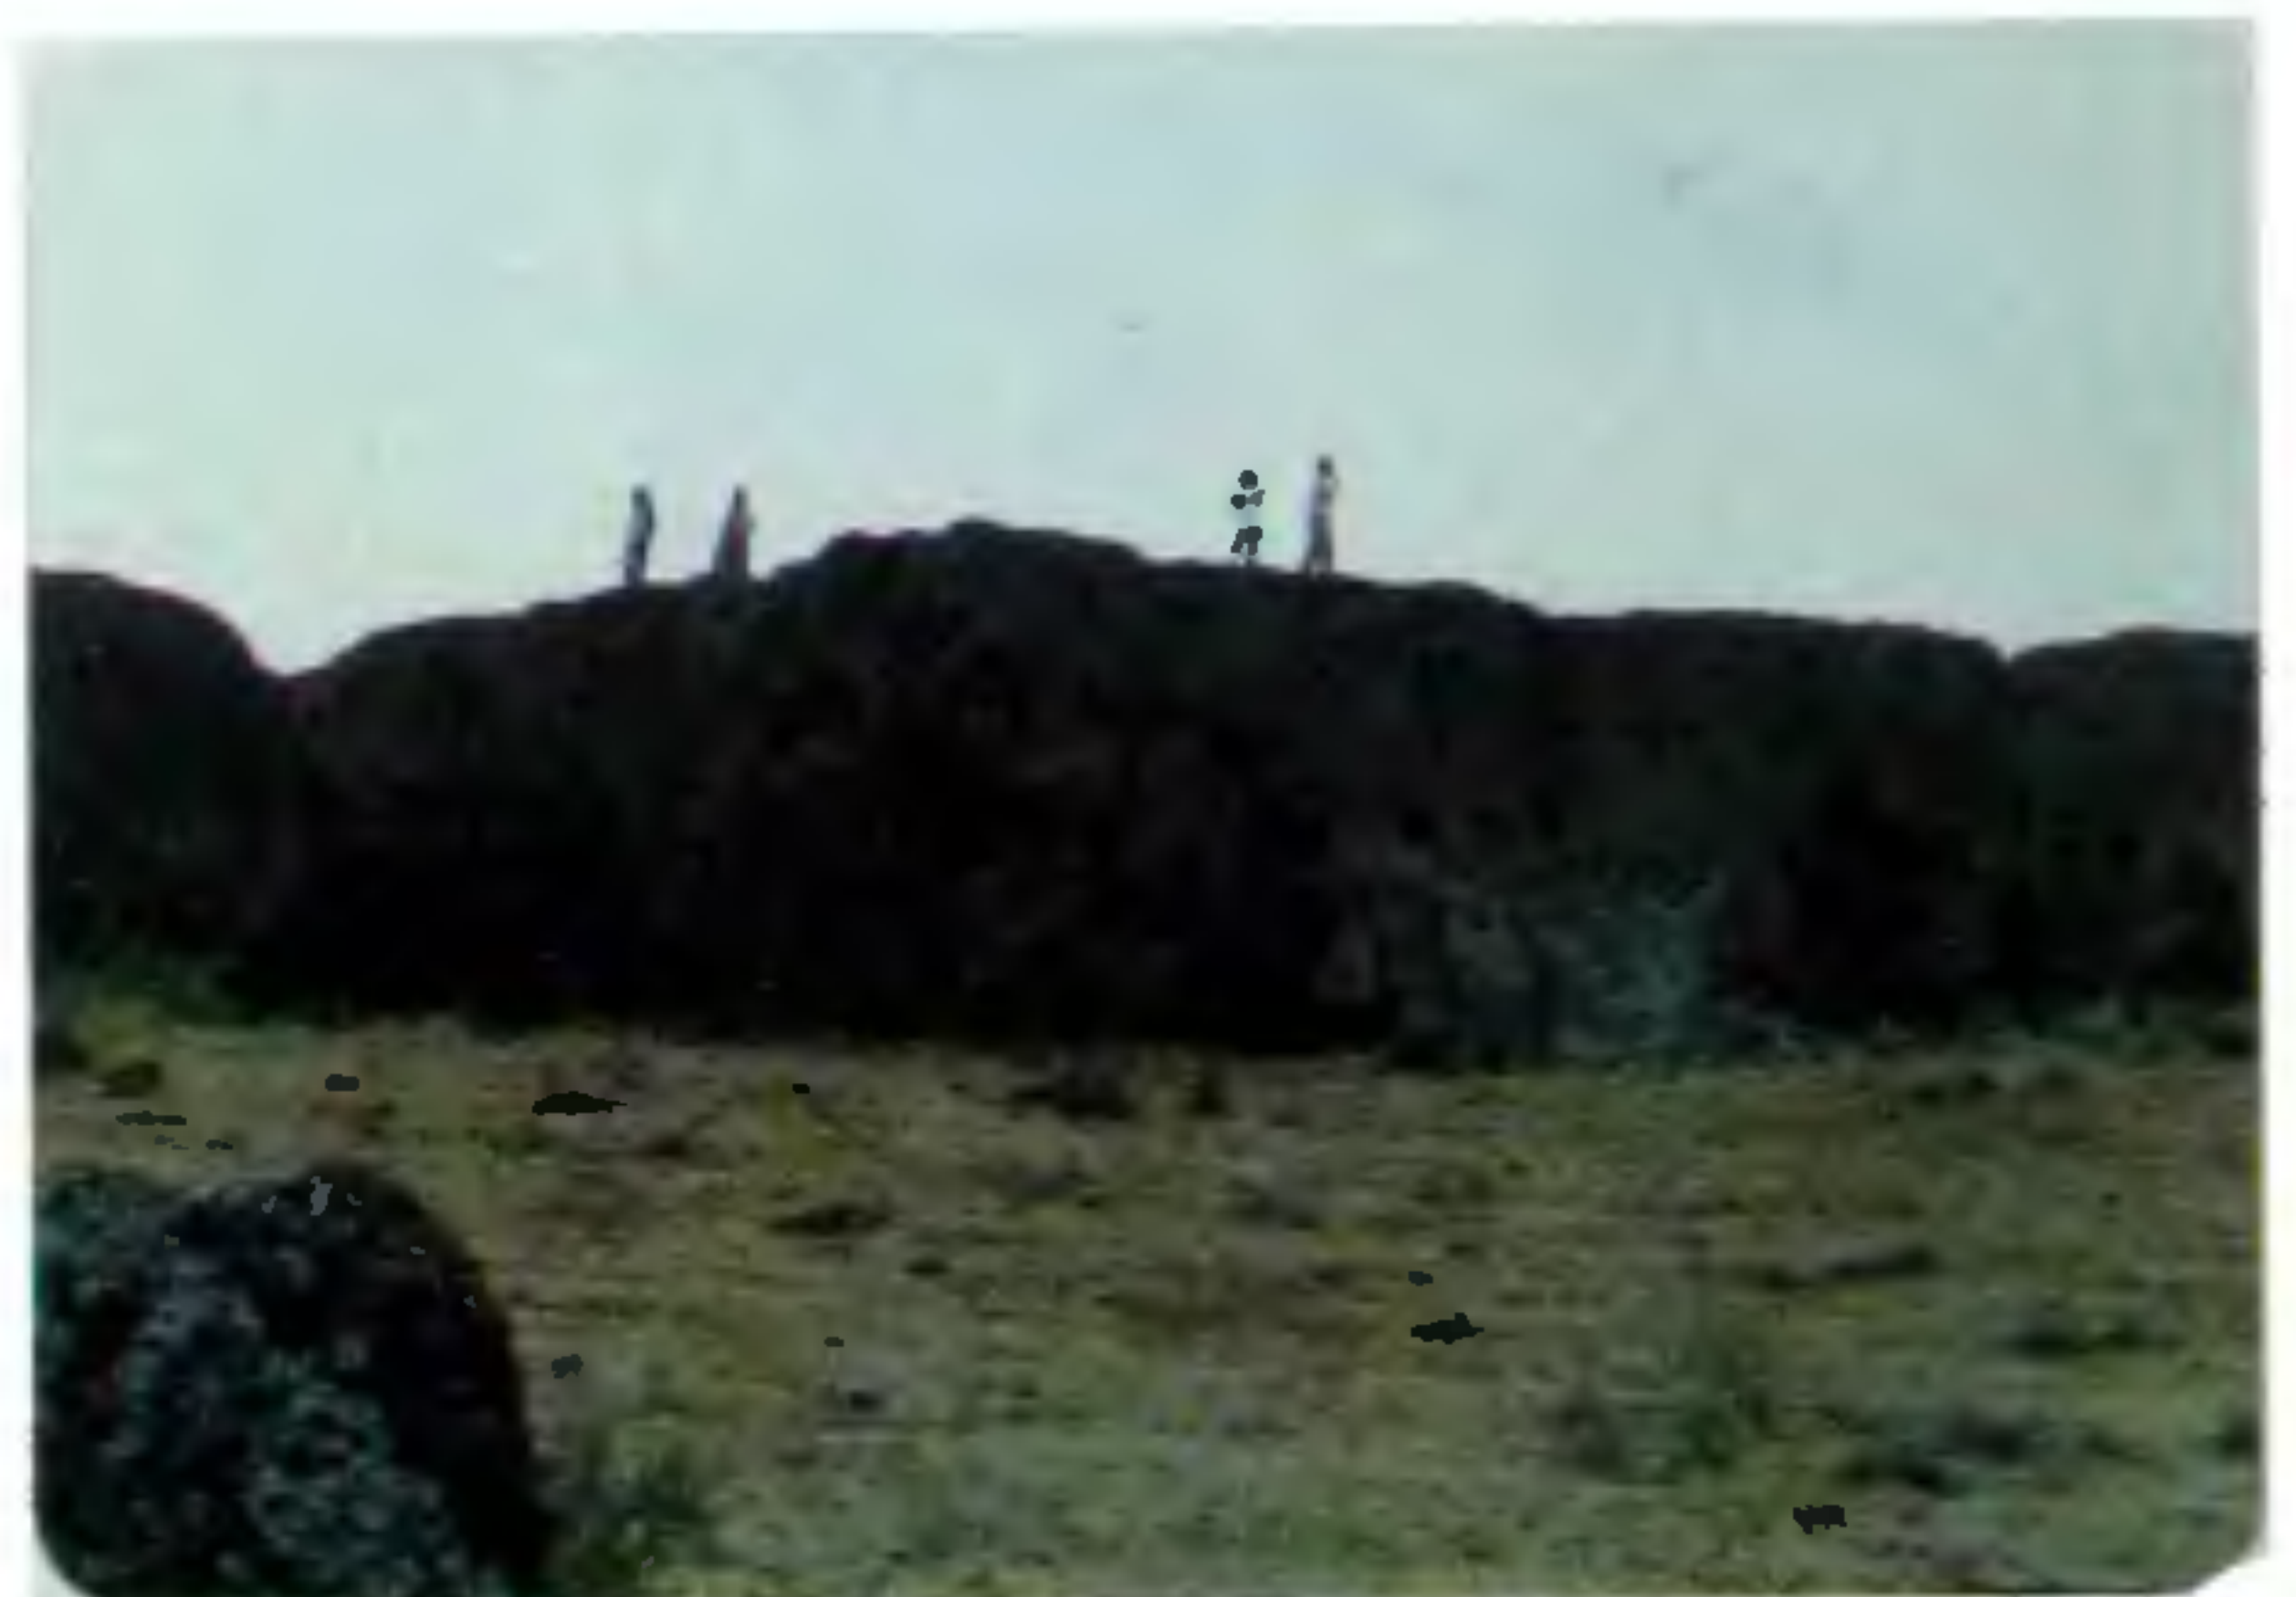
Figure 28. Old fault on Lamjan–Nilanga road.

The effect of the earthquake on the natural relief could not be studied in detail. At Khilari and Rajegaon, there were reports of ground cracks, which got closed due to the heavy rains which followed the earthquake. Thus, we could not verify these reports. However, away from the epicentre, we observed two instances of ground cracking. The first was in Gulbarga district in village Alanga in Aland taluk. A nearly 30 m long, 2 cm wide crack could be seen on the ground ending up at a nearby borewell. In the village of Thair, the floor in a hut showed a crack running nearly in the NW-SE direction. The crack was nearly 5 cm wide and was visible for about 30 m in the open field also. An interesting geological feature near the epicentral region is an old fault with a vertical uplift of the ground (Figure 28). This can be seen in the fields to the right of the road connecting Lamjan and Nilanga. The vertical face of the exposed part is considerably weathered. On both sides of this East-West running fracture, the ground

is nearly level and is cultivated. Local people call the place Kengal, which means red stone. The soil nearby looks brick red, with a large number of pebbles strewn out of the vertical face of the uplifted ground. No fresh movement of the fault is apparently visible to the eye. Geological study of this feature is essential to understand the tectonics of the region.
