# **Subsidence-Induced Damage Assessment of Buildings on Joshimath Hills**

Ajay Chourasia<sup>1\*</sup>, Mickey Mecon Dalbehera,<sup>2</sup> Ashish Kapoor<sup>3</sup>, Kishor S. Kulkarni<sup>2</sup>, Govind Gaurav<sup>3</sup>, Satyavrat Singh<sup>4</sup> and R Pradeep Kumar<sup>5</sup>

<sup>1</sup>Chief Scientist, <sup>2</sup>Senior Scientist, <sup>3</sup>Scientist, <sup>4</sup>Project Fellow, <sup>5</sup>Director,  
CSIR-Central Building Research Institute, Roorkee, India – 247667

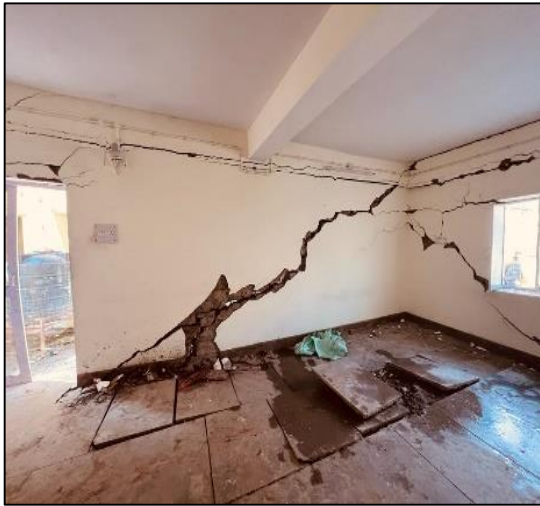
a. Failure in Masonry building due to land subsidence

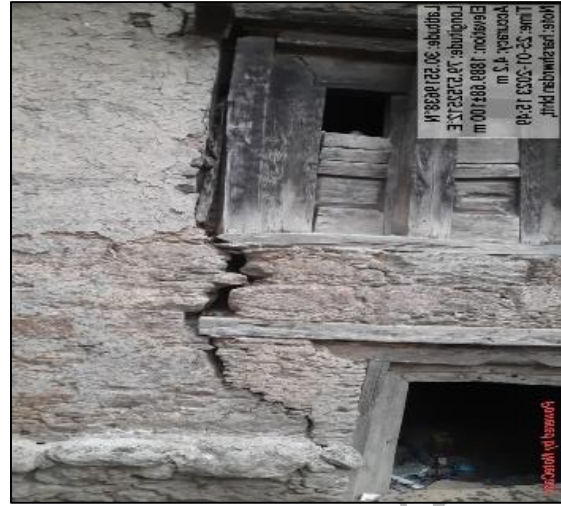
b. Failure of rubble masonry due to unavailability of firm ground and footing

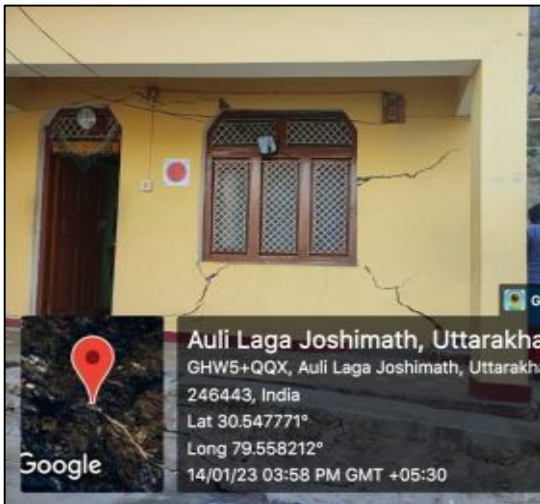
c. Diagonal shear Failure of Masonry Infill

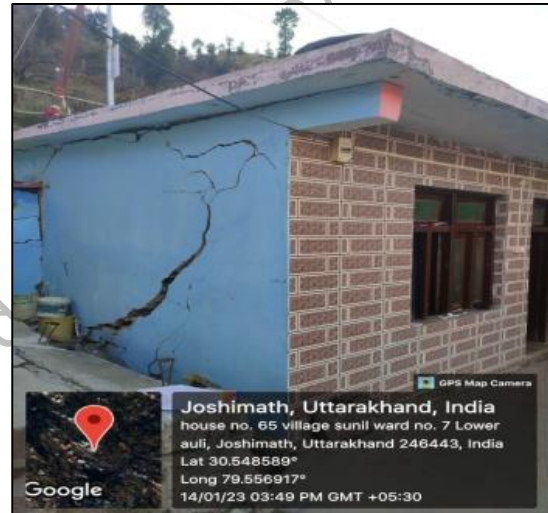
d. Failure of masonry infill due to land subsidence

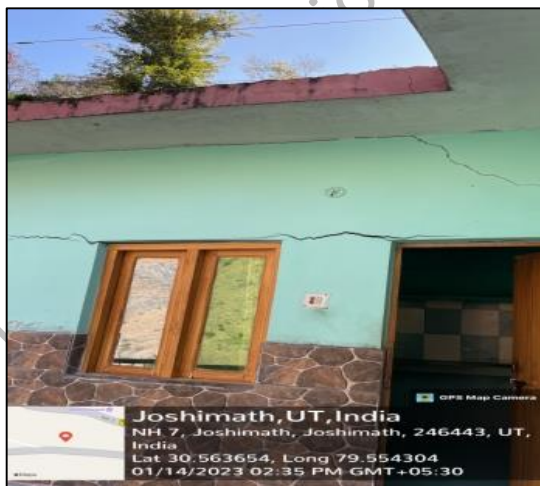
e. Sliding Shear Failure of Masonry Building

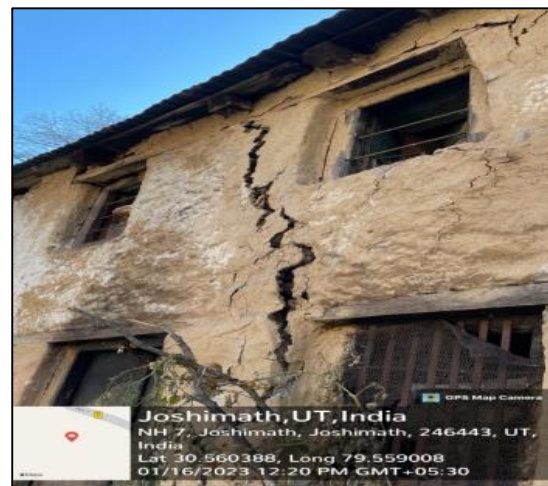
The distress in the masonry buildings is primarily due to non-engineering practices (Fig.2.a-f) along with lack of maintenance and poor quality of construction. Diagonal cracks have been observed in the walls due to differential settlement of the foundation (Fig.2-a). Wythes separations in stone masonry occurred due to the unavailability of through stones (Fig.2-b). Diagonal shear cracks have been observed in the corners of the walls and doors of the masonry buildings (Fig.2-c). Fig.2-d shows the typical crack pattern in the wall of the masonry building due to land subsidence with crack width being maximum at the bottom and gradually decreasing with height due to local adjustment. Sliding shear failure is observed in most of the ground-story buildings due to low vertical load accompanied by poor-quality of mortar (Fig.2-e). Vertical shear cracks along the height of the building have been observed in mud masonry

houses (Fig.2-f). The engineered buildings performed relatively well as compared to non-engineered buildings and were subjected to minor cracks.

f. Vertical shear crack along the wall

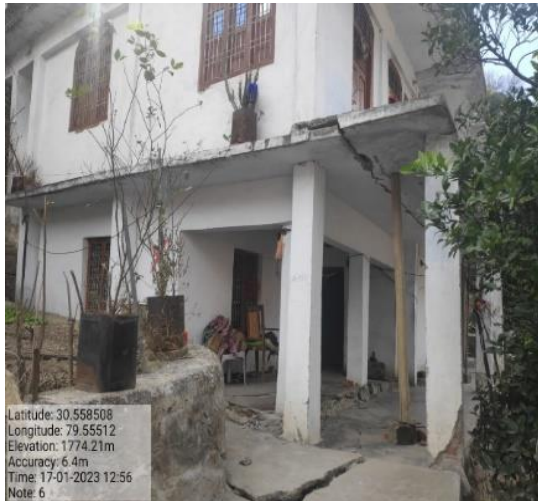
a. Excessive cantilever projection

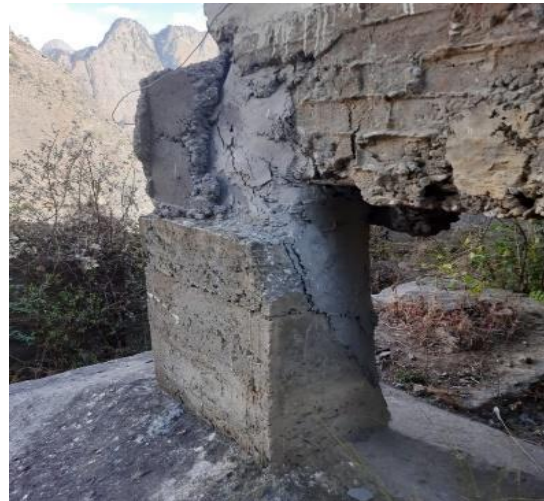
b. Shear Failure at column footing junction

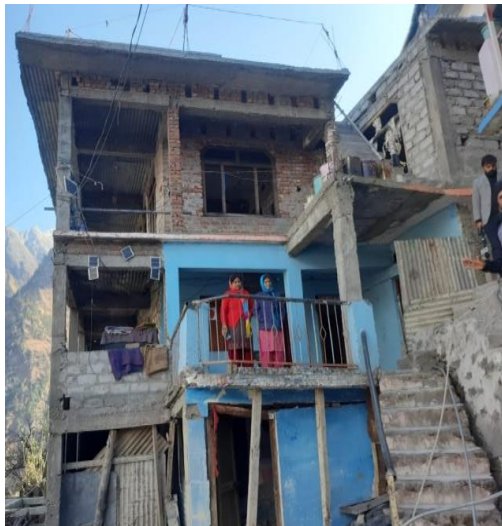
c. Bearing failure of the ground story

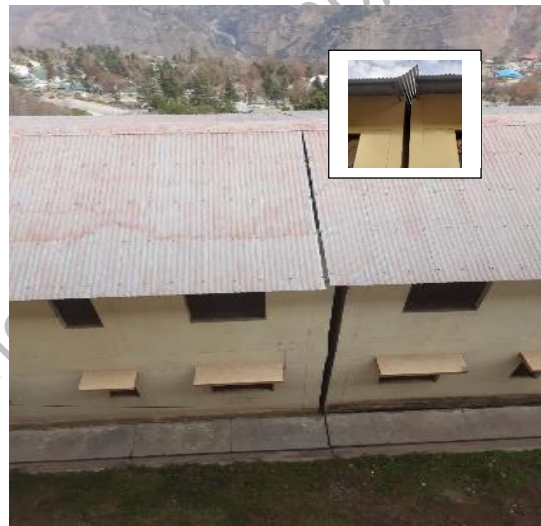
d. Roof sliding due to land subsidence

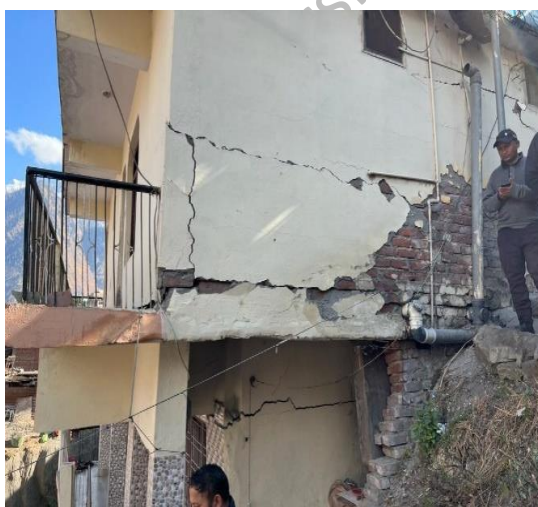
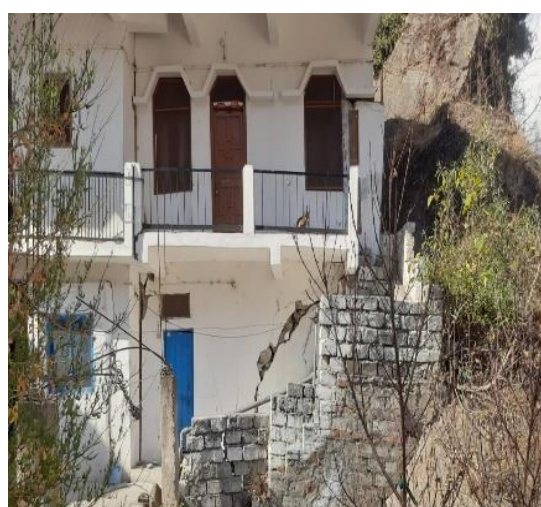
e. Damage due to lateral soil thrust

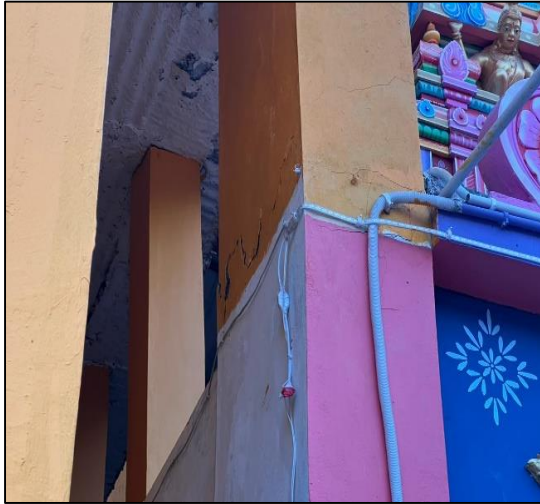
f. Rotation in RCC Column

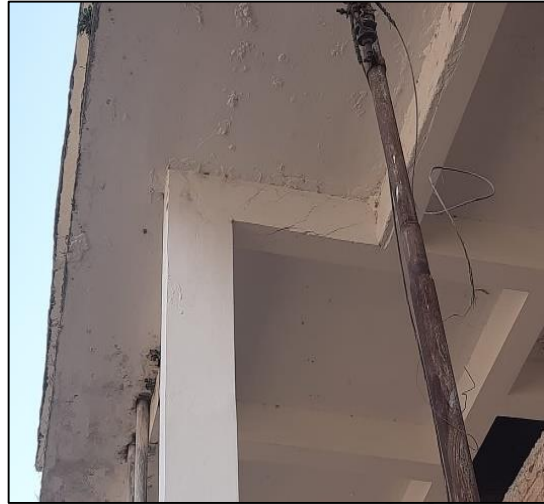
g. Shear failure in RC Beam
