## Recent landslides in Uttarakhand: nature's fury or human folly

*S. P. Sati, Y. P. Sundriyal, Naresh Rana and Surekha Dangwal*

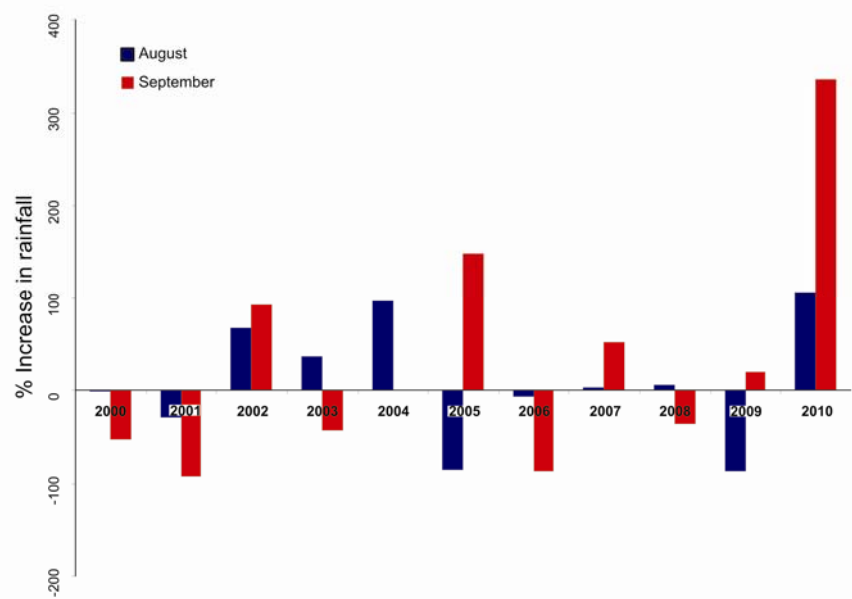
**Figure 2.** Bar diagram showing rainfall variability in percentage during August and September (summer monsoon) for the past 10 years. Exceptionally high rainfall in September 2010 can be observed.

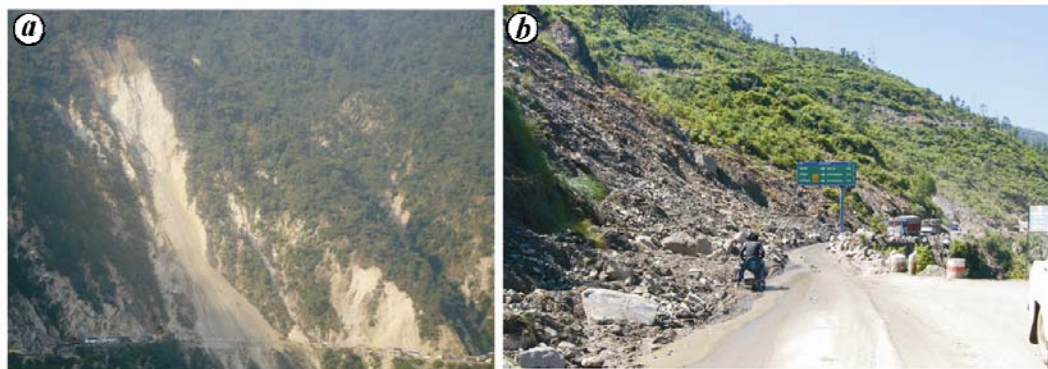
**Figure 4.** *a*, Kaliyasaur landslide (along NH-58) reactivated due to heavy rainfall in September 2010. It has become a major bottleneck for vehicular traffic on the Rishikesh–Badrinath road. *b*, Road widening work in progress along NH-58. Note the massive debris that has slid down after the angle of repose was disturbed during road-widening work followed by heavy precipitation in September 2010 along NH-58.

of various dimensions riddled NH-58 in September 2010. Majority of them occurred south of the Main Central Thrust between the Alaknanda Fault (AF) and Saknidhar Thrust (ST; Figure 1). In addition, 20 urban settlements located along the highways were severely damaged. The chronic Kaliyasaur landslide which had been dormant for a few years due to the efforts of various government agencies has now been reactivated (Figure 4). Based on the nature of distribution of landslides in the Alaknanda Valley, it can be suggested that this time the Lesser Himalaya had to bear the brunt of slope instability.

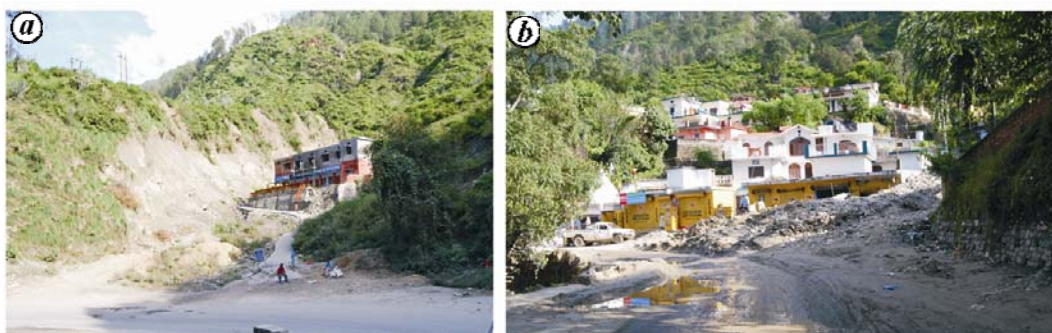
**Figure 5.** *a*, Disaster in the making – defying all safety norms, a school was allowed to be constructed on old landslide debris on the bank of a seasonal stream. *b*, Shops and houses constructed along the bank of an ephemeral nala. Shops seen buried under debris from upslope due to heavy rain in September 2010.

debris-laden waters into the habitation areas (Figure 5 *b*). The unscientific urban development speaks volumes about the poor governance and lack of urban development policy. According to Barnard *et al.*<sup>12</sup>, approximately two-thirds of the landslides in the Alaknanda Valley were accelerated by anthropogenic intervention, mostly by the removal of slope toes at road cuts.

heavy machinery. In a terrain where roads are unscientifically planned and their construction is badly executed<sup>5</sup> without considering proper measures at the base of road cut slopes, if the slopes of such roads are tampered with, it is bound to create fresh landslide zones. Additionally, after the creation of Uttarakhand, a significant increase in the built-up areas in the Alaknanda River has taken place. Particularly, there has been a quantum jump in the built-up areas around Srinagar, Devprayag, Rudraprayag, Karnprayag, Nandprayag and Joshimath. Since the safe-habitation slopes are scanty in these towns, unsafe slopes have been modified for house construction and a school building was also found constructed on the old landslide along an ephemeral stream course (Figure 5).
