The 18 September 2011, North Sikkim earthquake

Kusala Rajendran^{1*}, C. P. Rajendran¹,
N. Thulasiraman¹, Ronia Andrews¹ and
Nima Sherpa²

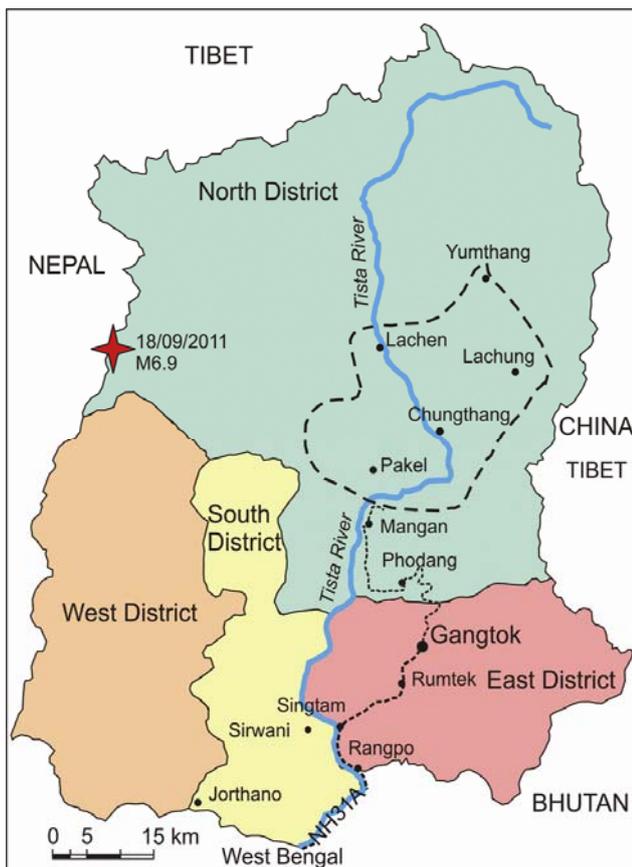
Figure 2. Map of Sikkim showing the approximate location of the epicentre and areas most affected by the earthquake and the subsequent landslides (dashed area). Sites discussed in the text are shown.

Lachung, located about 60 km east of the epicentre also suffered severe damage, mostly from landslides and rock falls, and the village was not accessible by road during the time of our survey. The area of maximum damage, which covers this village, as shown in Figure 2, is based on inputs from aerial surveys conducted by the Land Revenue and Disaster Management Department, Government of Sikkim, which is also involved in rescue and relief operations.

The nearest town, Mangan, was not seriously affected by this earthquake (see Figure 2 for location). Here the buildings did not suffer any notable damage, except for a few poorly engineered structures. The only notable damage was at the Rumgom Gumpa (the monastery at Rumgom), established in 1852; the rubble-wood structure collapsed at its roof level (Figure 3). A wall poster at the monastery documents that it was damaged twice in the past, once in 1913 (reason not known) and later in 1983, due to a flood. It is not clear how this monastery located at a higher elevation could have been affected by a flood. From the severity of damage to this two-storied structure, we infer that it may not have experienced similar shaking since its existence for more than 150 years.

colluvium. A typical case is the minor damage to the well-engineered RCC buildings in the campus of the Sikkim Manipal Institute of Technology at Rangpo, located ~70 km south of the earthquake source (see Figure 2 for location). Some of the buildings in this large complex are located on the colluvial deposits of the river terrace, which might have amplified the shaking intensity. While most of the damage to structures was in the form of minor cracks or peeling of wall plaster, there was some minor structural damage to the pagoda, an ornamental structure that adorns the roof of the college building. We also noted that almost every multi-storied building that was damaged, particularly in the capital city of Gangtok, had more than three storeys. Another critical aspect is the quality of construction. We noted instances wherein two five-storied buildings under construction in the outskirts of Gangtok collapsed completely, whereas the adjoining building remained unscathed. A few new buildings at the hilltop monastery at Rumtek, south of Gangtok, were also affected, with some significant structural damage (see Figure 2 for location).

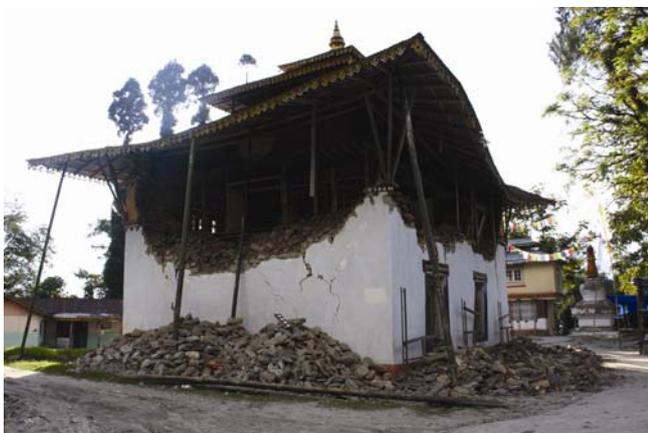
Figure 3. Collapsed monastery at Rumgom near Mangan.

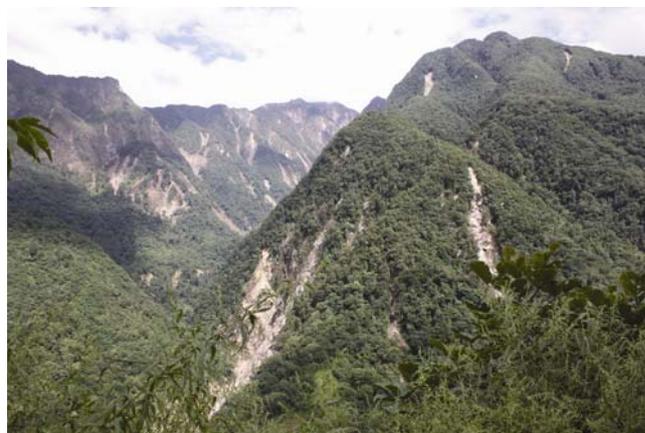
Figure 4. An areal view of landslides along the road to Chungthang.

The morphology of Sikkim is prone to landslides and the earthquake was followed by numerous landslides and rock falls in the epicentral area (Figure 4). The severe rains that occurred in the days following the earthquake also contributed to the density and severity of landslides. No evidence of surface faulting was noted; a few instances of fissures and pavement failures were reported. We noted similar failures on the road leading to the Rumtek monastery and also at one location in the Urja Colony.
