## The Baluchistan Earthquake of May 31, 1935.\*

By W. D. West,  
*Geological Survey of India.*

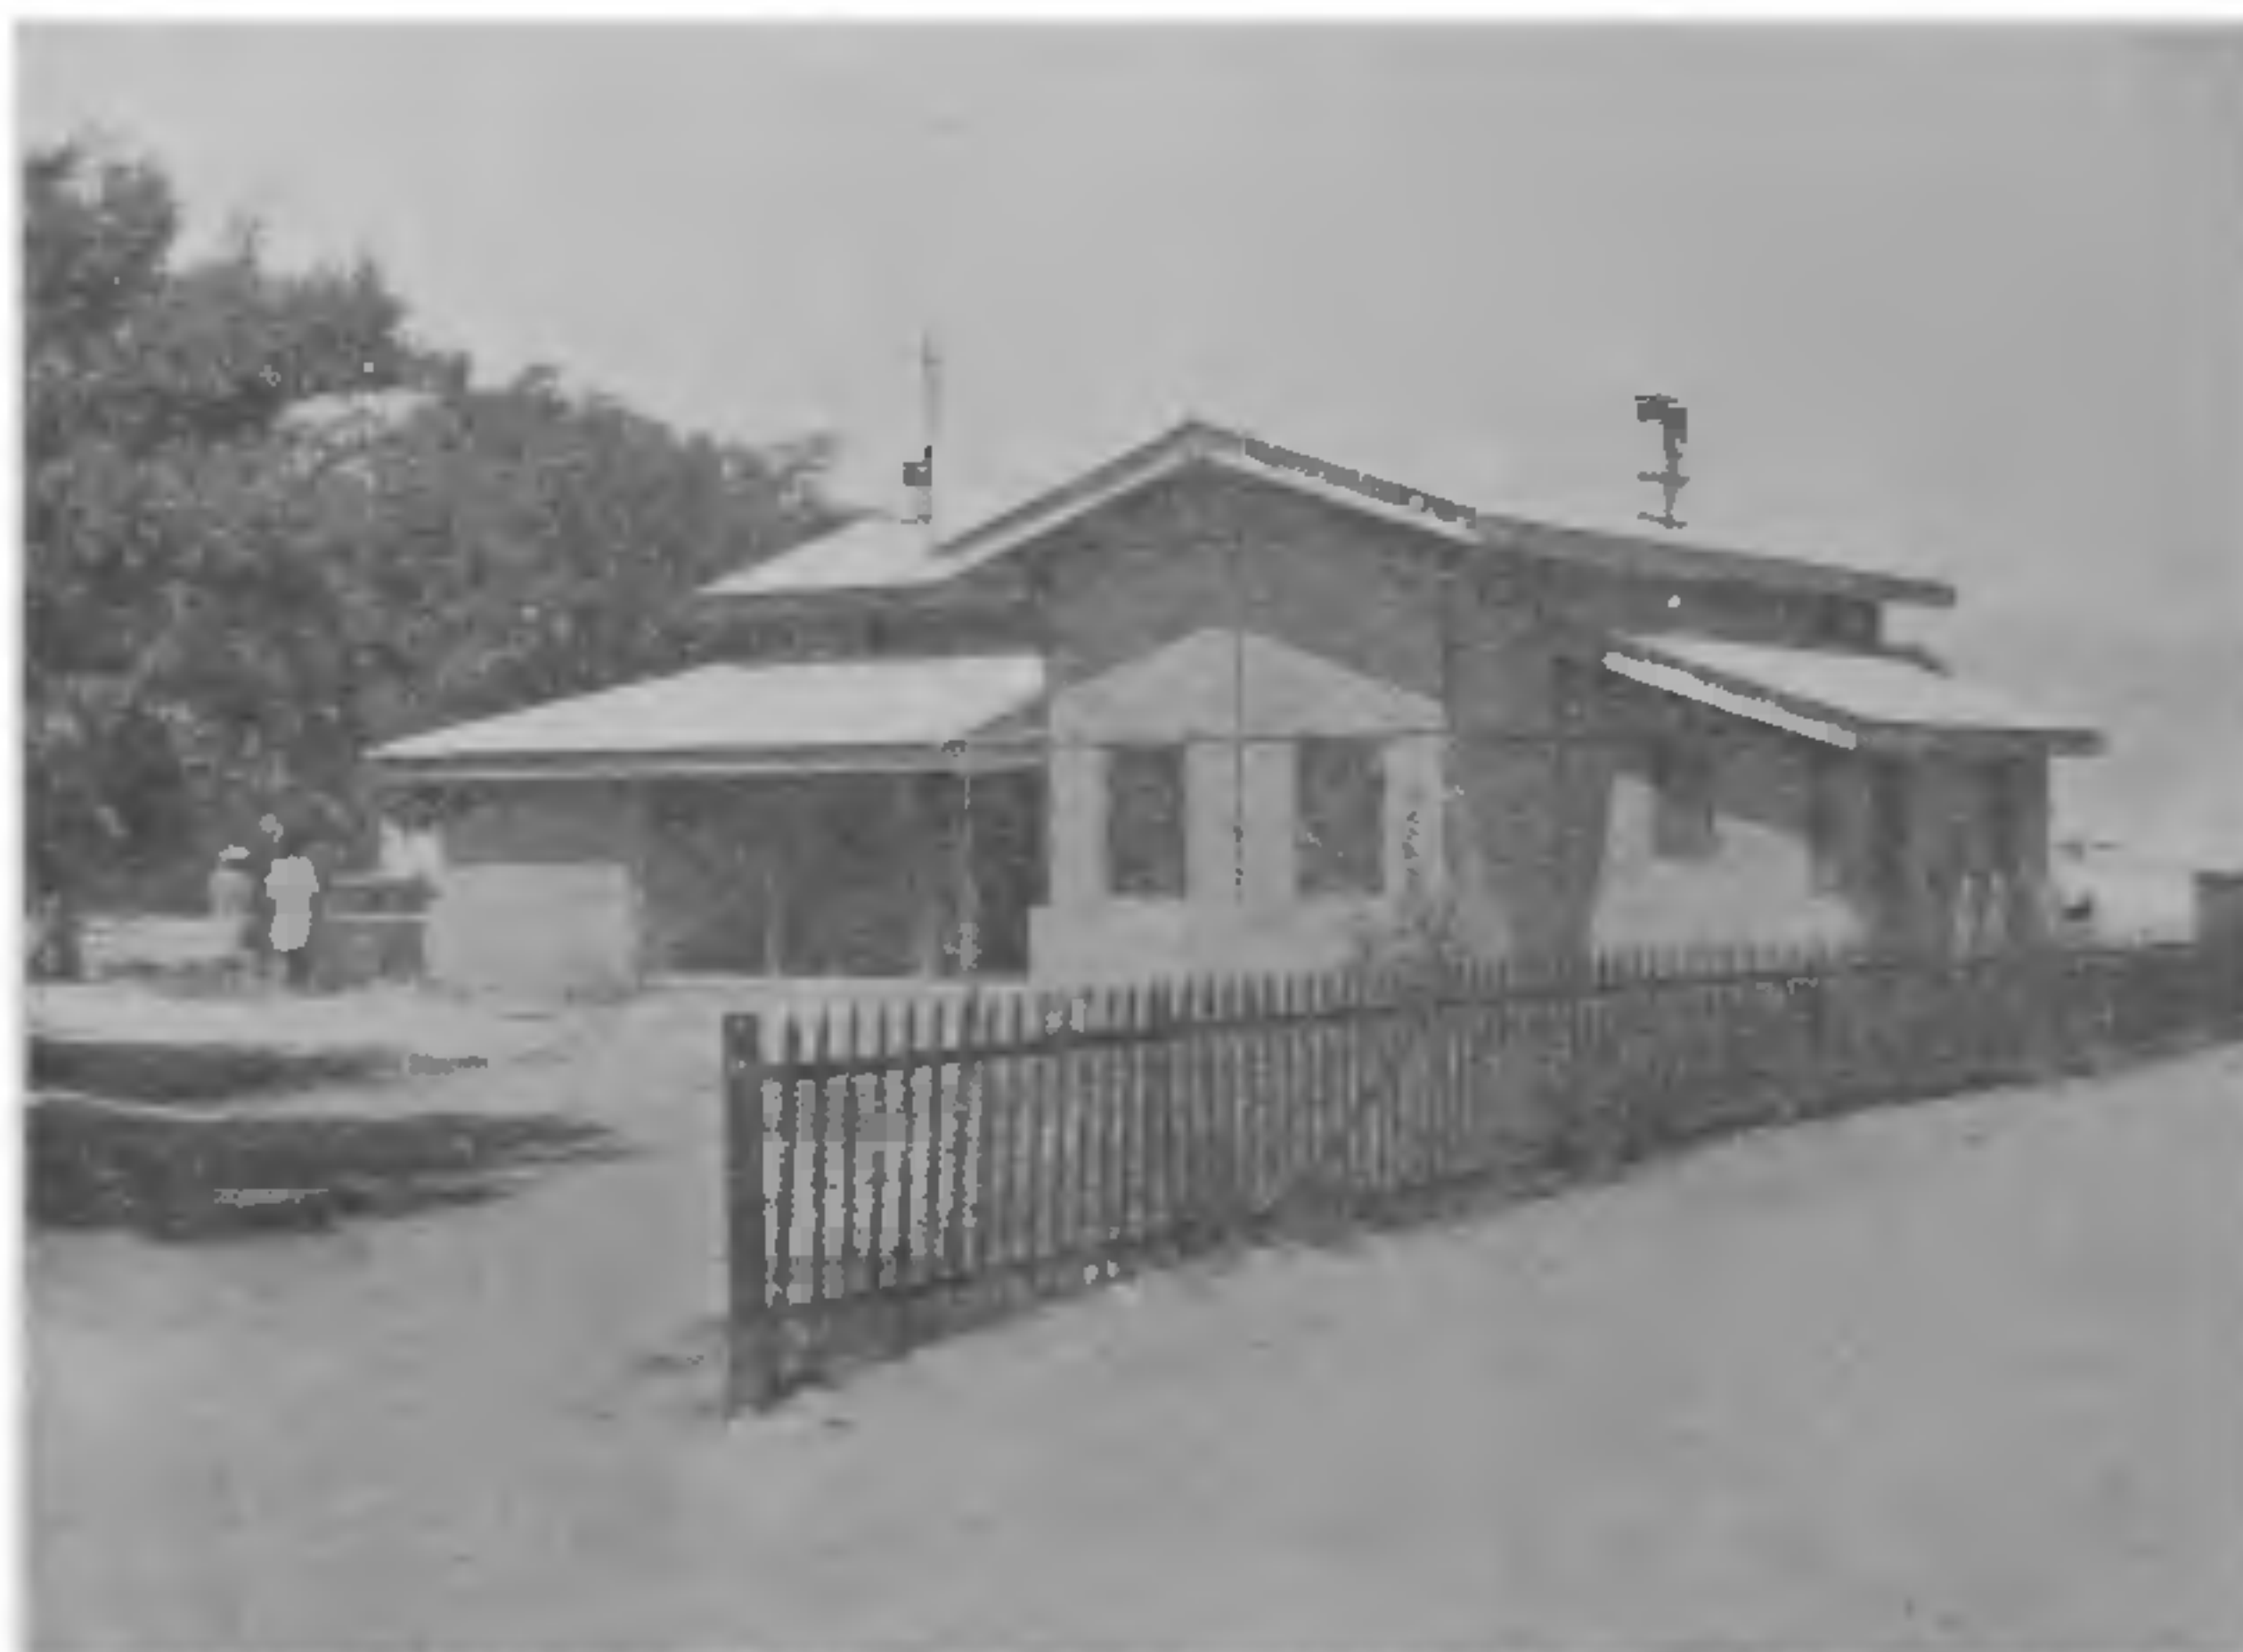
Fig. 1.  
An earthquake-proof bungalow built by the North-Western Railway.

The enormous death roll which occurred at Quetta is directly attributable to the very poor manner in which nearly all the buildings were constructed. Owing to the scanty rainfall in this part of India, it has been the practice in the past to use a mud mortar. Such a mortar has very little bonding power, and when an earthquake occurs, the very heavy lateral force to which the building is subjected simply causes the bricks to slide over one another, and the building collapses. In the case of the present earthquake a feature of great interest was provided by certain North-Western Railway bungalows which had been built since the 1931 earthquake and

had been designed on earthquake-proof lines. Although surrounded by smashed buildings, they are without a single crack. The accompanying photographs show the completely ruined Dak bungalow in Lytton Road and one of the new earthquake-proof Railway bungalows situated on the other side of the road. It is difficult to imagine a more striking illustration of the efficacy of sound earthquake-proof construction, in which rigidity has been the main consideration. By making a building as rigid as possible, instead of the building falling apart during an earthquake, due to the different parts of the building behaving differently, it will move as a whole and so avoid being cracked. That these Railway bungalows did move as a whole was clearly shown by the fact that those who were living in them were so severely shaken that they were unable to stand up inside the bungalow during the earthquake, while heavy almirahs were also thrown down. These bungalows had been made rigid by bracing with vertical and horizontal iron rails, and had been constructed to withstand a horizontal acceleration of 3.2 feet per second per second. From this, however, it is not to be inferred that the acceleration of the earthquake motion was less than 3.2 feet per second per second, because in constructional work a considerable factor of safety is always allowed, which may be as much as 3 or 4.

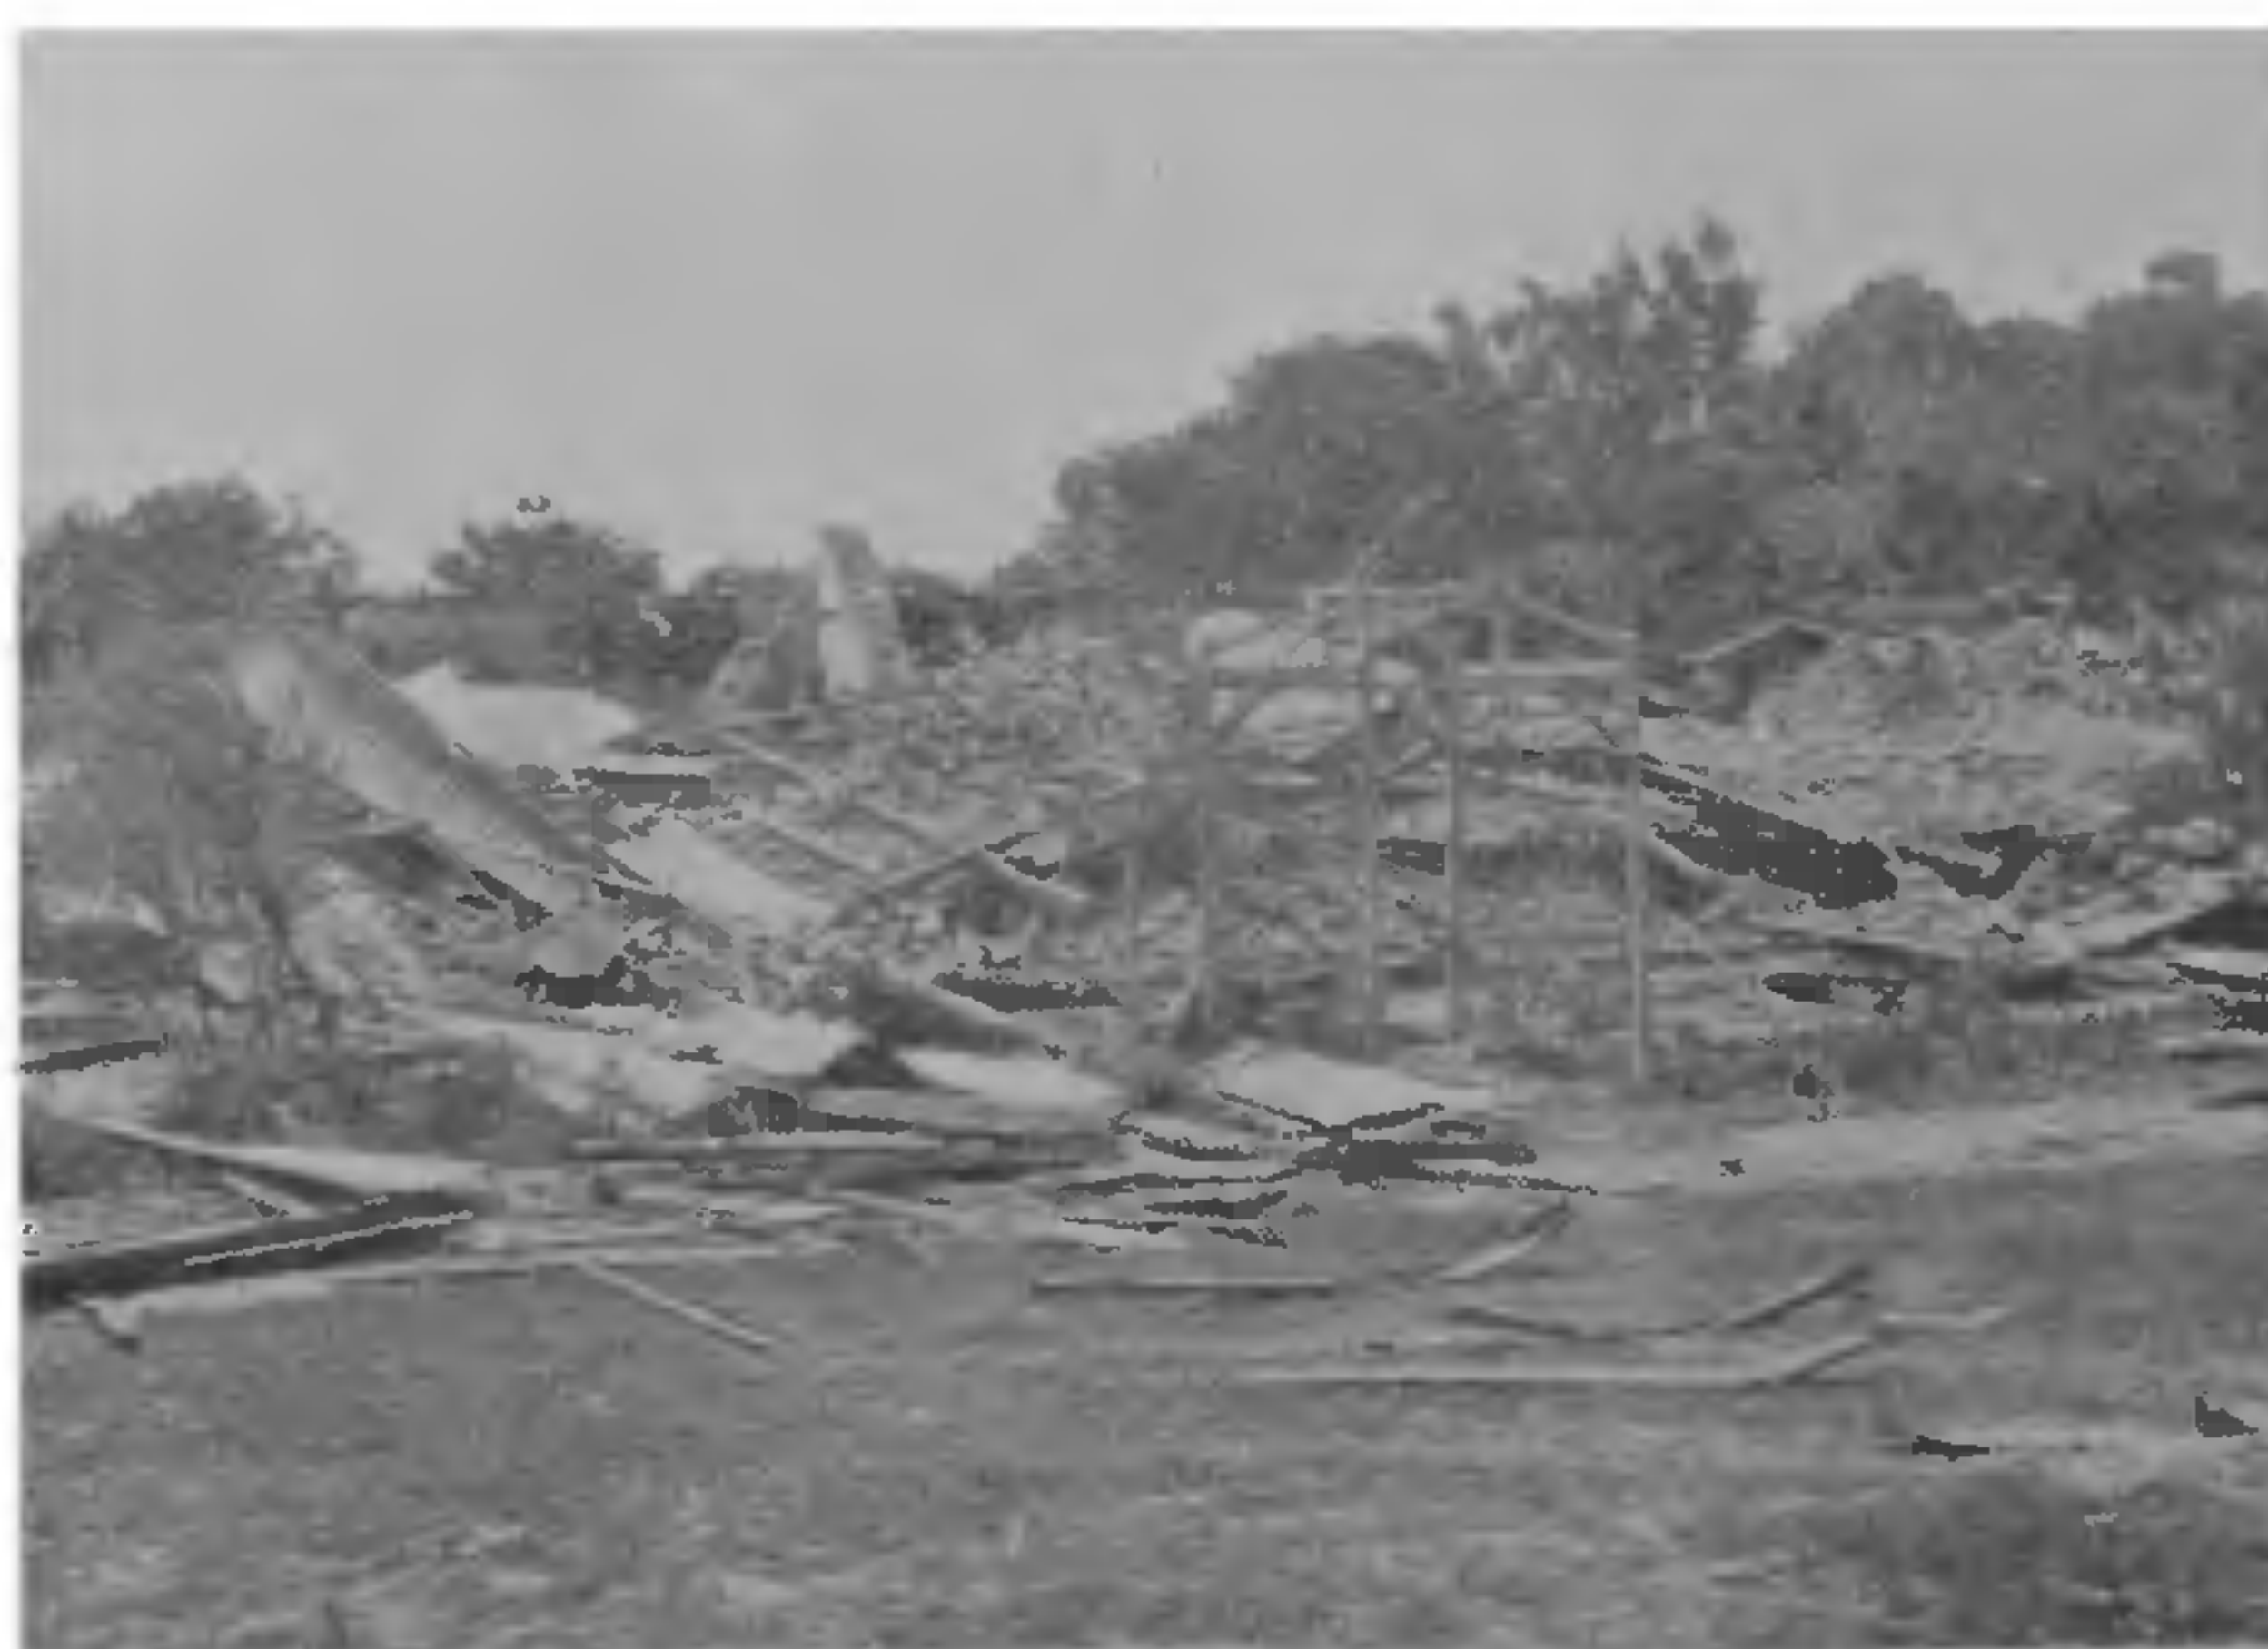
Fig. 2.  
The Dak Bungalow, Quetta.
