## ON THE SLUMPINGS OF THE VALLEYS ENCOMPASSING IDUKKI RESERVOIR, CENTRAL KERALA, INDIA.

K. SASEENDRAN, P. K. RAJAN, D. SALIM and K. K. RAMACHANDRAN  
*Centre for Earth Science Studies, Trivandrum 695 010, India.*

### ABSTRACT

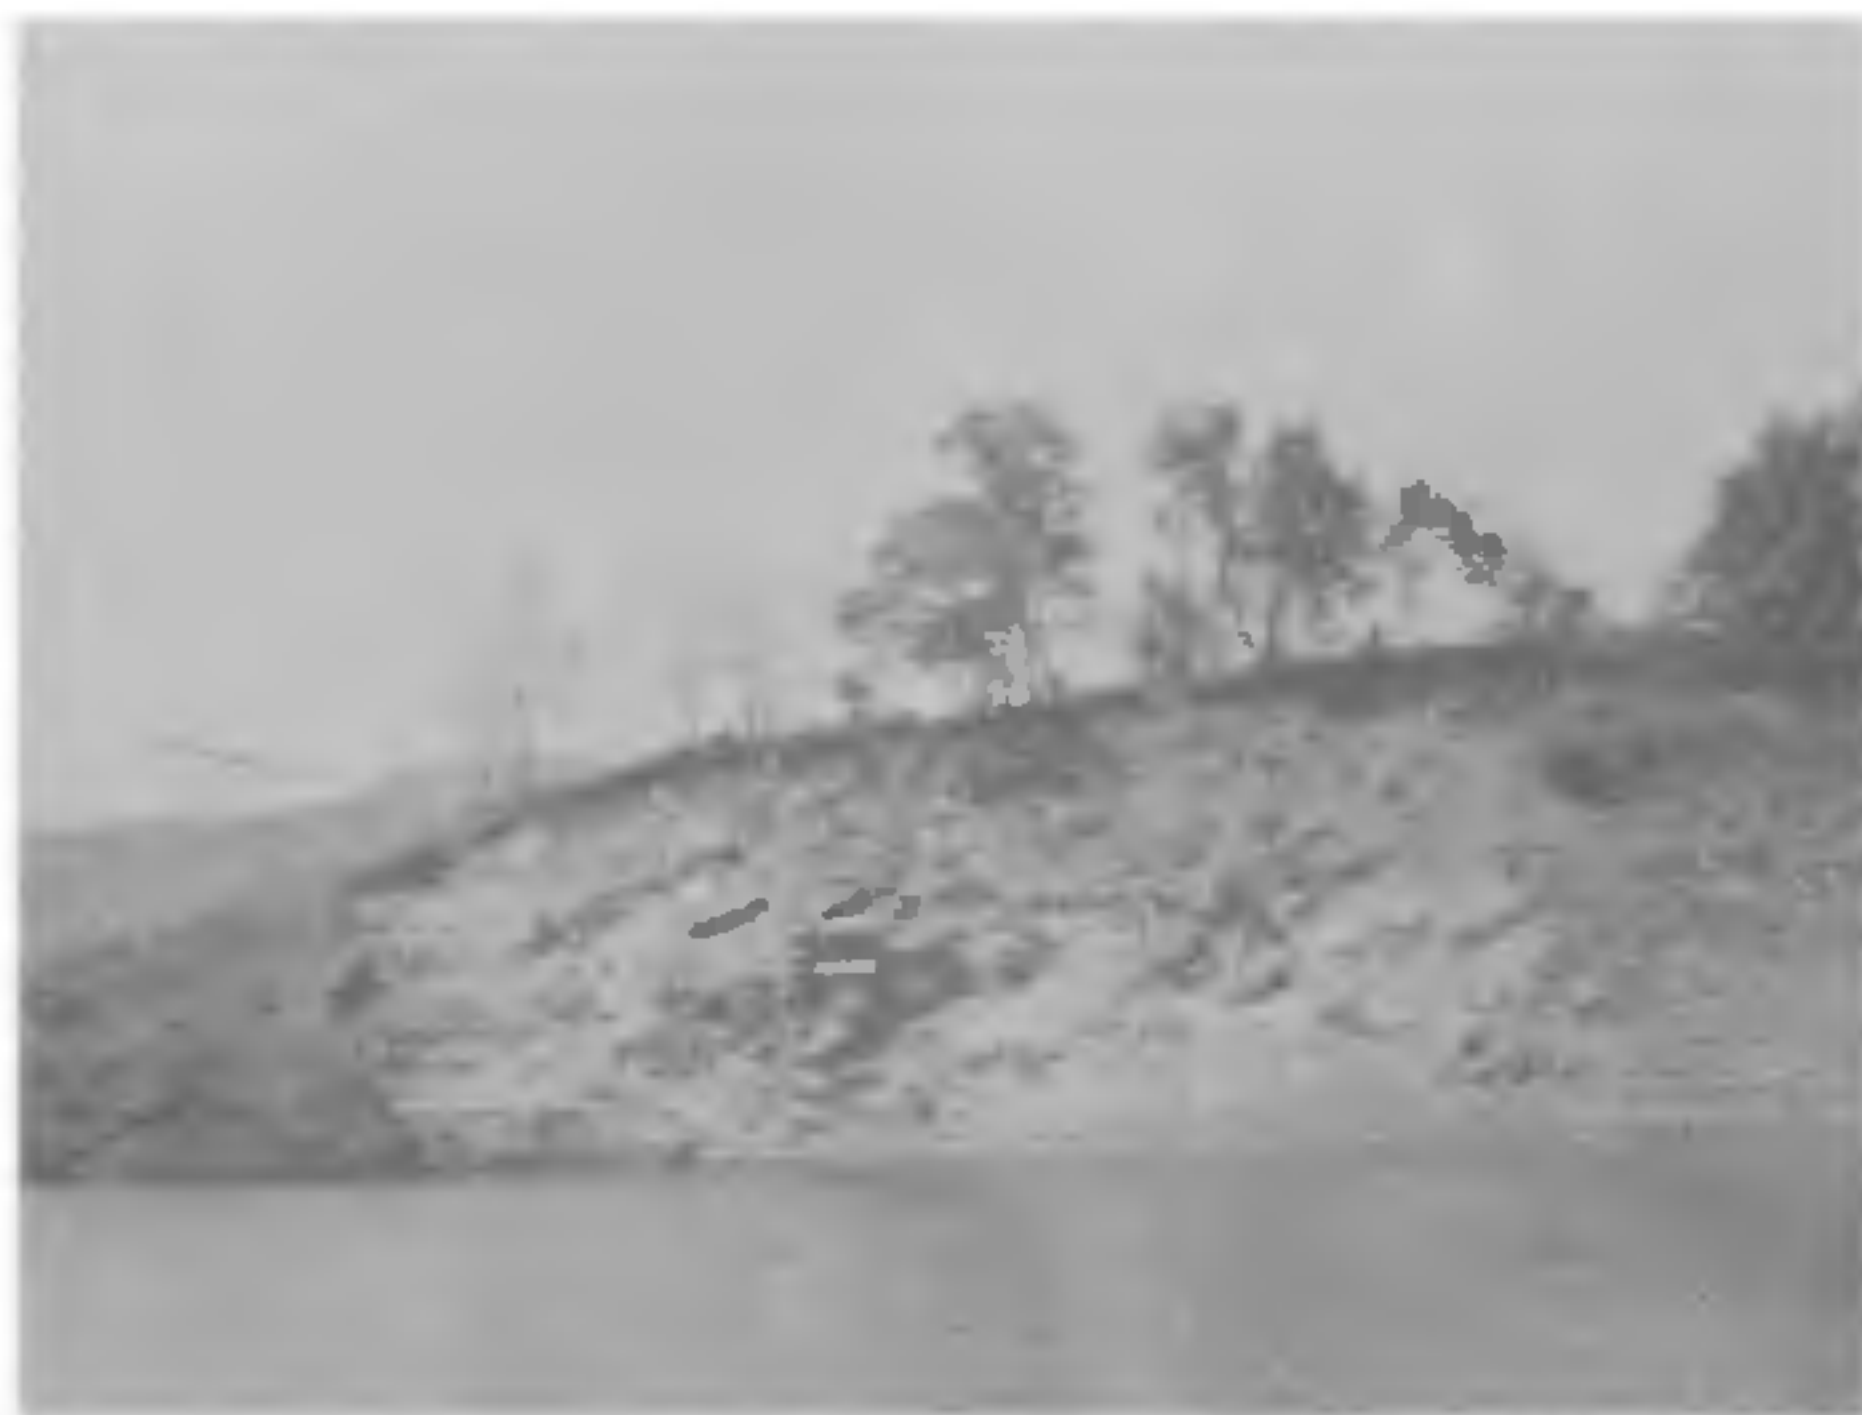
**Figure 3.** A major slumping in Periyar arm of the Idukki reservoir. The terracing on the slope is the result of beach action of reservoir water at different periods of lowering.

The notable feature found in these valleys is the slumpings of the weathered mantle. They are normal gravity slides of overburden which moves down on a curved or spoonlike surface, occurring either within the overburden or at the junction of the basal rock and the overburden (figures 3 and 4). These slumpings are also known as "circular failures"<sup>7</sup>.
