Studies on weathering of Kailasanatha Temple, Kancheepuram

M. Singh

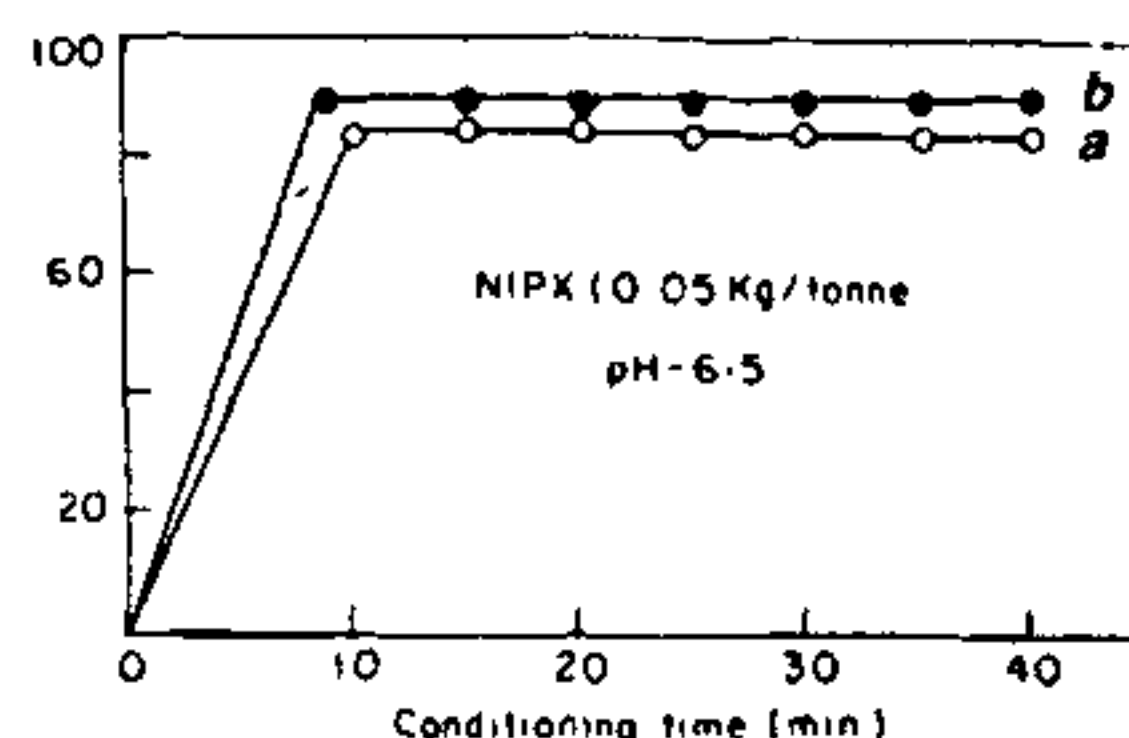
Figure 2. Effect of ultrasonication on the flotability of galena. *a*, sonication + stirring in distilled water + 10 min conditioning with collector; *b*, sonication + stirring in distilled water + 10 min conditioning with collector + desliming

Figure 2a shows the effectiveness of ultrasonication with stirring in distilled water followed by collector addition and conditioning. It was presumed that introduction of stirring in distilled water (no collector) during ultrasonication prevented adsorption of some collector by slimes. Subsequent addition of collector followed by conditioning (5 minutes) led to substantial improvement in recoveries. Exposure of the clean galena surfaces which are more conducive to xanthate adsorption resulted in

Figure 2b corresponds to the conditions of Figure 2a except for the desliming prior to flotation. The flotation recovery in this case was found to be higher. The presence of slime generally hinders particle-bubble attachment and leads to excessive collector consumption. The above results indicate that ultrasonication under appropriate conditions can achieve at least a 40–50% reduction in collector consumption. The imposition of ultrasonication creates a surface which is not only partially hydrophobic but also highly conducive to collector adsorption.

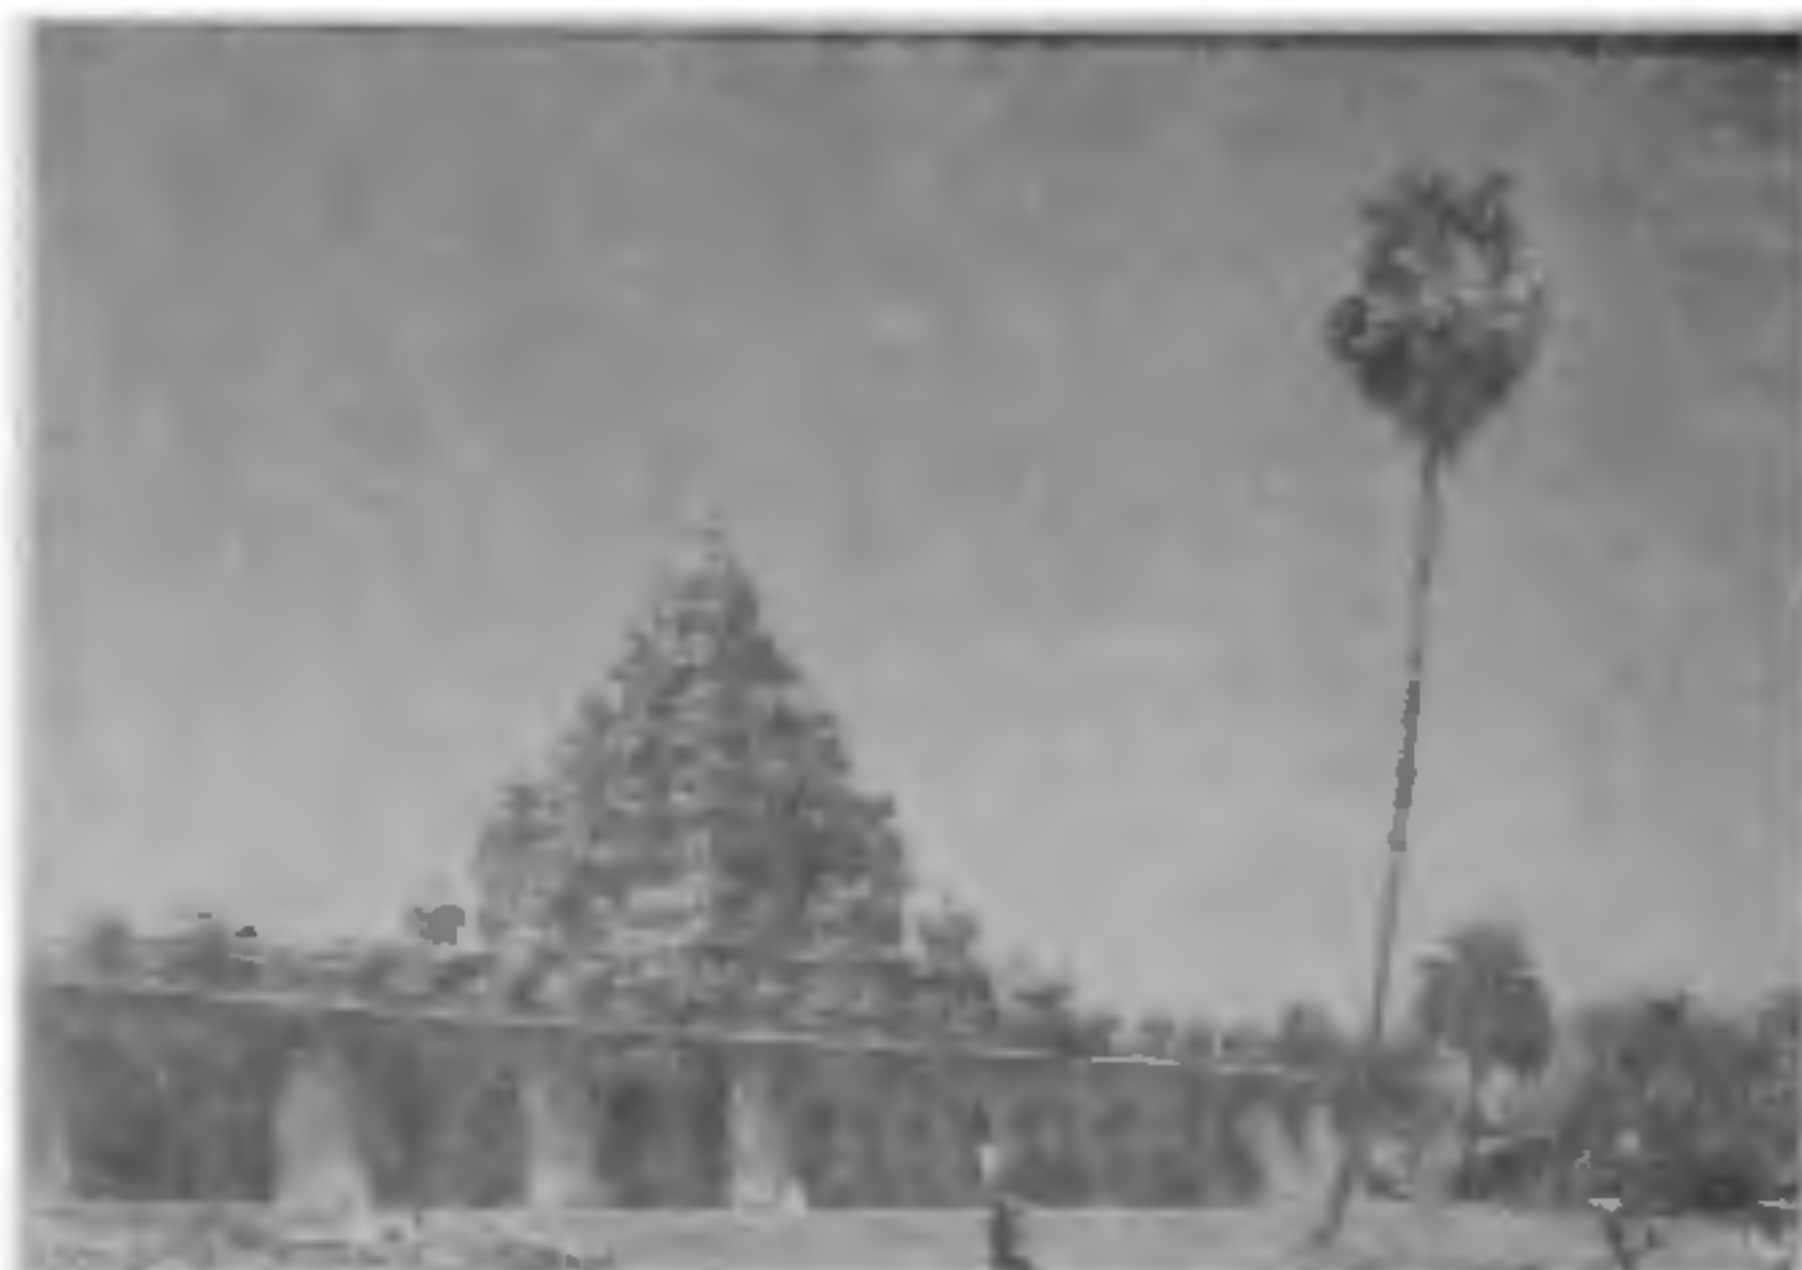
The temple consists of the main Vimana (Figure 1) a four-storey structure, and was named after its builder Rajasimheswara. On the eastern side, there is a small shrine called Mahendravermeswara, built by his son Mahendra Varman. The entire temple complex is surrounded by a compound wall which was built in array of 58 cells (Figure 2) on the inner side and contains figures of Gods and paintings.

Figure 1. A view of the Kailasanatha Temple, Kancheepuram.

The Vimana became black due to biological growth.

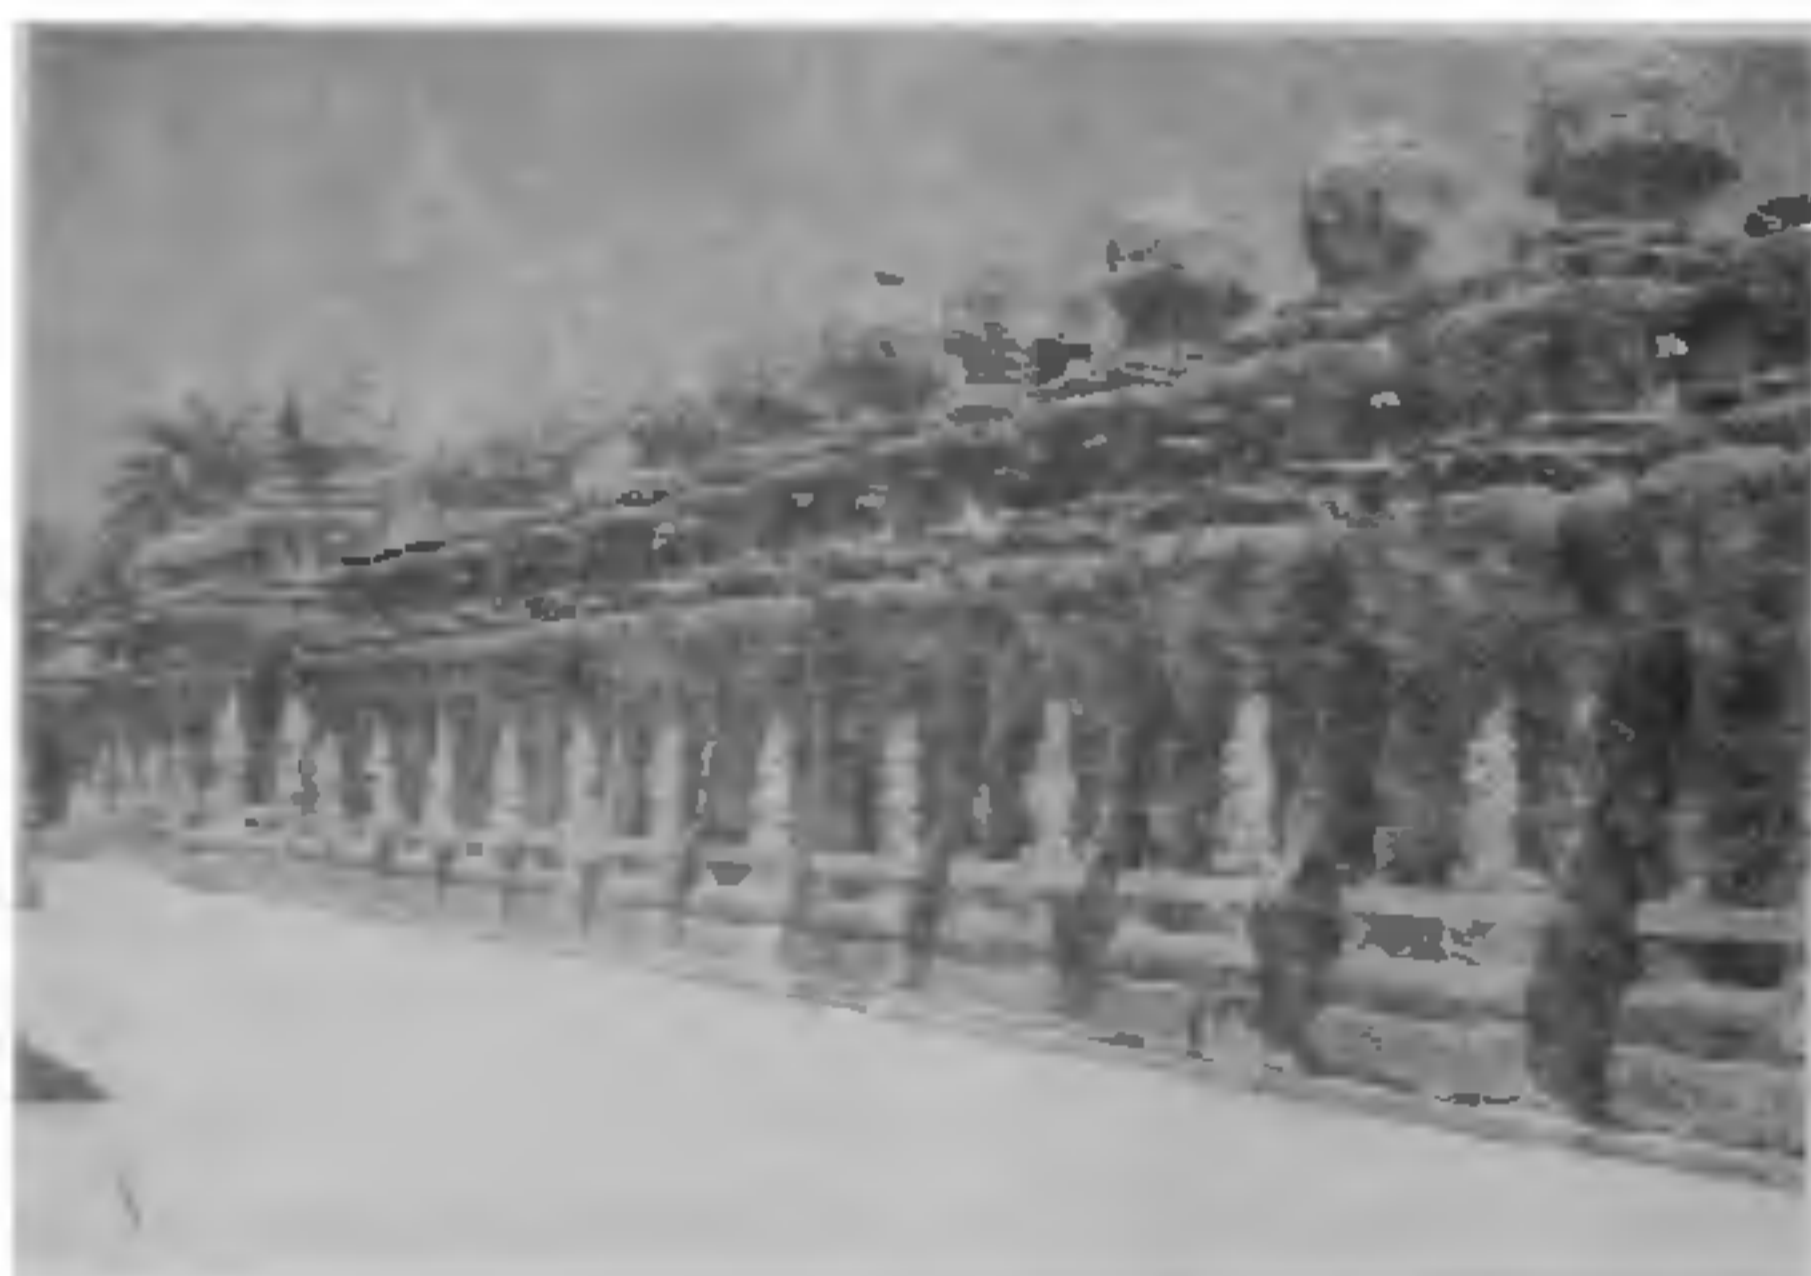
Figure 2. The inner cells of the temple.

grained consisting of quartz cemented by calcite. The deterioration of the temple was due to biological growth and salt action. Salts were carried by speedy sea winds or capillary action. Due to this as well as the variation in atmospheric conditions, sandstone lost its compactness and became powdery. The surface was so pulverized that sharp features of the sculptures and fineness of the ornamental design were lost (Figure 3). The plinth walls and pillars of the cells lost their finely-chiselled polish surface and show sand particles loosely adhering to the surface.

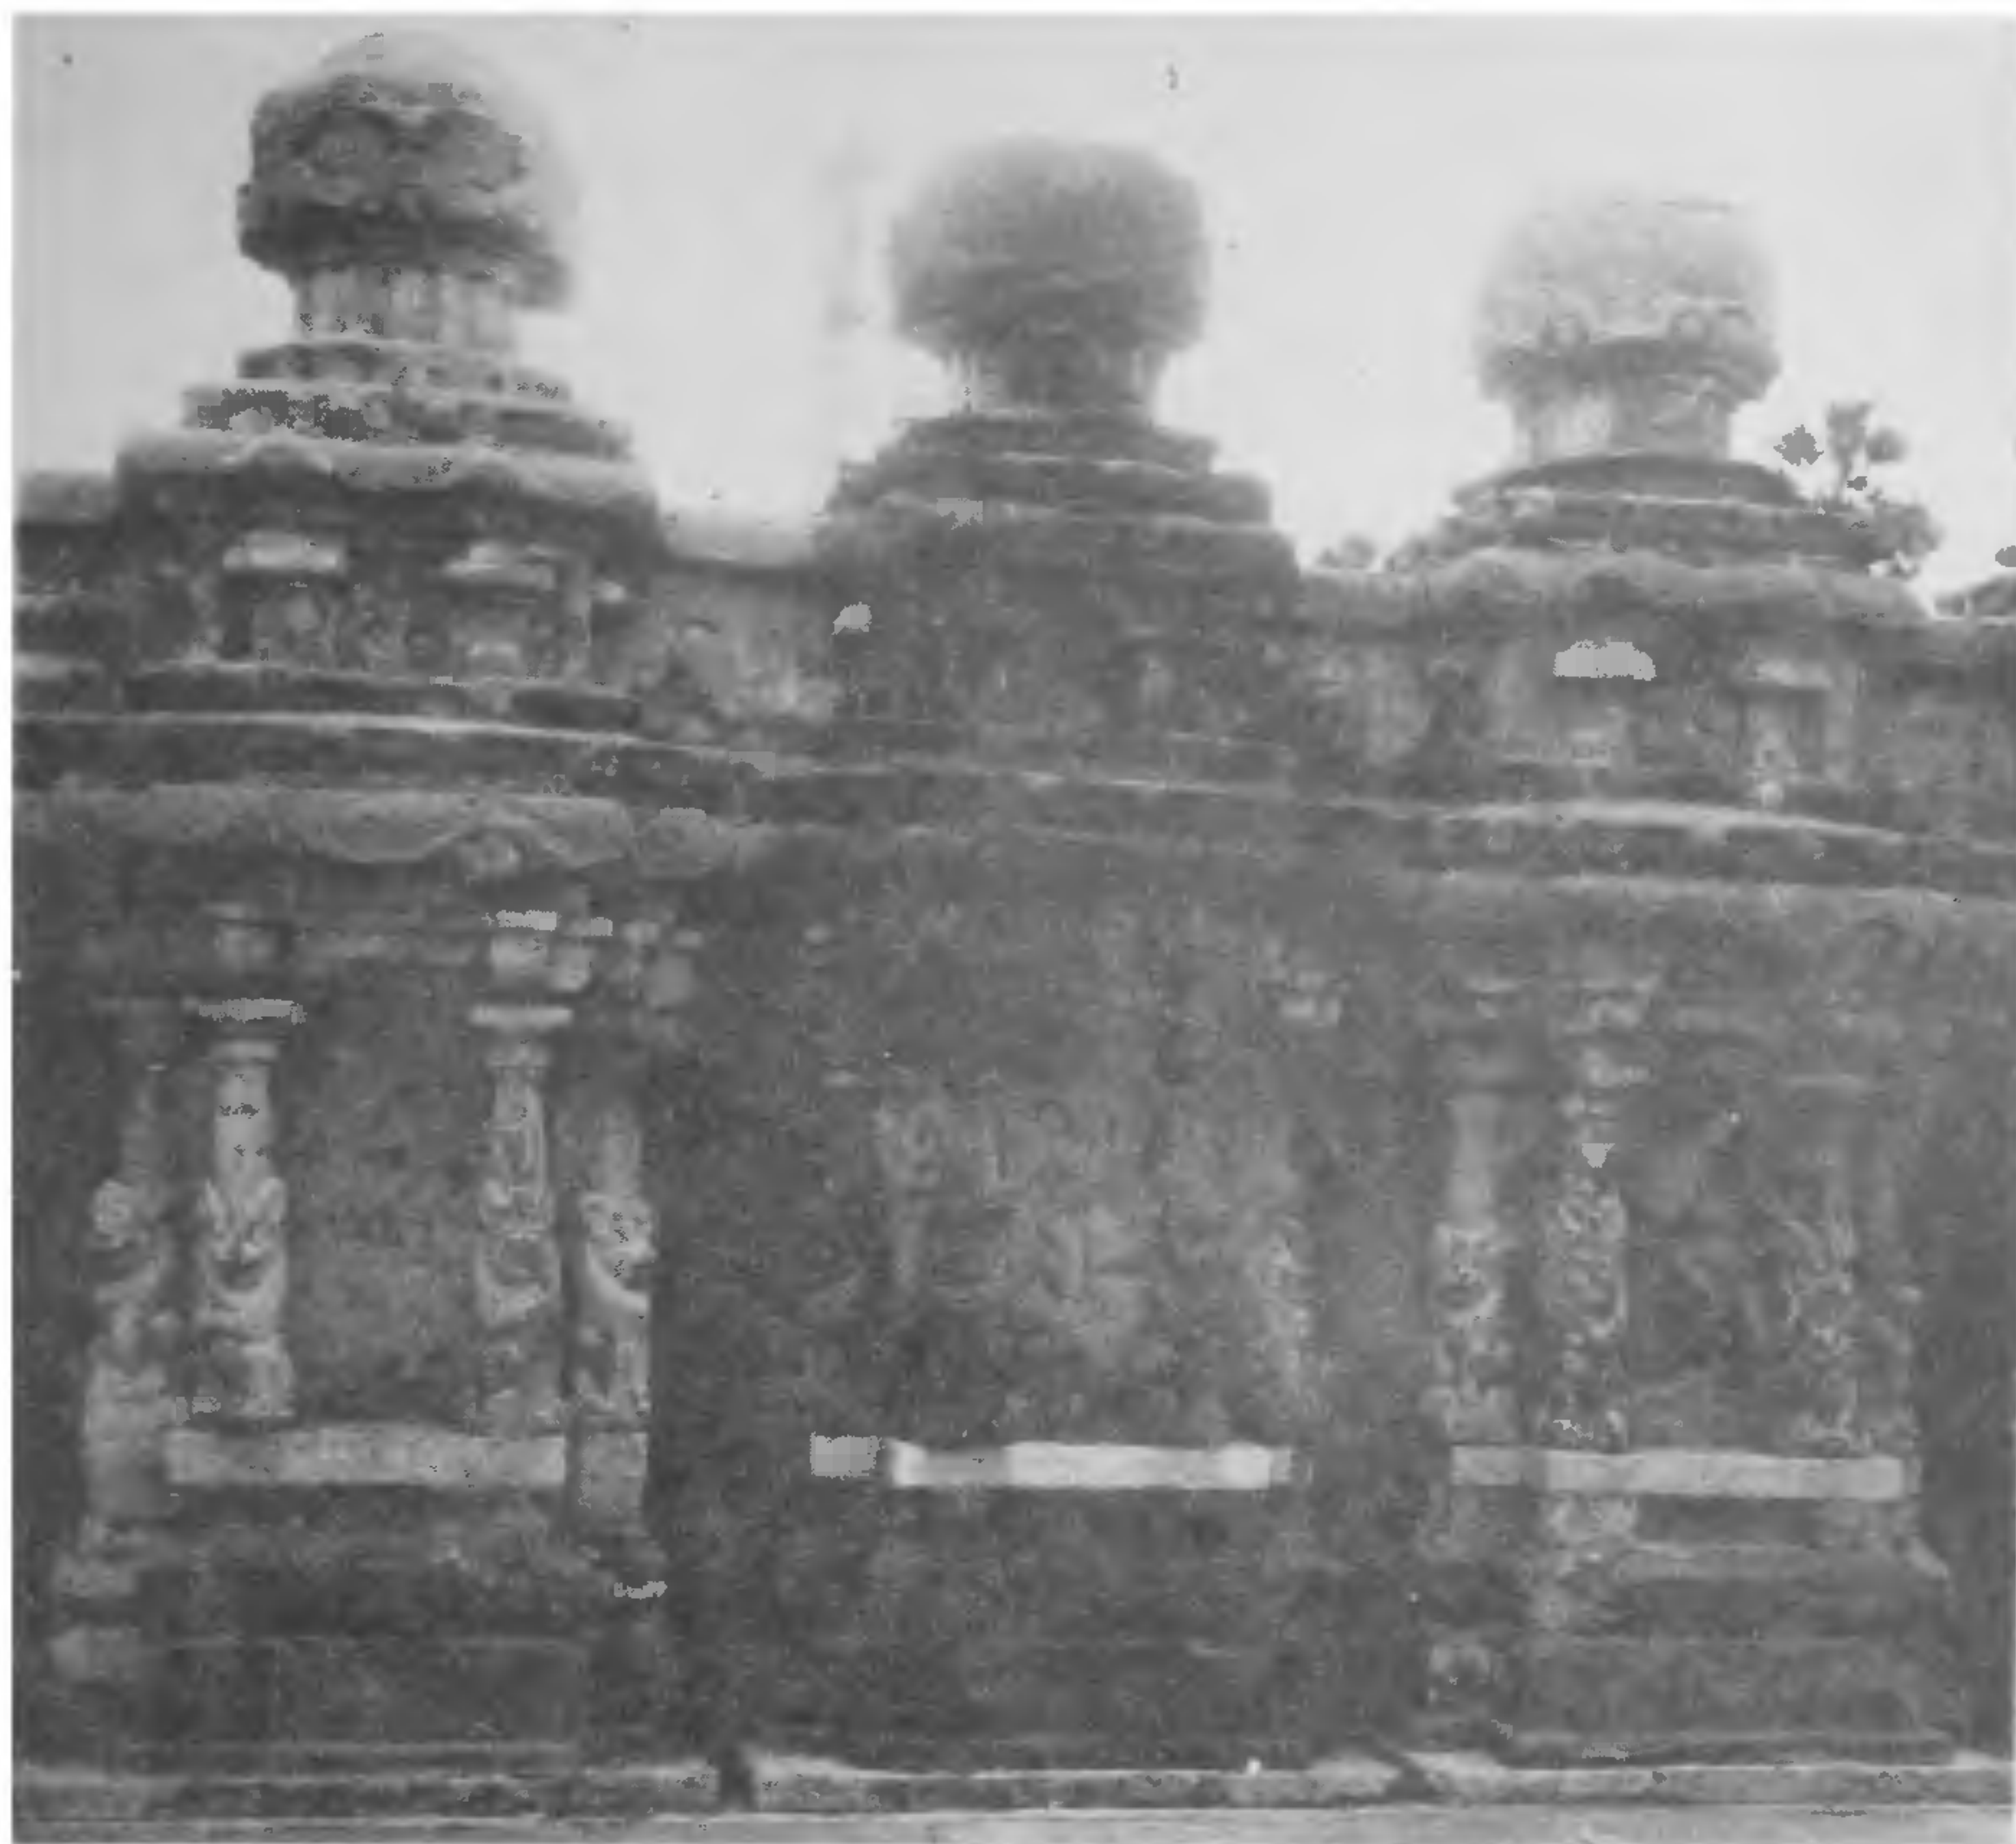
Figure 3. Loss of ornamental design due to weathering.

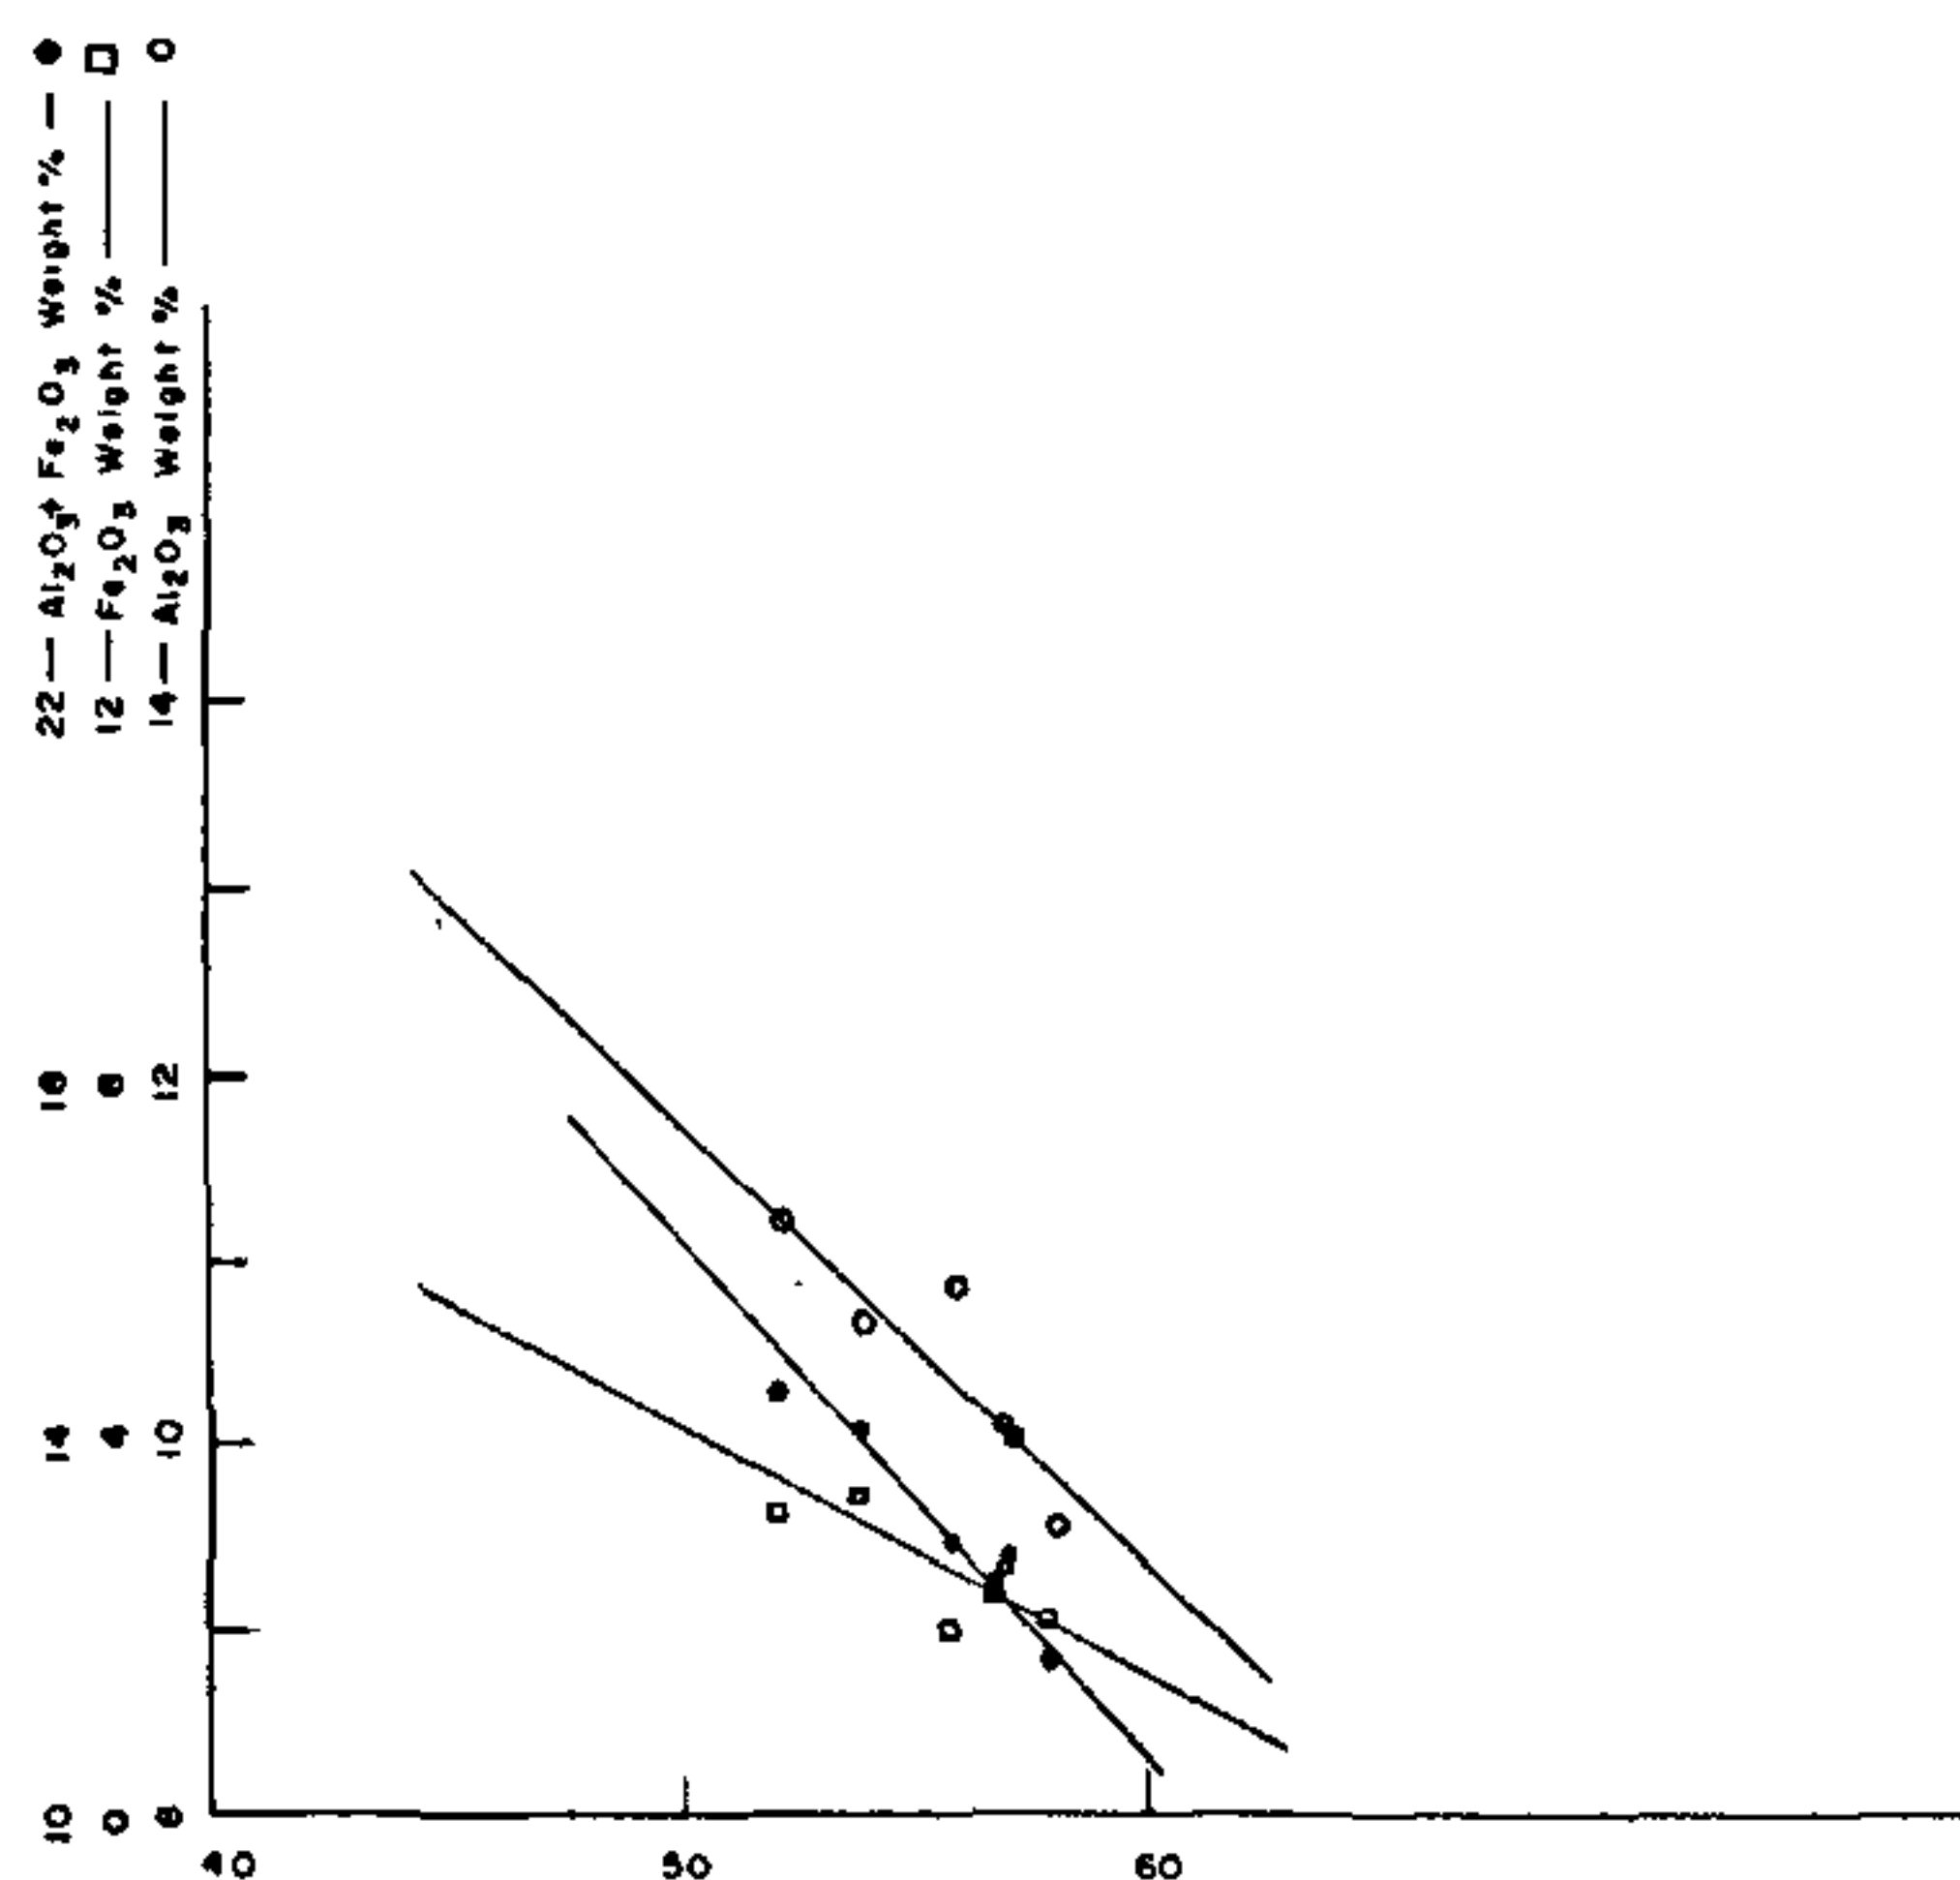
ing that Al_2O_3 or Fe_2O_3 decreases with corresponding increase in SiO_2 (Figure 4). Al_2O_3 and Fe_2O_3 taken together show similar relationship with SiO_2 (Figure 4). In general, a decrease in Al_2O_3 is seen to register a much larger decrease in the Fe_2O_3 content. This

indicates that $\text{Al}_2\text{O}_3 + \text{Fe}_2\text{O}_3$ together may be taken as an index of weathering. Analytical results also show a gradual increase of silica with corresponding increase in sodium and potassium oxides on the weathered stone. Hence, in conjugation with other factors of

Figure 4. Variation of SiO_2 with Al_2O_3 , Fe_2O_3 and $\text{Al}_2\text{O}_3 + \text{Fe}_2\text{O}_3$.

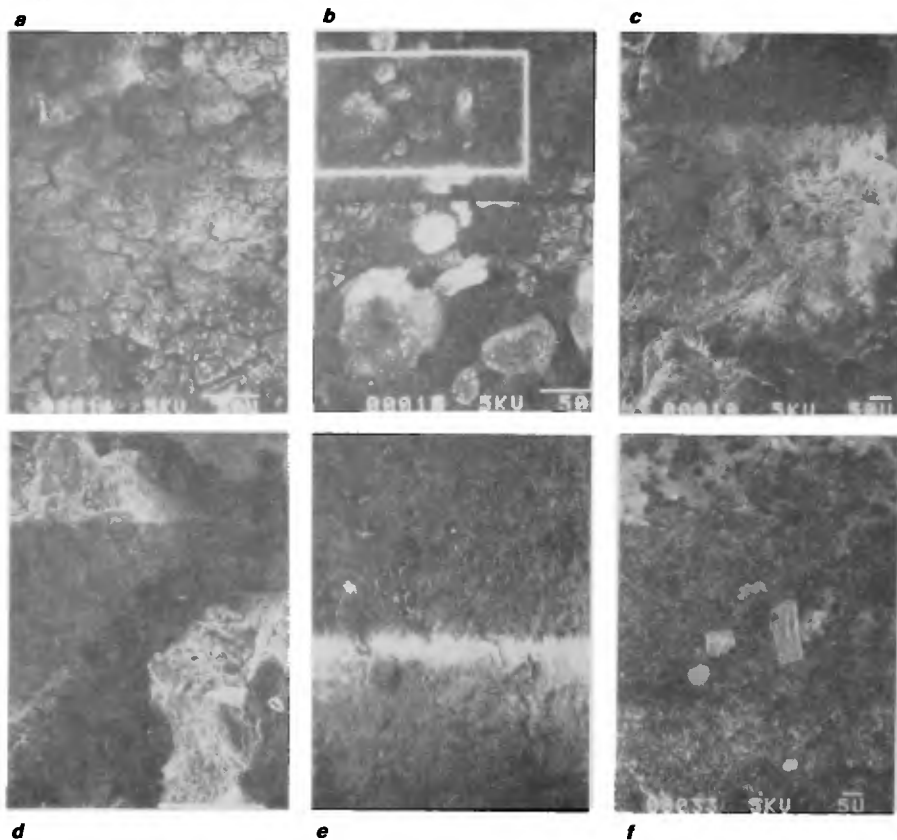
In order to compare the structural alteration, both weathered and unweathered stones were scanned on a Hitachi-450 SEM. The SEM micrographs of weathered sand stones show the presence of quartz, feldspar, felsic minerals, loose quartz grains, calcite and biotite. The grain sizes are heterogeneous. Cracks and cavities filled with ferruginous cementing material can be very distinctly seen. The micro-morphology of unweathered rock is quite different. The grains of constituent minerals are quite intact, homogeneous and without any structural defects. Figures 5a-d illustrate the cross-section of decayed sandstones. Figures 5e, f show micrographs of a sound sand stone and granite stone respectively.

Figures 5a-f. Scanning electron photomicrographs. **a**, The lattice pattern with distinct demarcations ($\times 300$); **b**, The box at the upper half of the photograph ($\times 300$) has been enlarged further two times in the lower half, shows the presence of corroded quartz grains as a result of weathering; **c**, Abrased surface of crystals with their uneven and indiscipline distribution ($\times 100$); **d**, A deep crack ($\times 50$); **e**, Homogenous agglomeration of minerals in calcite cementing material ($\times 100$); **f**, Grains of quartz feldspar, etc. and their distribution in the granite stone ($\times 100$).
