The Chamoli earthquake, Garhwal Himalaya: Field observations and implications for seismic hazard

Kusala Rajendran*, C. P. Rajendran, Sudhir K. Jain, C. V. R. Murty and Jaswant N. Arlekar

The Chamoli earthquake in the northern part of Uttar Pradesh is an important event from the point of view of seismic hazard and risk assessment in the Himalaya. Tectonically, it is significant due to its location in the 'central seismic gap', a 700-km-long segment between the 1905 Kangra (M 8.6) and the 1934 Bihar (M 8.4) earthquakes. Occurrence of two moderate earthquakes (1991 Uttarkashi and 1999 Chamoli) within a period of nine years naturally raises concern about the seismogenic potential of the region. In this paper we present observations made during the post-earthquake survey around Chamoli, and address some issues regarding the regional seismic hazard.

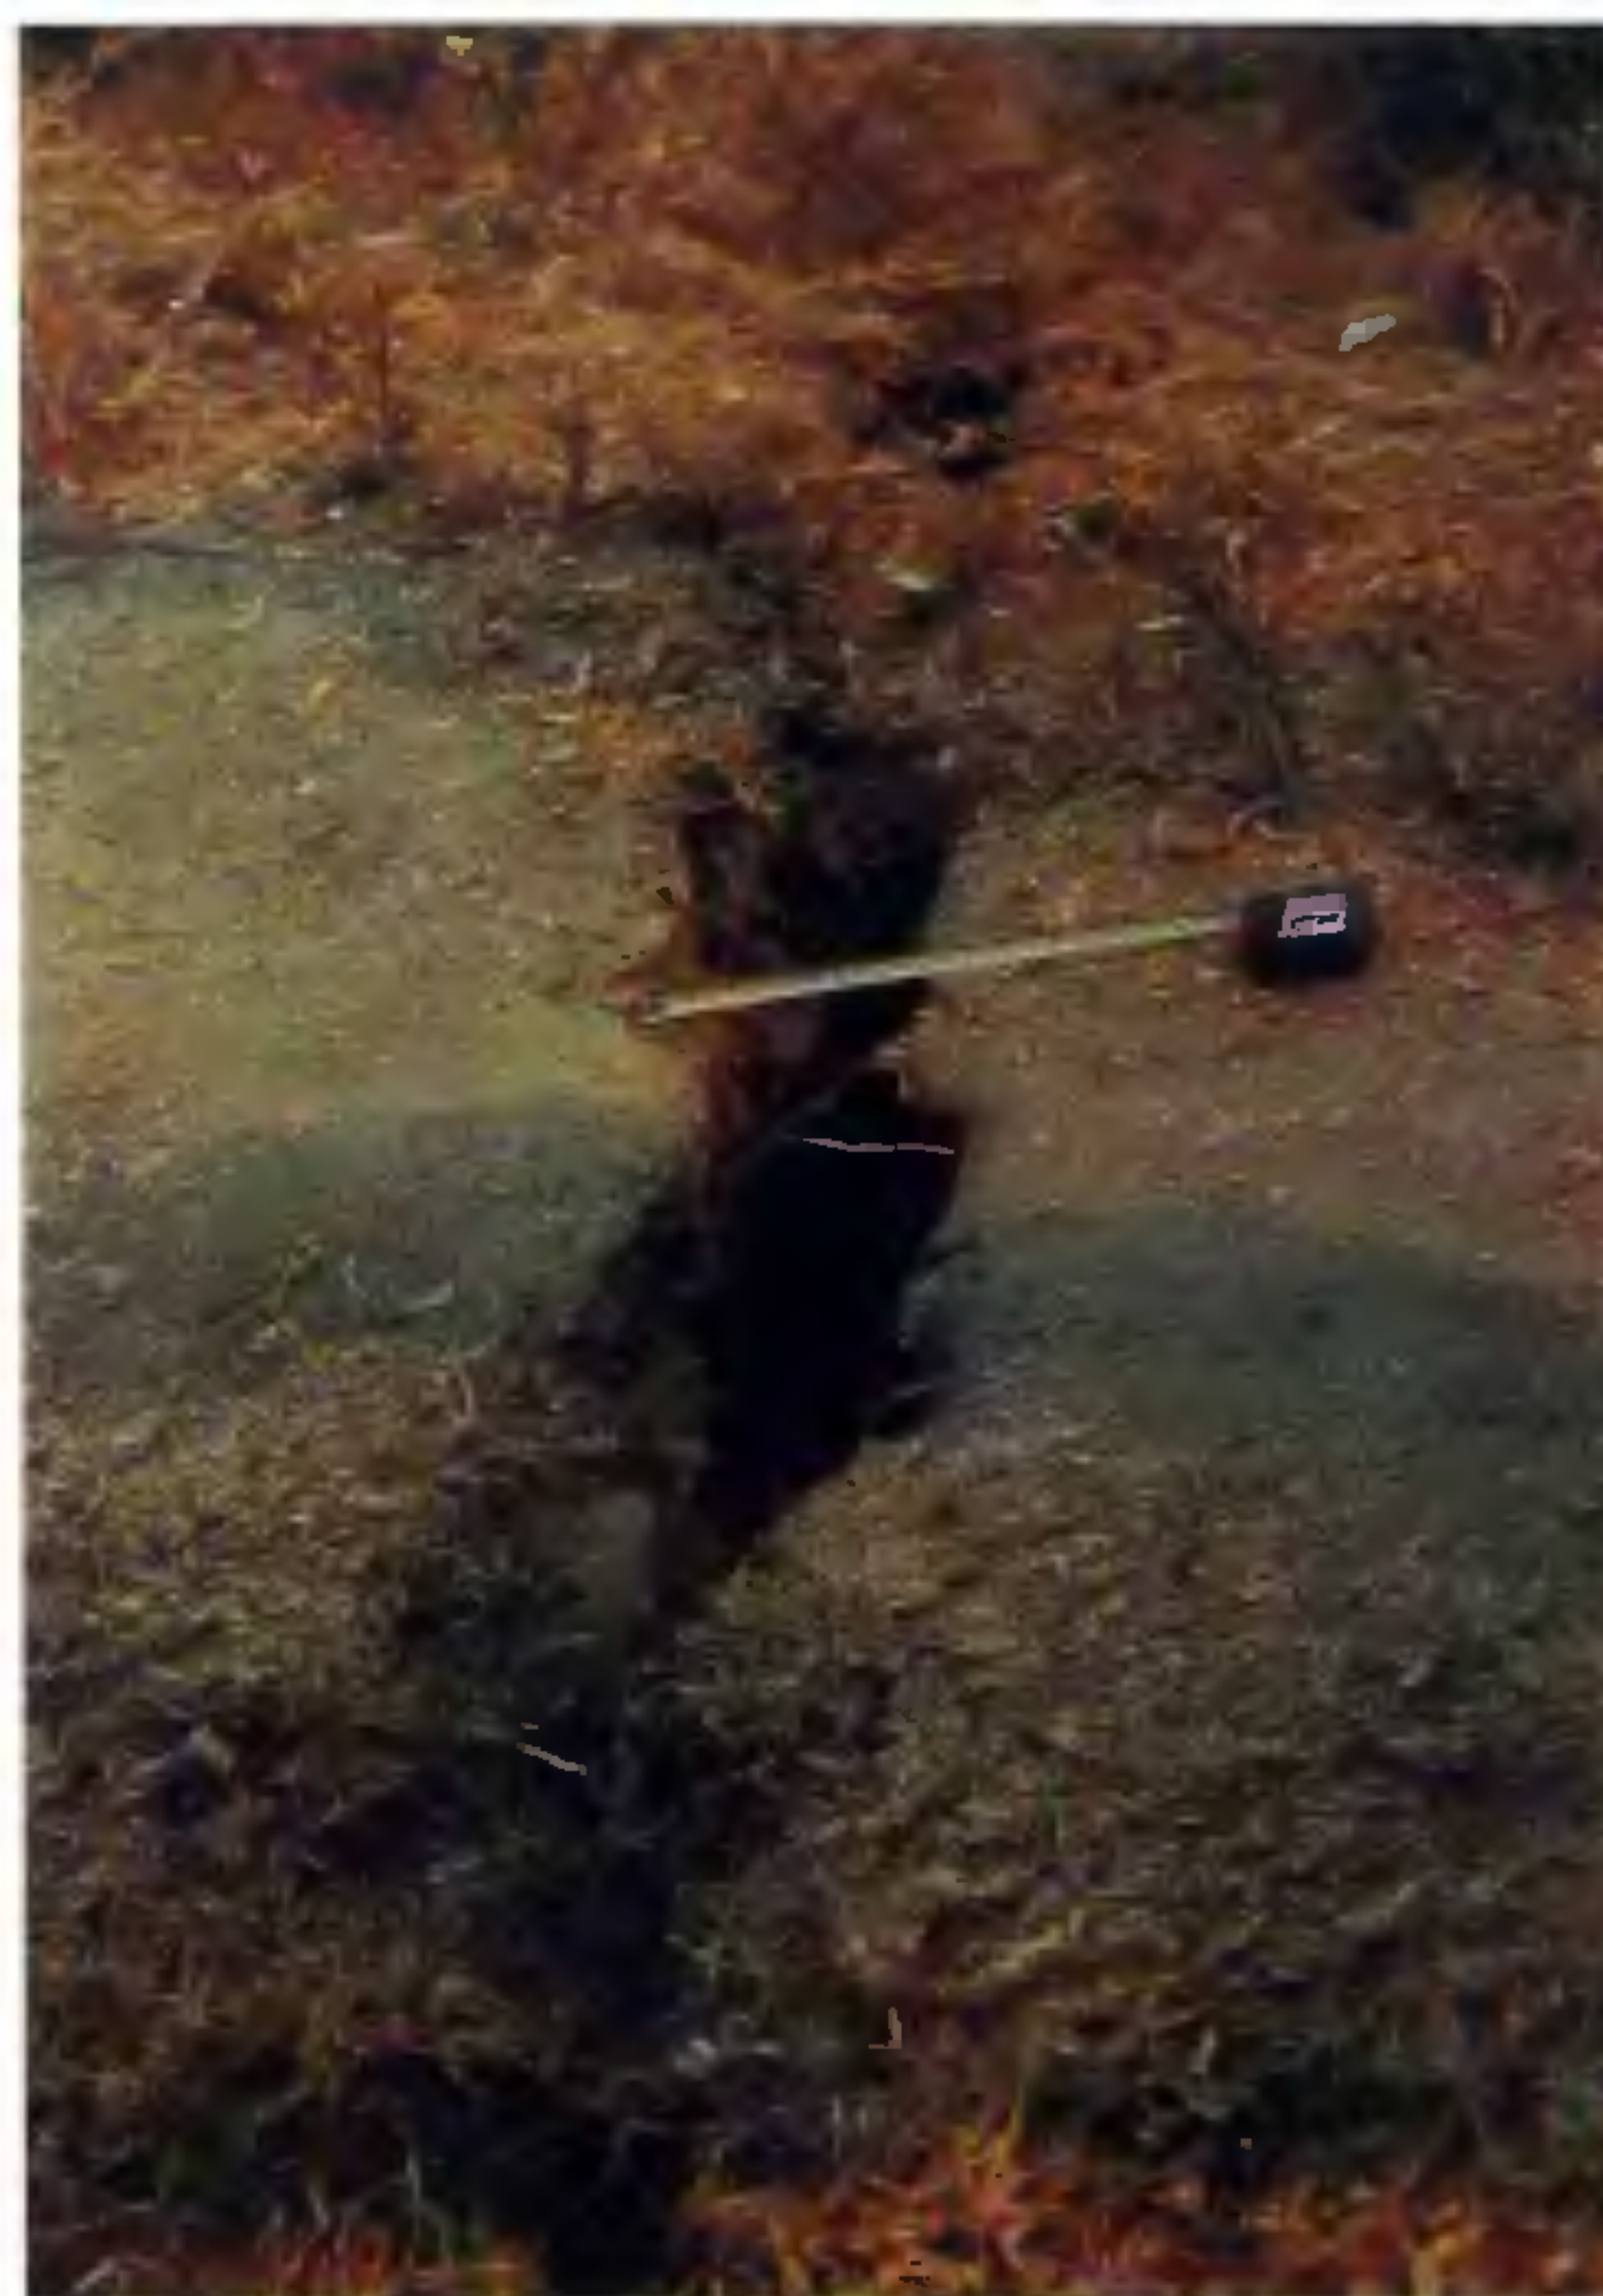
Figure 6. Ground fissure at Telecom Hill near Gopeshwar.

Ground cracks developed at several places as part of slope failure, causing threat to the settlements. Well-developed ground cracks trending roughly in the east-west direction and showing lateral movement of up to ~ 12 cm were observed at Gopeshwar, Chamoli and Bairagna (Figure 6). Attempts to make trenches across the ground fissures at Telecom Hill in Gopeshwar were unsuccessful since these were bottomed on the rubble and boulders at shallow depths (~ 1 m), which form a part of the debris. In one of these trenches, a poorly defined thrust plane was detected, but its growth and overburden followed a complex pattern. Although the trench sections did not reveal fault planes convincingly, the fissures which had cut through concrete steps and well-consolidated debris could be traced for nearly 1 km. Orientation of these ground fissures, although discontinuous, conforms to the trend of the MCT and also to one of the nodal planes (282°) inferred from the focal mechanism (Figures 2 and 4). The predominance of east-west oriented fissures, particularly those developed in the well-consolidated debris, may be manifestation of a blind thrust.

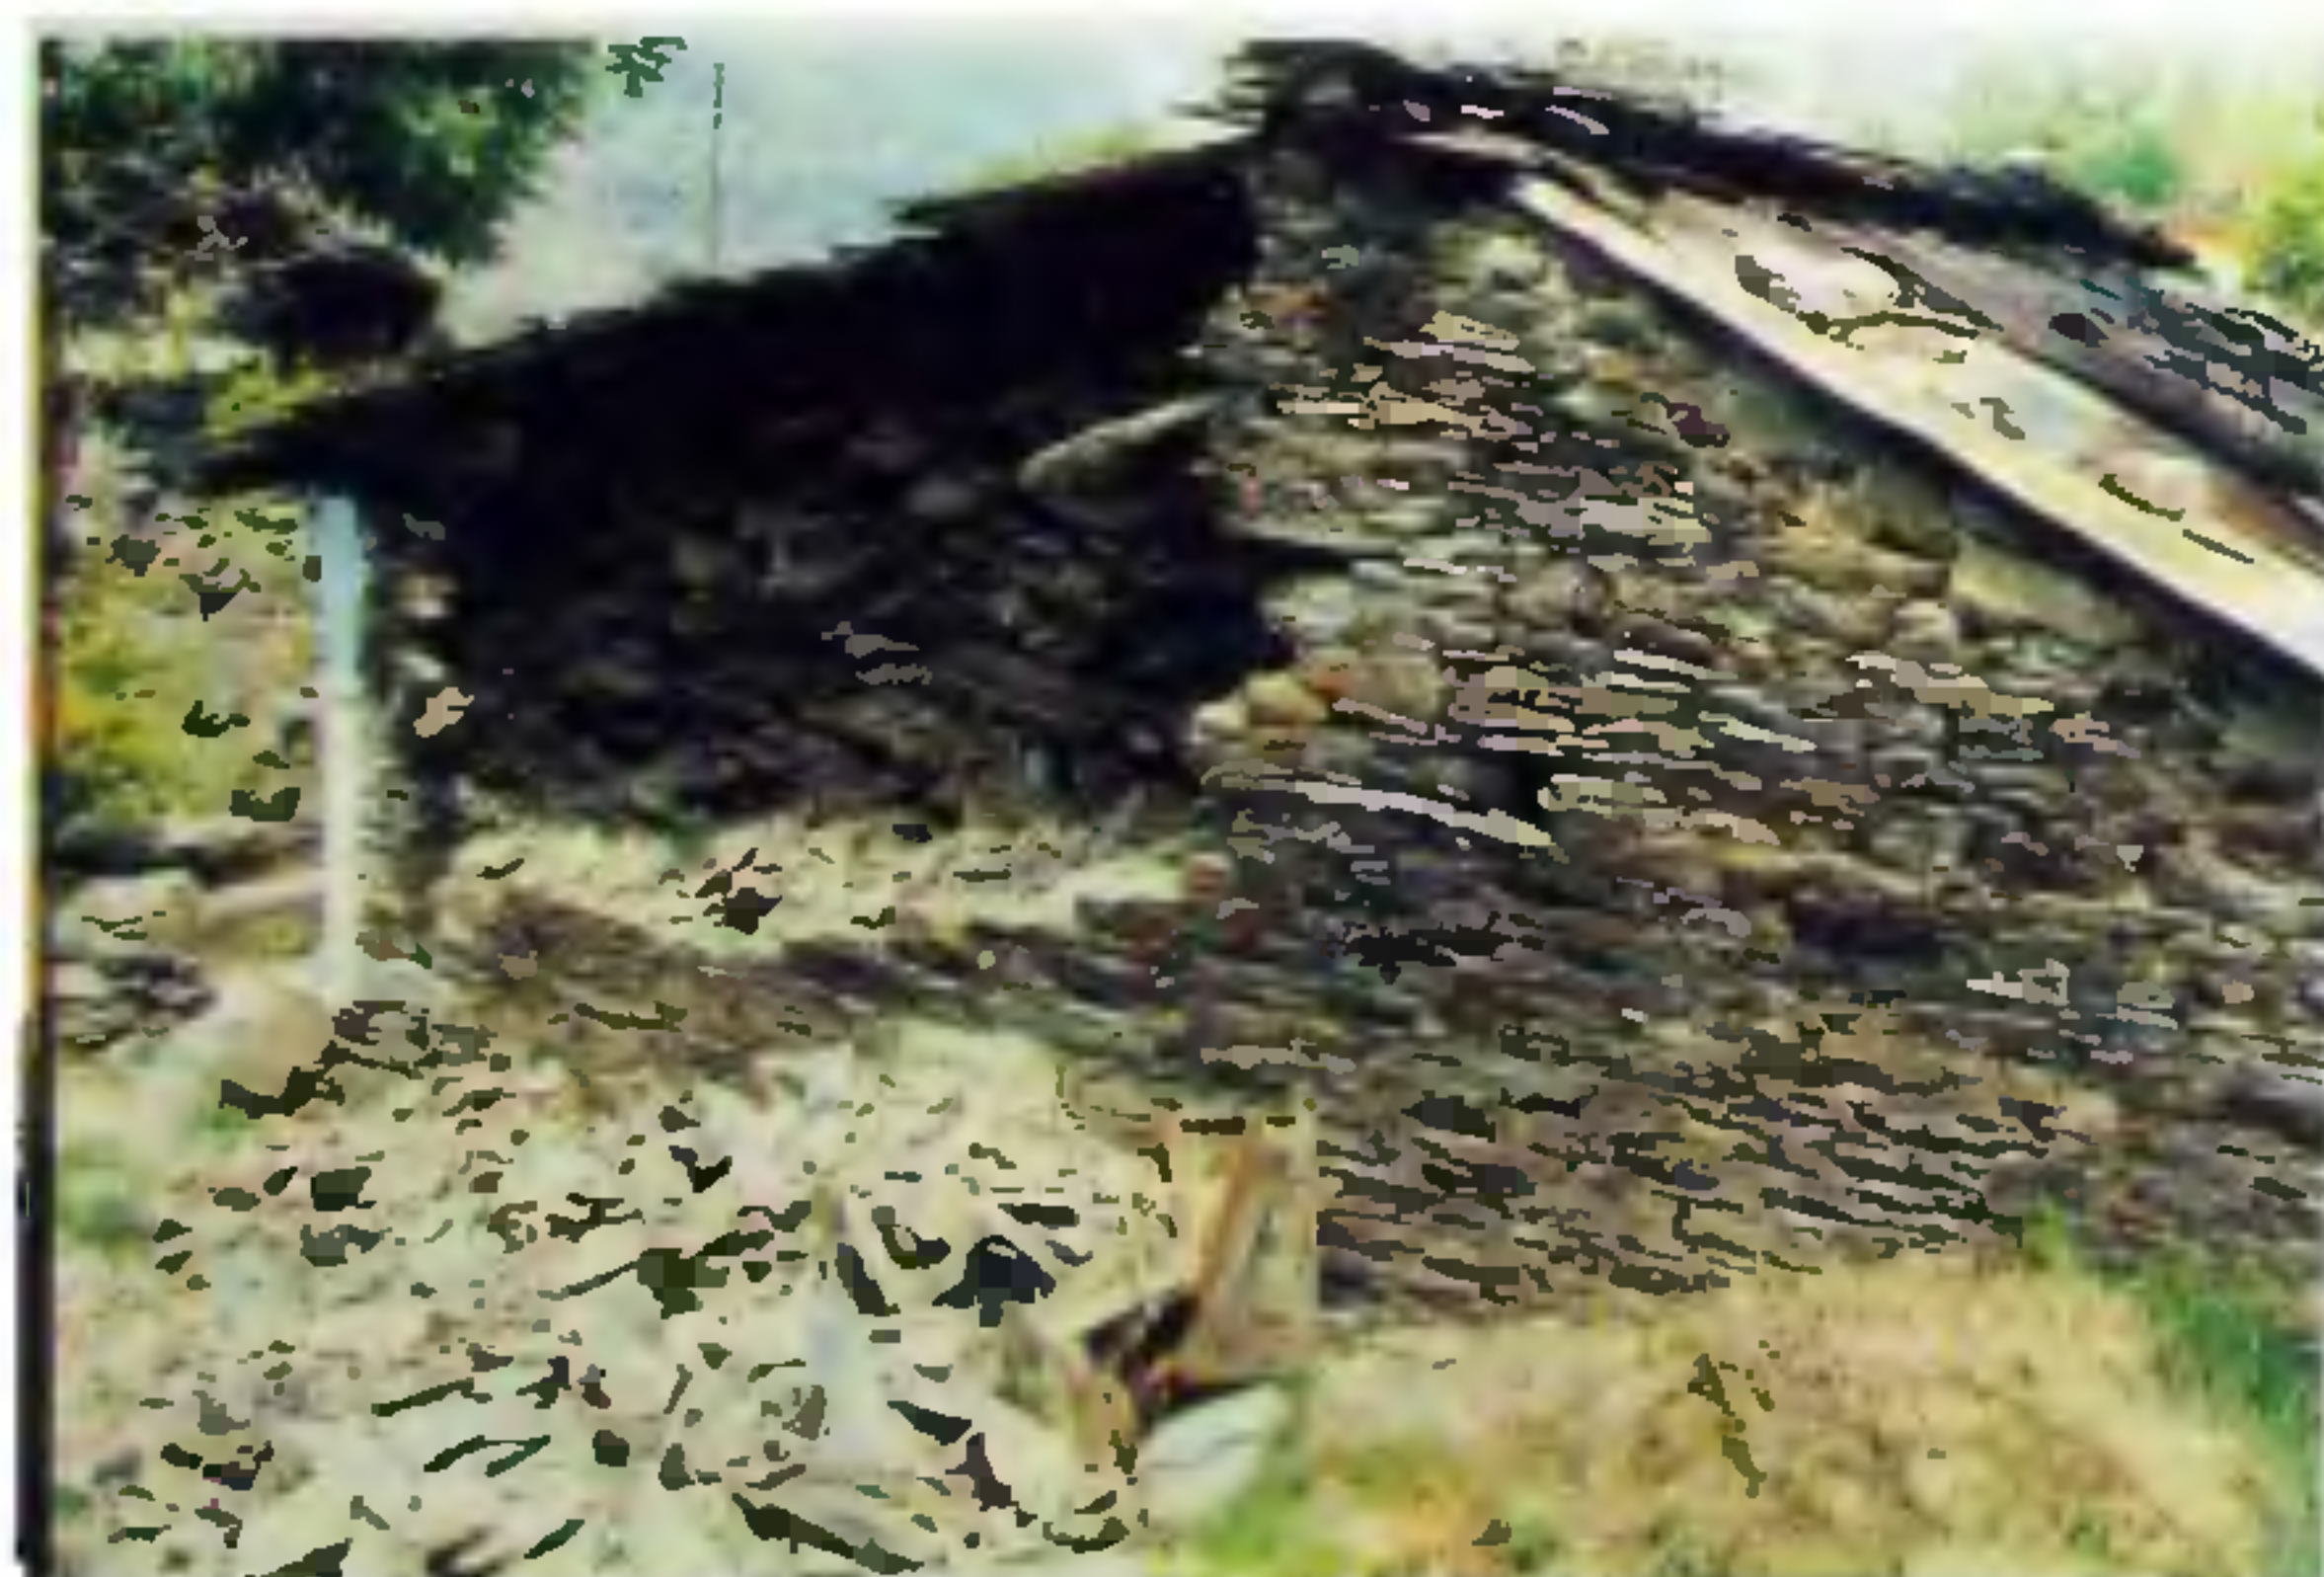
Figure 7. Collapse of one of the wythes in a traditional house in slate wafer masonry.

Houses described above performed poorly, as expected, and most deaths and injuries were caused by the collapse of such constructions. Among these types of constructions, those with masonry walls in slate wafers performed better than those in random rubble masonry, probably due to better interlocking in the latter. The most common damage pattern was the separation of wythes following which the walls tended to buckle (Figure 7).

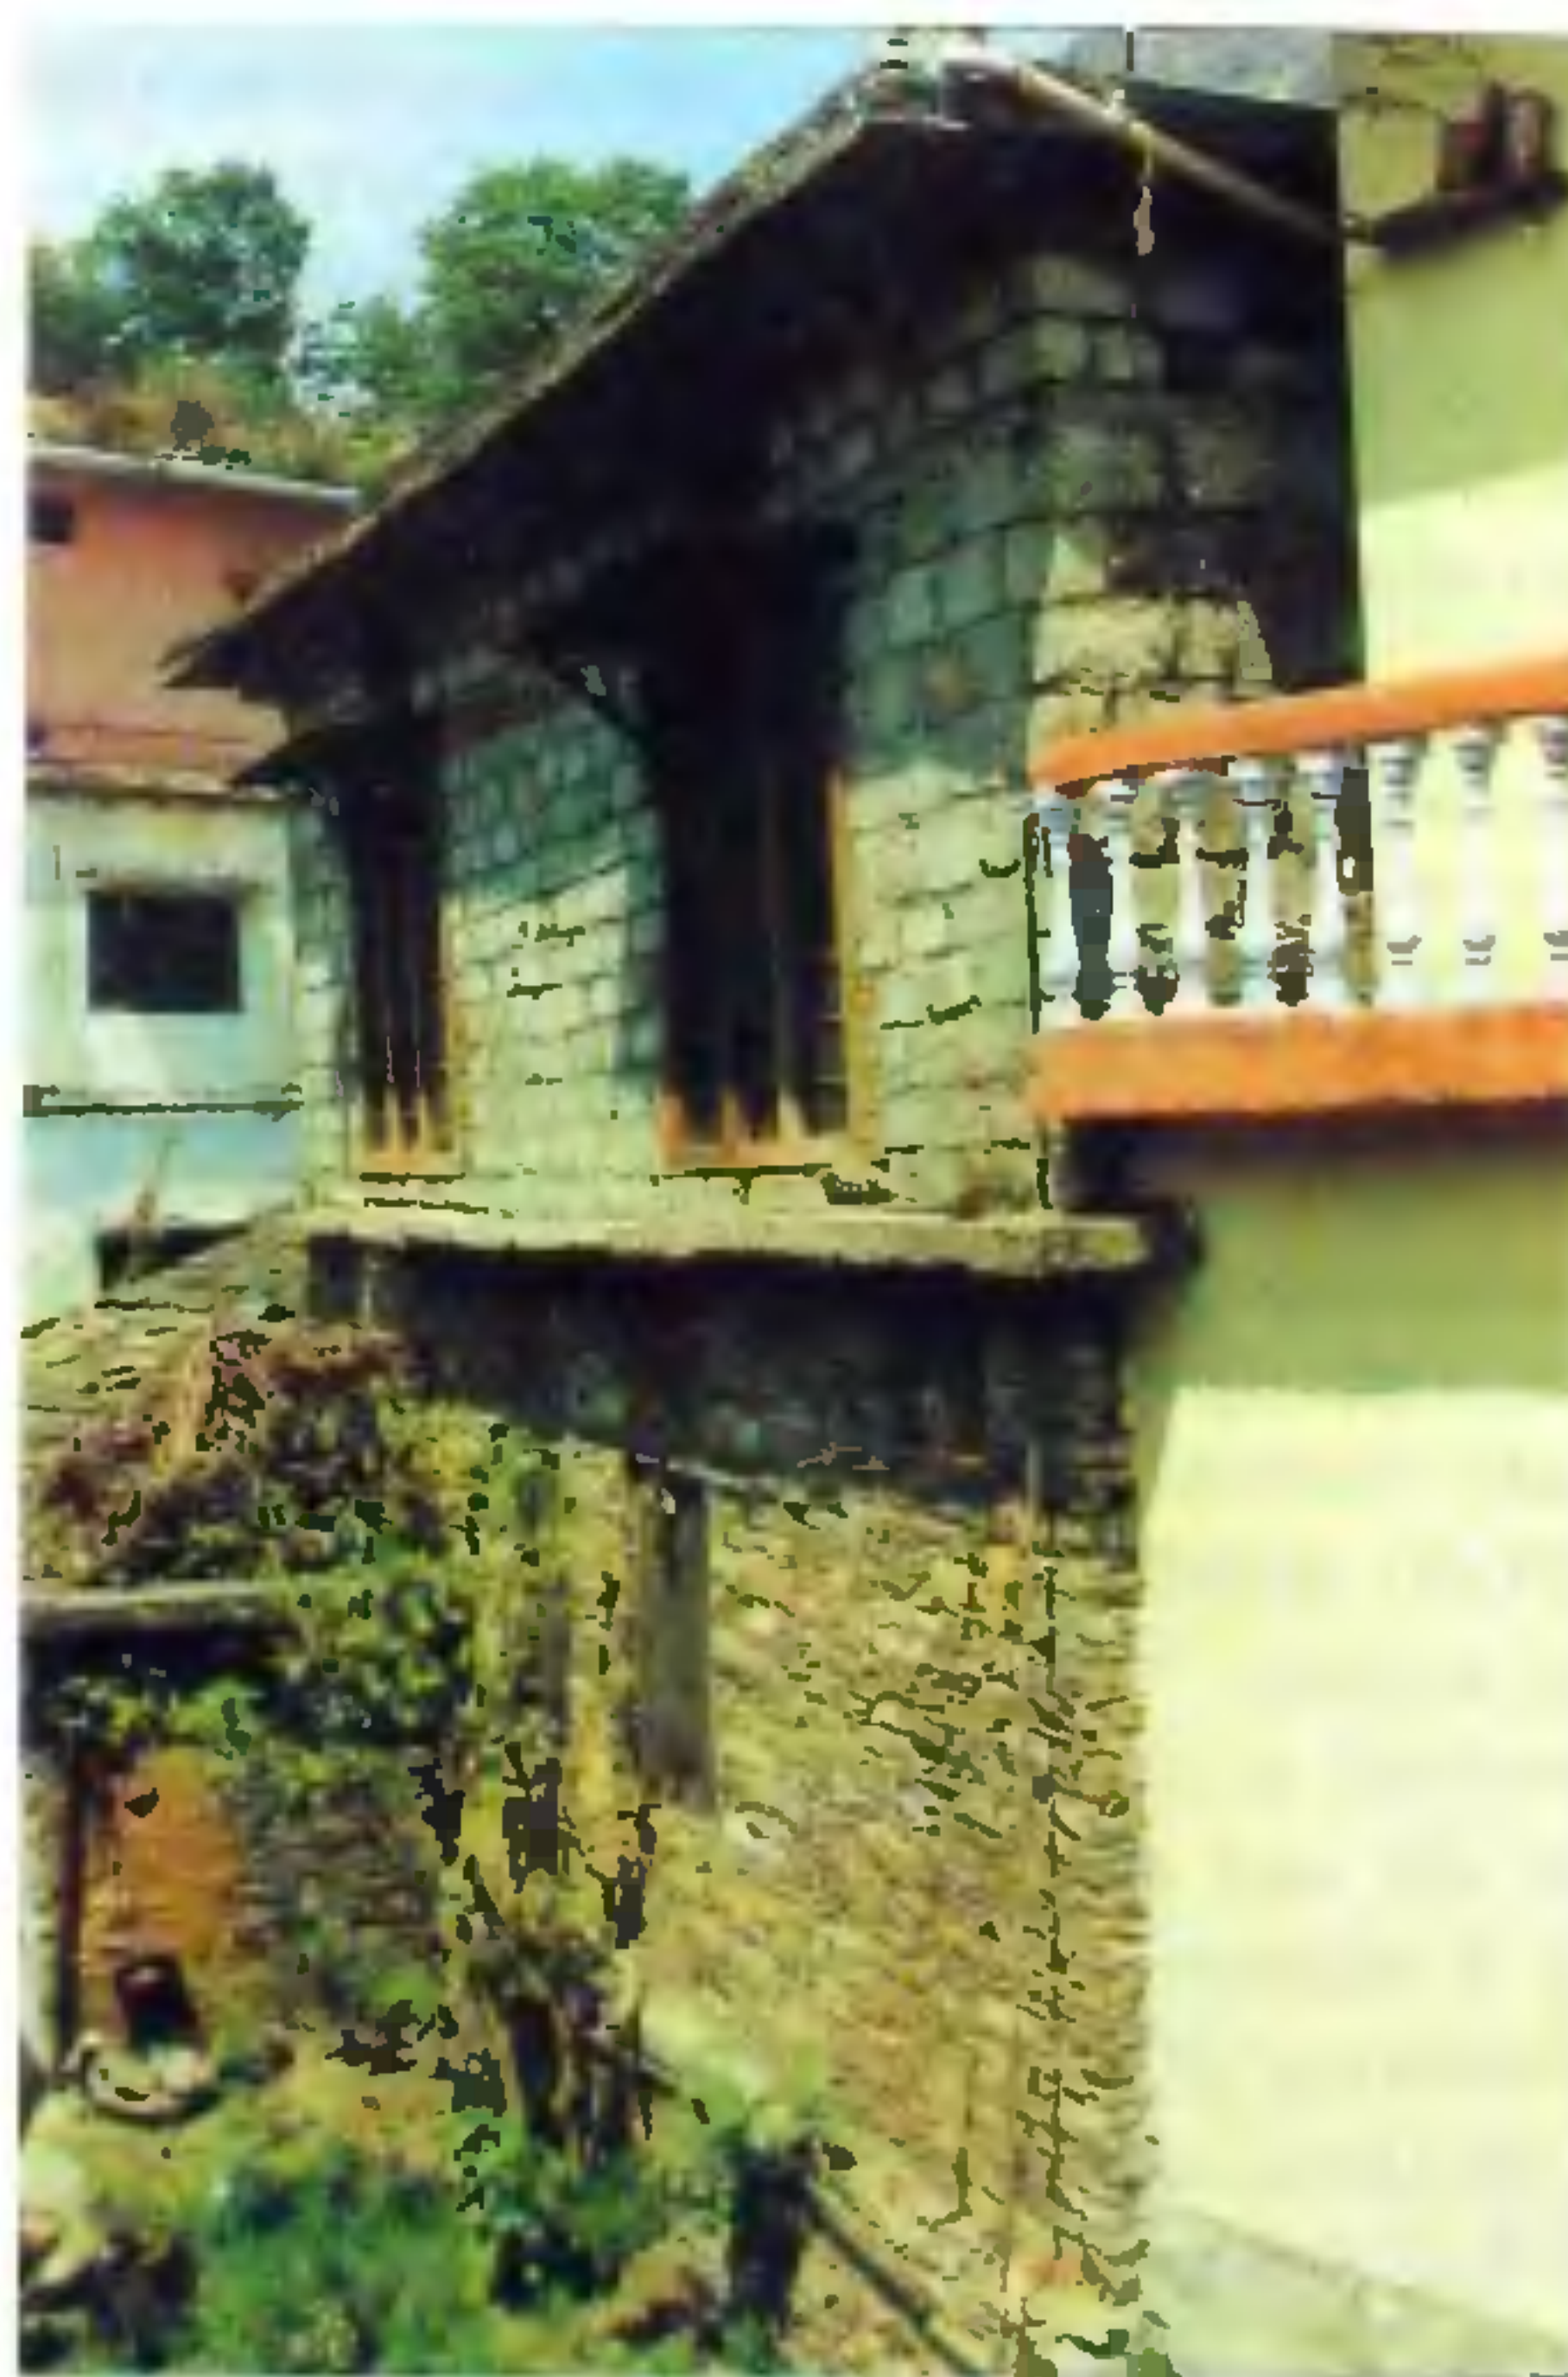
Figure 8. Two-storey house at Pipalkoti showing no damage. The ground storey is in slate wafer masonry, upper storey in concrete block masonry has been added later. Both storeys have RC lintel band.

In general, buildings with burnt brick masonry in mud or cement mortar performed much better than the traditional stone masonry buildings. Numerous recent constructions in stone as well as brick/concrete block masonry are provided with a RC lintel band. Often rooms are provided with a RC shelf of about half metre width, projecting from the wall at the lintel level, serving the dual purpose of a storage slab and a lintel band. Most houses with lintel bands performed very well (Figure 8).
