Field investigation of the 30 September 1993 earthquake in Maharashtra

R. N. Iyengar*, C. S. Manohar and O. R. Jaiswal

Department of Civil Engineering, Indian Institute of Science, Bangalore 560 012, India

An engineering field study of the 30 September Marathwada earthquake is reported. The study covered Osmanabad, Latur, Sholapur, Bijapur, Gulbarga and Bidar districts. The level of ground acceleration was estimated based on tilting of free standing objects. The study shows that the epicentral intensity has been VIII on the UNESCO scale. The horizontal ground acceleration near the epicentre has been estimated to be about 0.2 g.

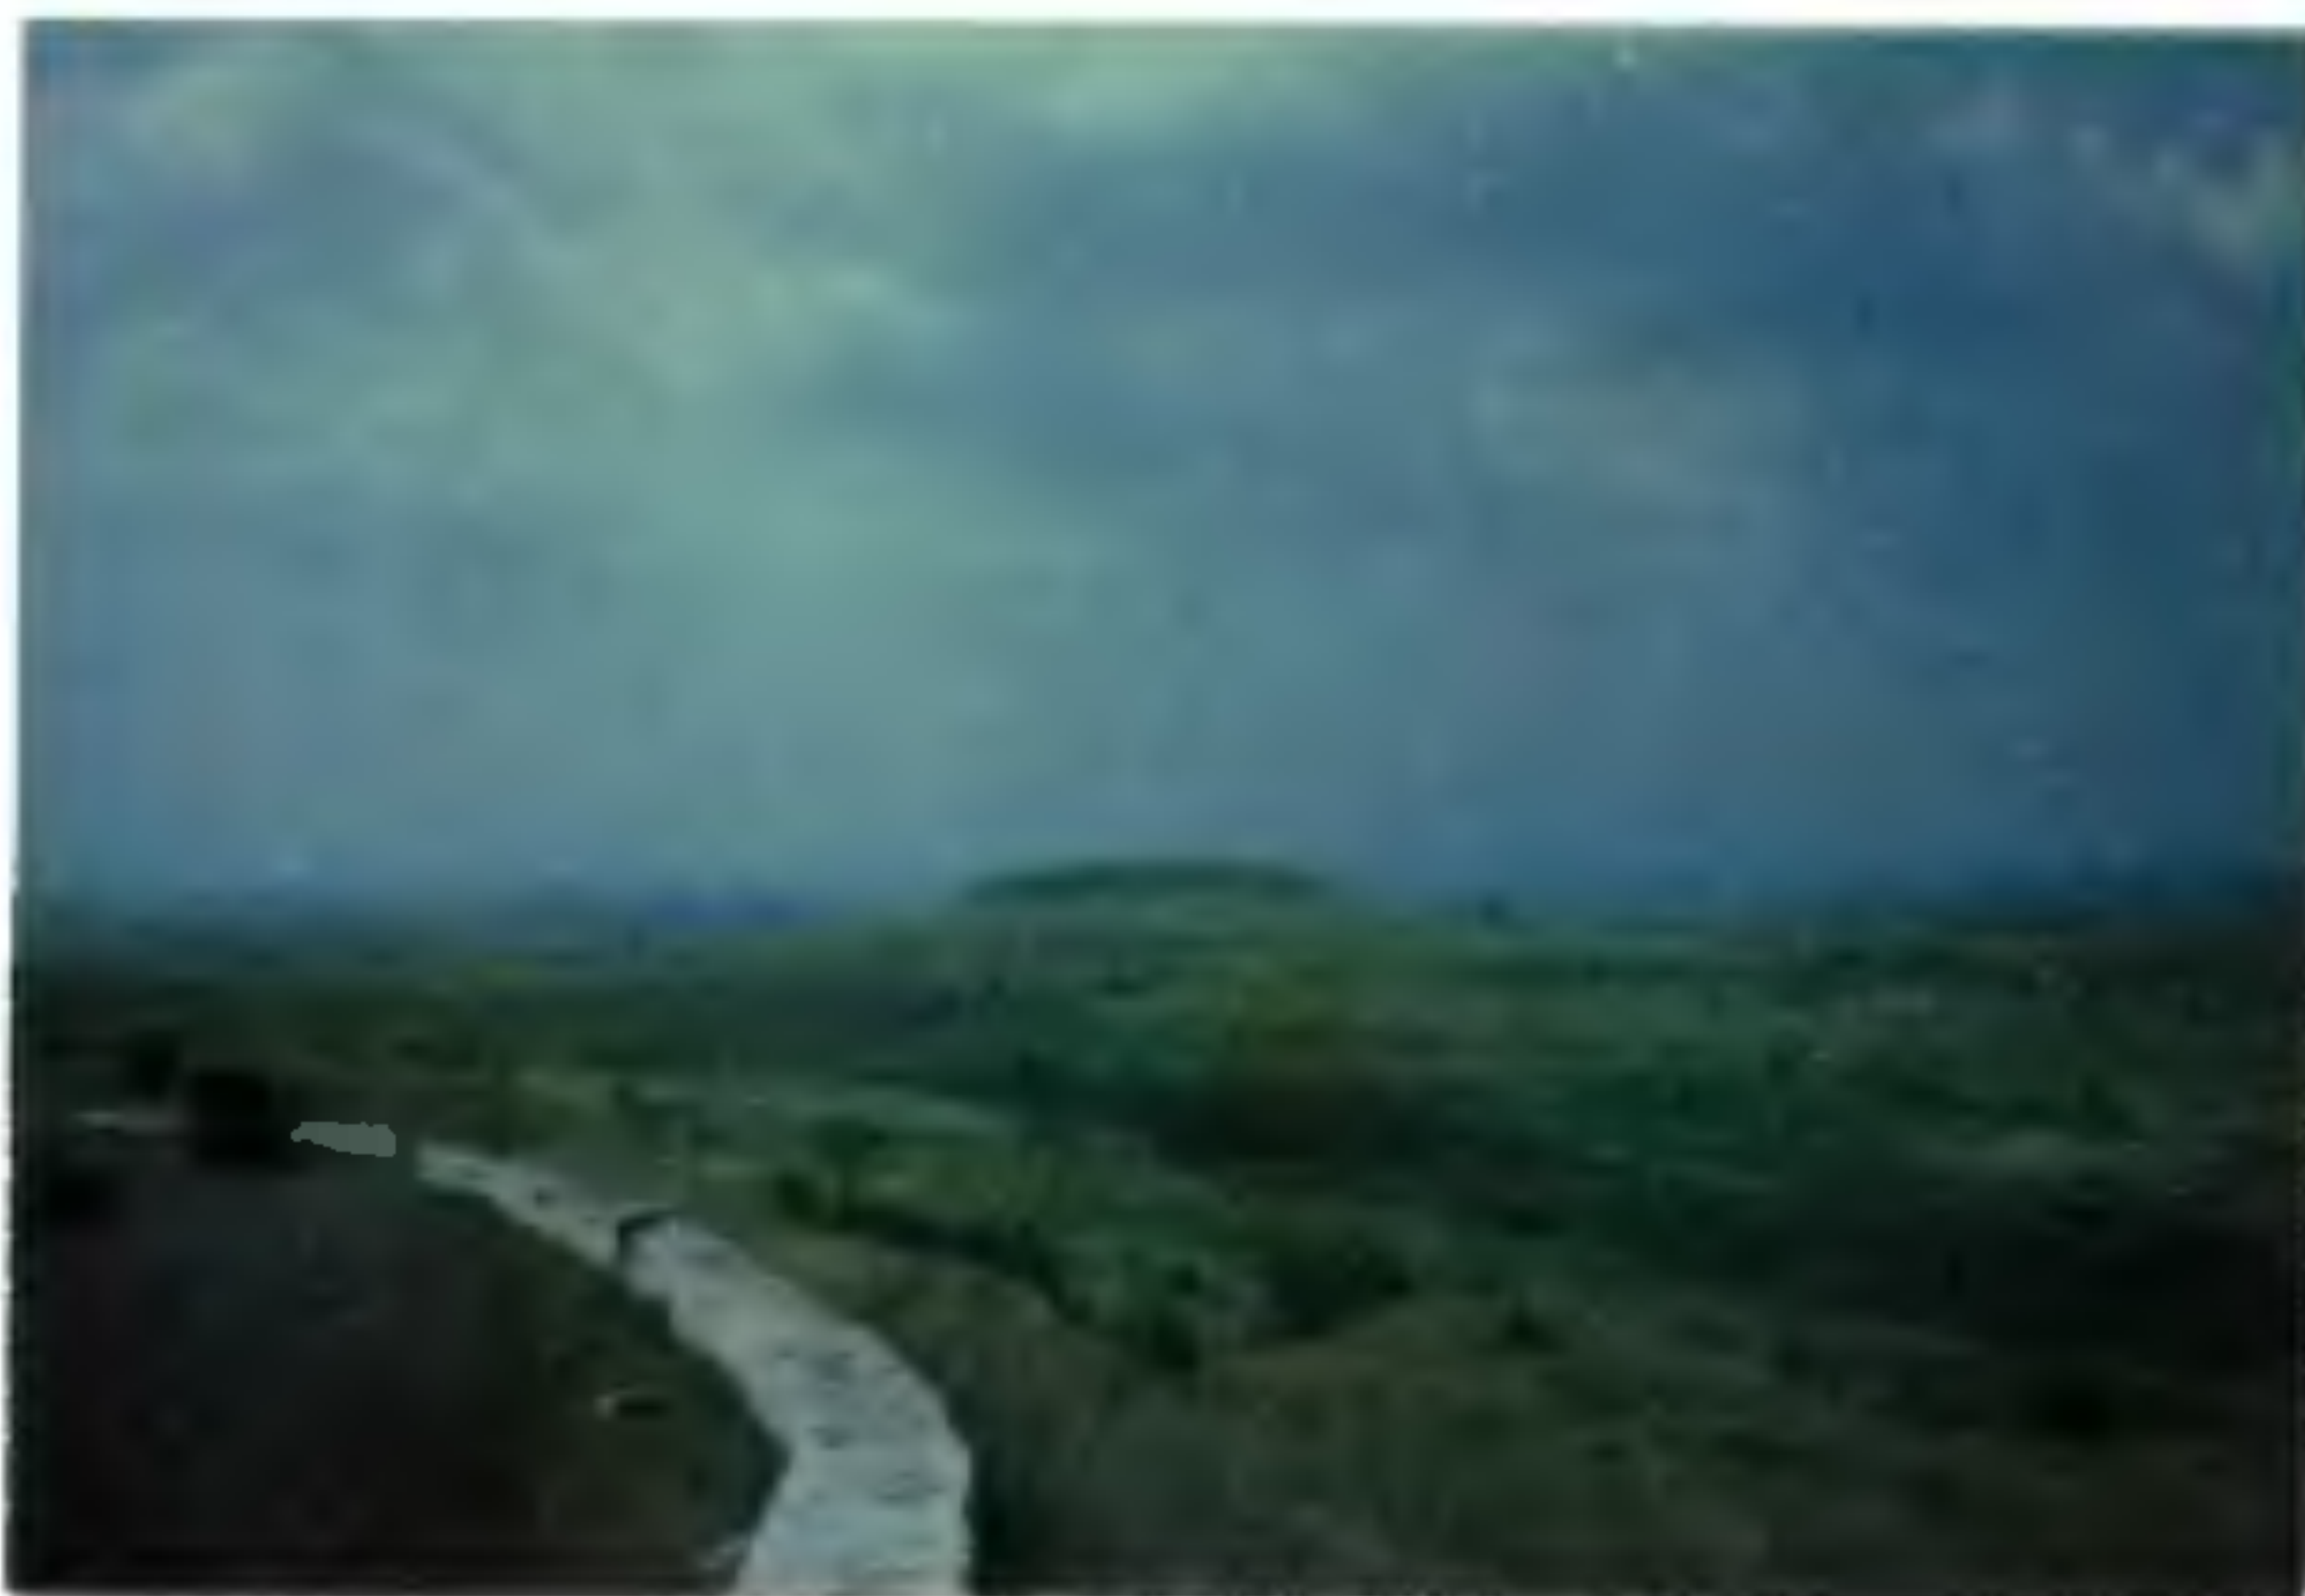
The topography of the region affected by the earthquake may be described as being mildly undulating. A view of the region as seen from an elevated site on the Gulbarga-Bidar highway is shown in Figure 2. The landscape is punctuated with many flat topped mounds interspersed with plain lands of black cotton soil and gentle valleys in which flow the rivers Terna, Bheema and Manjra. The predominant local building material in the rural areas is the freely available trap stone from the mounds (Figure 3).

Figure 2. Terrain view.

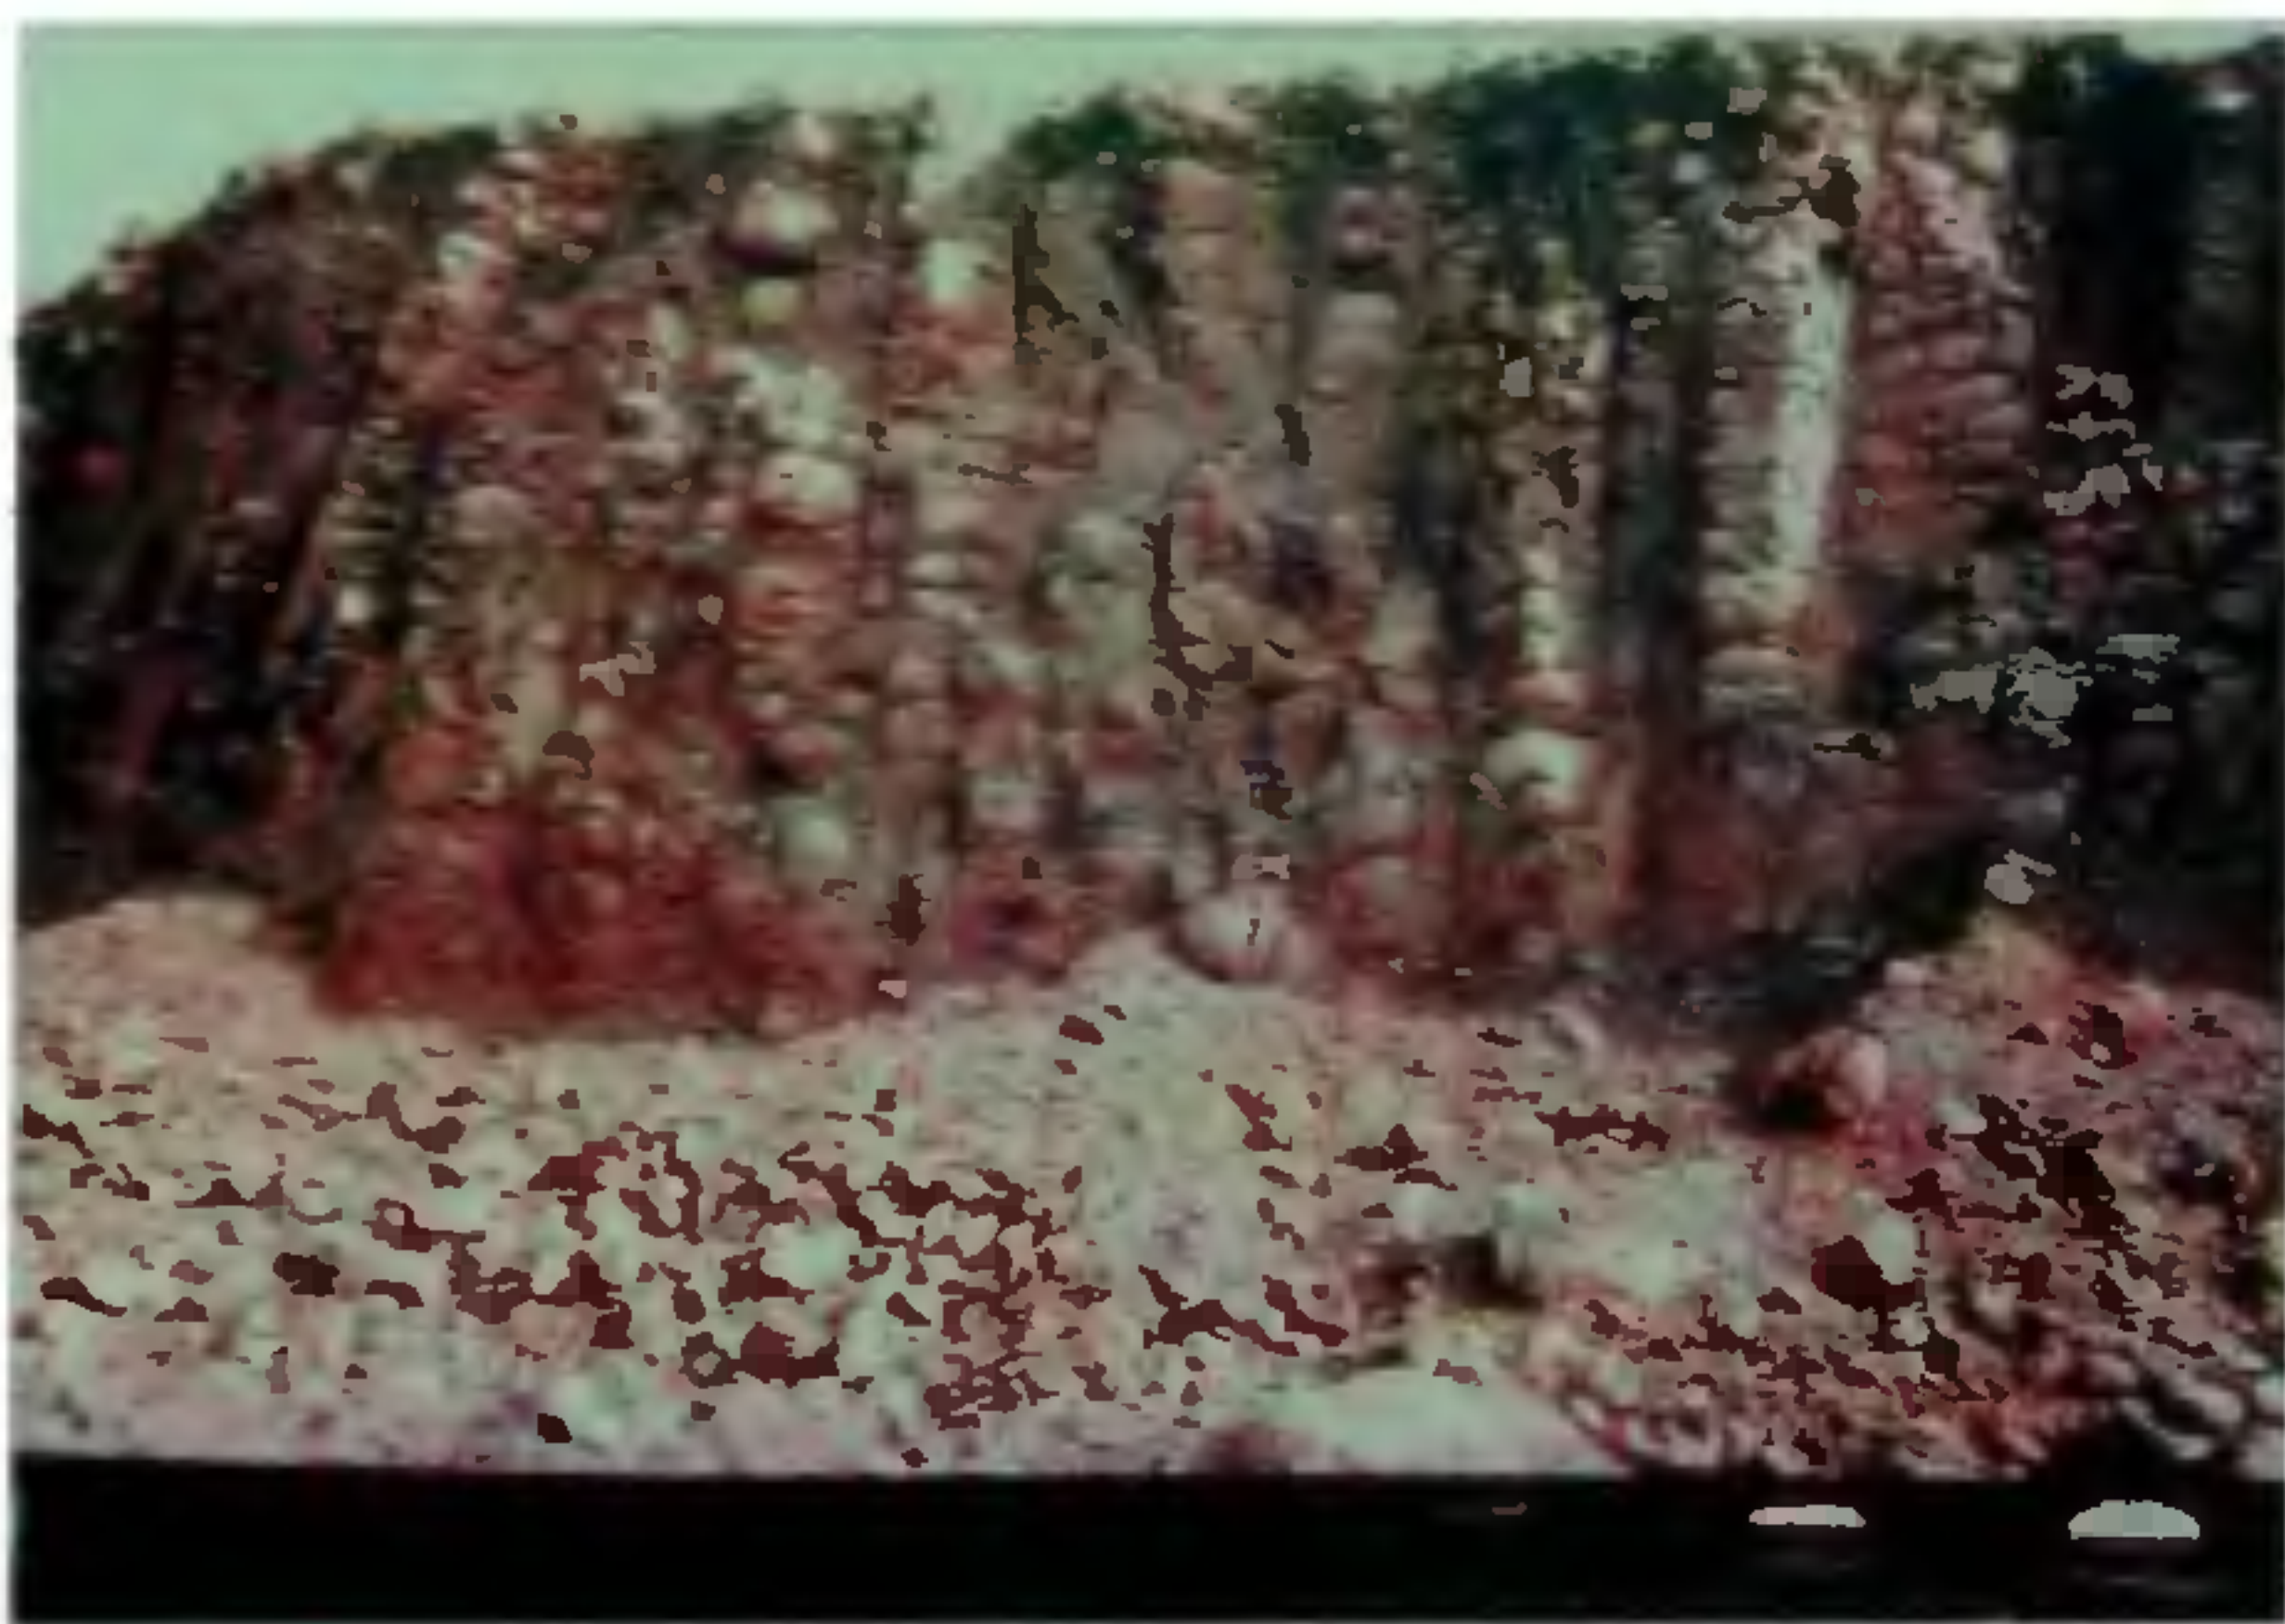
Figure 3. Soil section of a mound.

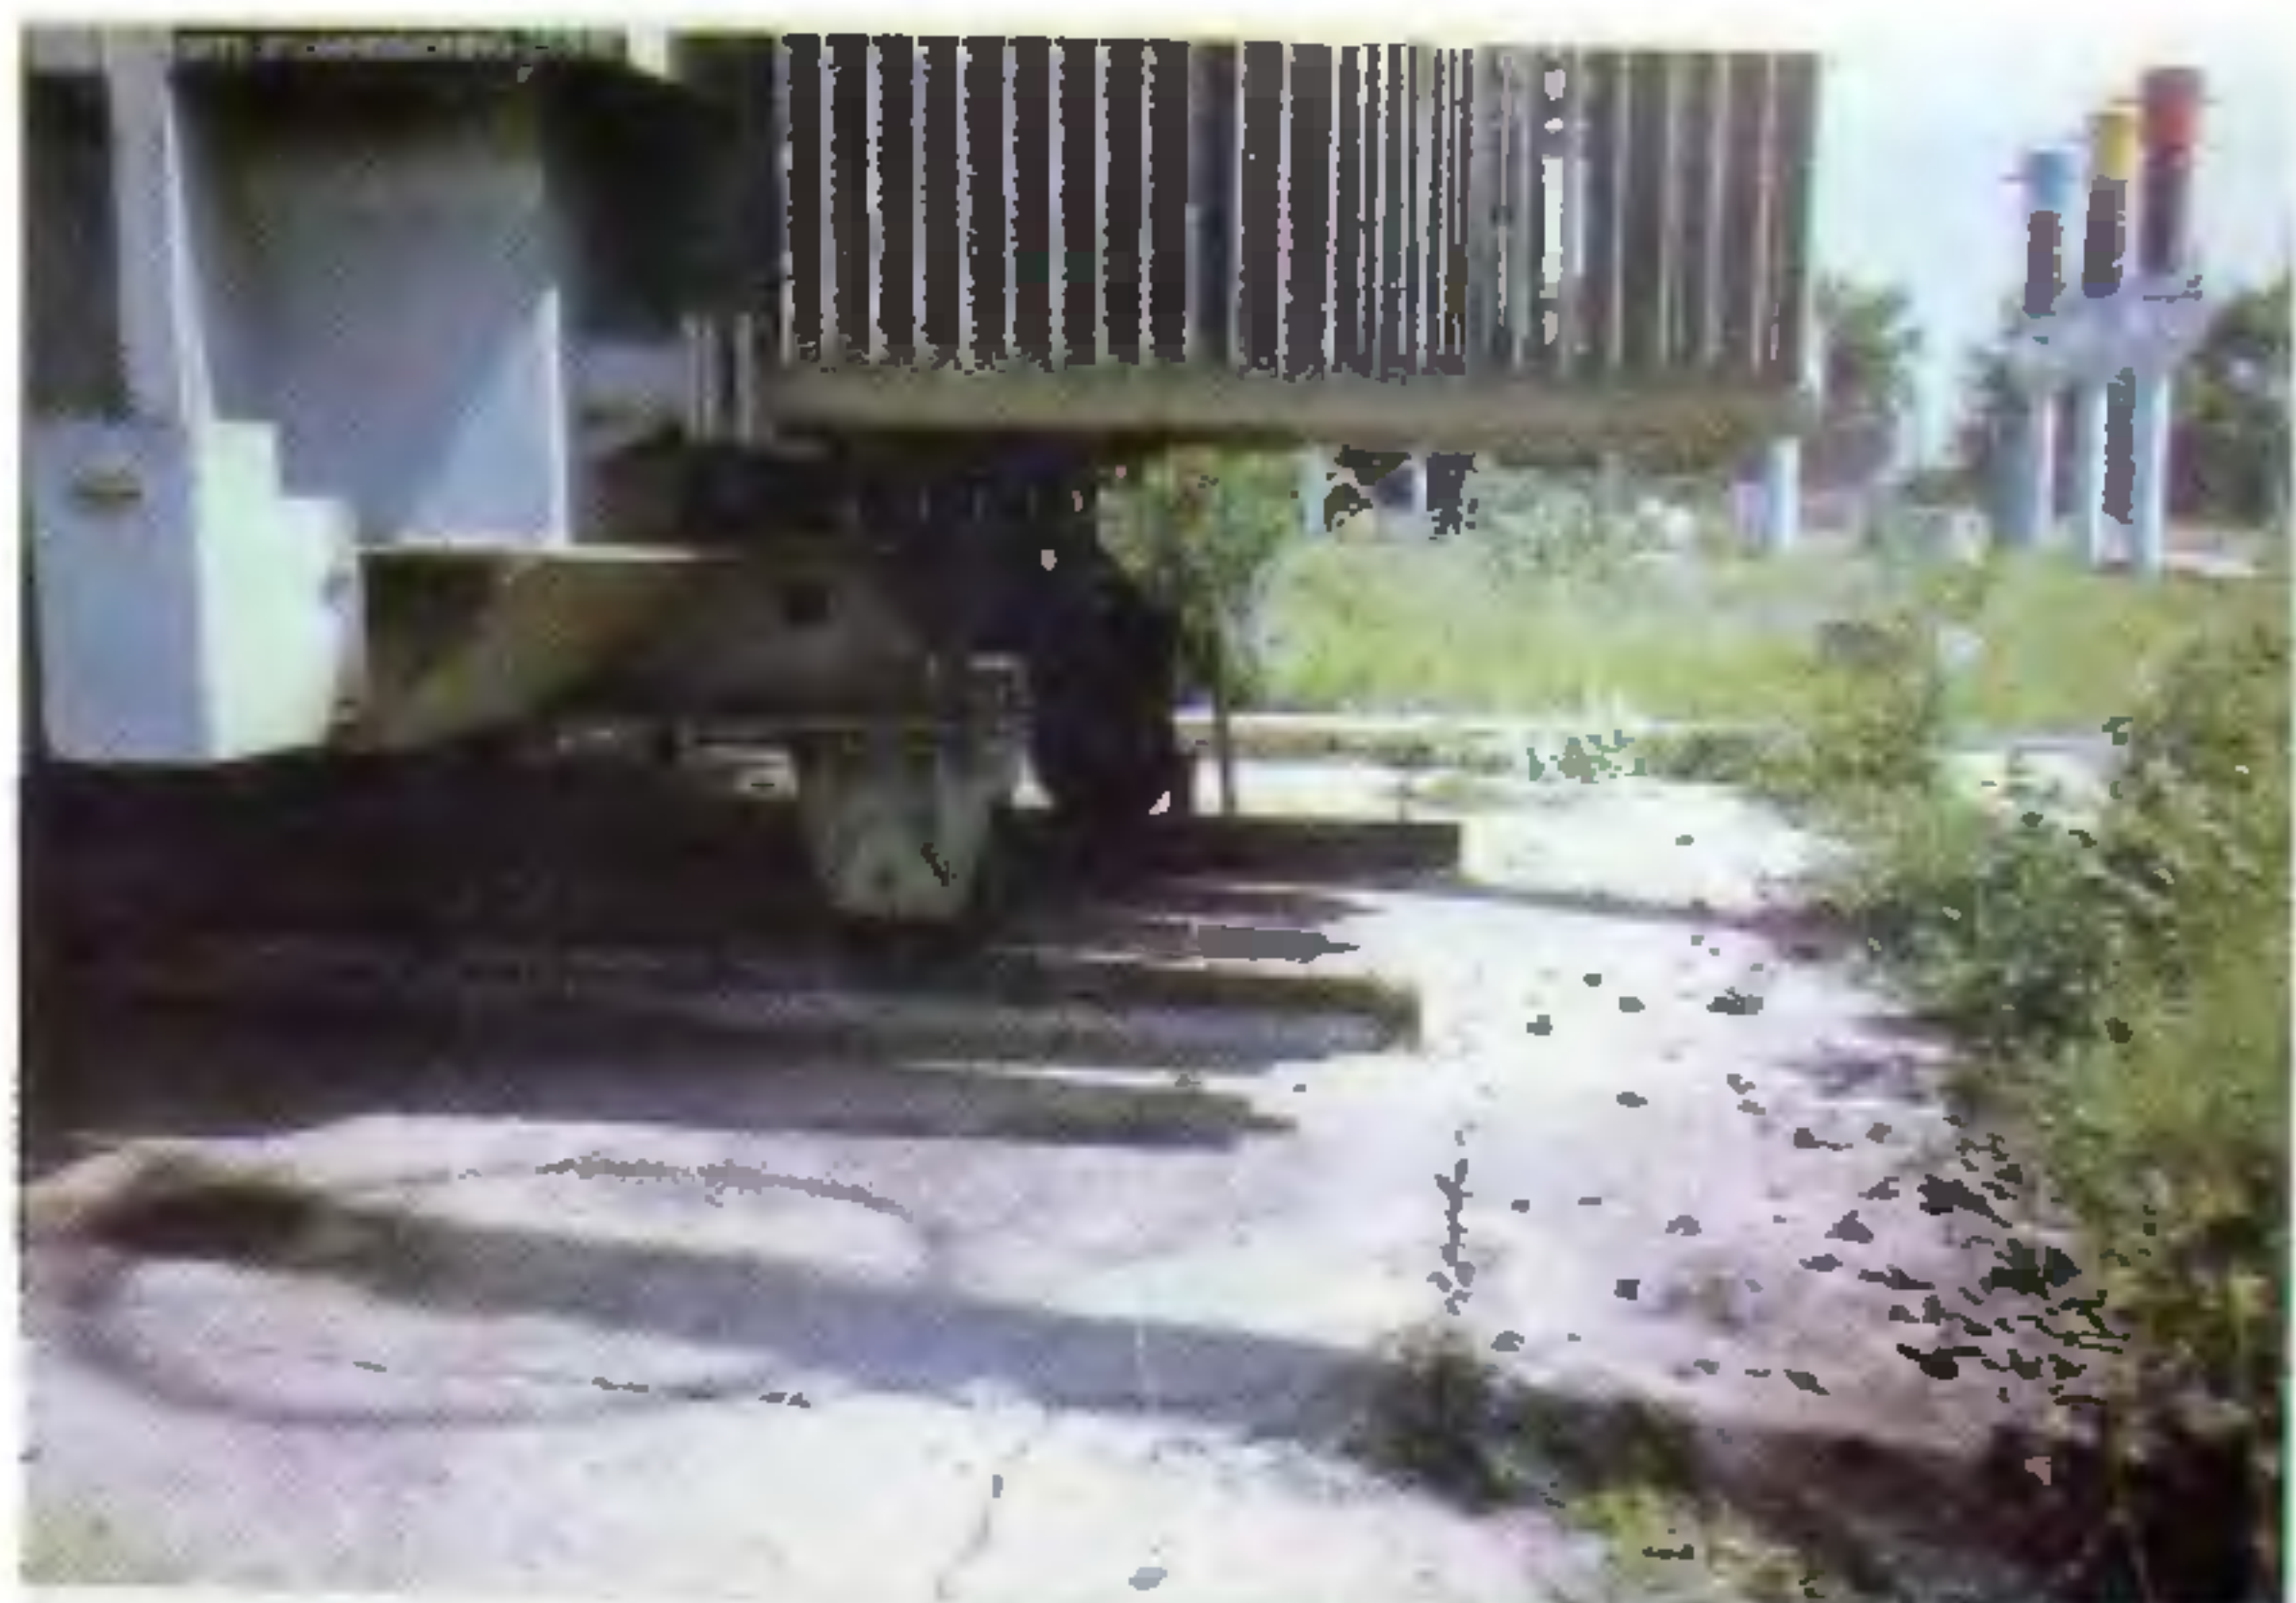
Figure 21. MSEB substation at Umerga.

By and large, there was no significant damage to industrial plants in the epicentral region. However, minor damage to brick chimneys and machine foundation bolts was observed in the khandsari factories near Basavakalyan and Humnabad. Signs of land settlement leading to structural damage were observed in the 132 kV electric substation in Umerga. Here, the ground floor within a RC frame structure had subsided by about 2 cm over an area of 5 square meters. In the same place, the foundation slab of a transformer had also cracked due to ground subsidence (Figure 21). Damage to RC columns supporting the insulators can be seen in Figure 22. In the 33 kV electric substation in the epicentral village of Sastur, RC structures suffered considerable damage. In addition, the contact plates in the isolators were broken and also bolts at the joints reportedly came out. In the epicentral region, the electric poles, transmission and communication towers were largely unaffected. At a few places, however, I-section steel poles were seen

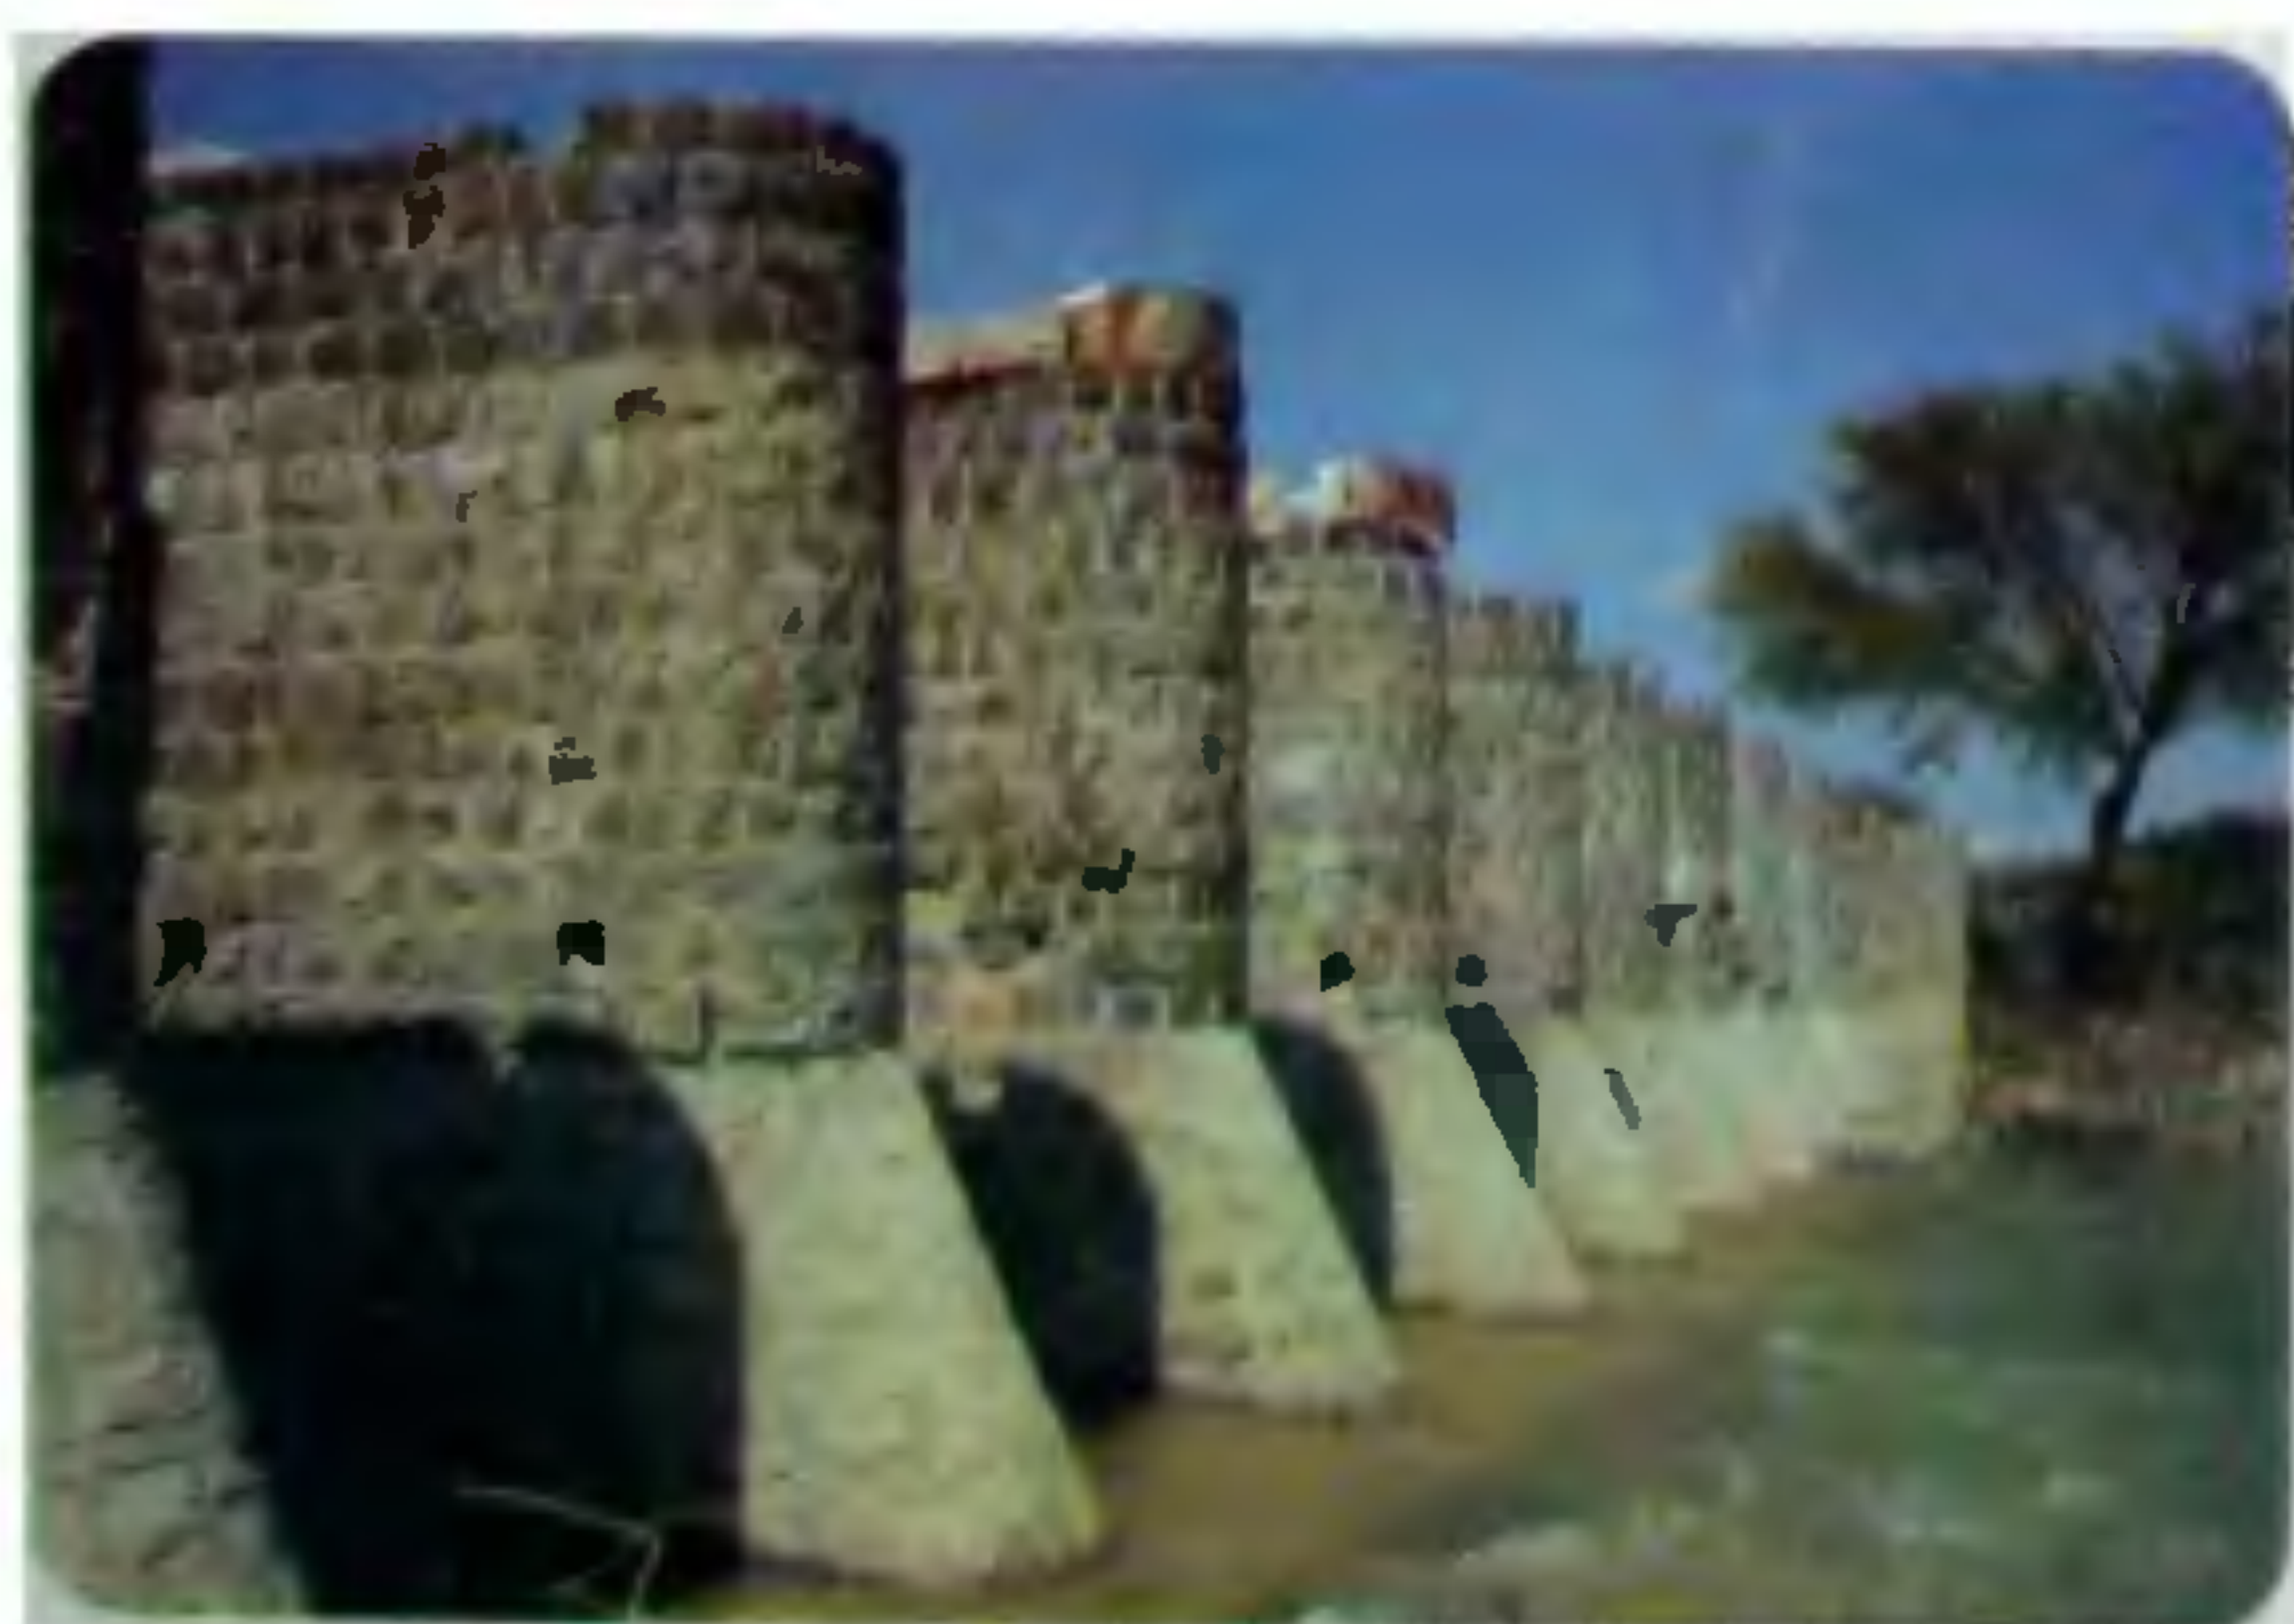
Figure 20. Hydraulic control structure near Rajegaon.

Cracks were observed at the abutments of a few bridges on the national highway between Humnabad and Umerga. The central pier of the Rudrawadi culvert near Aland, about 55 km away from Khilari was considerably damaged (Figure 19). Several culverts and parapets of small bridges in the epicentral region have also suffered damage. Near Khilari, cement concrete pipes of small culverts were damaged. The piers of a stone masonry hydraulic control structure, which was under construction near Rajegaon, have extensively cracked at about mid-height (Figure 20). The RC pads on the top of some of the piers have also cracked exposing the reinforcement at a few places. About 50 km away from the epicentre, RC aqueducts of the Upper Mullamari irrigation works near Hallikhed-K have cracked leaving open the steel at a few places. Some minor distress was also observed at aqueduct canal junctions.
