# **Subsidence-Induced Damage Assessment of Buildings on Joshimath Hills**

Ajay Chourasia<sup>1\*</sup>, Mickey Mecon Dalbehera,<sup>2</sup> Ashish Kapoor<sup>3</sup>, Kishor S. Kulkarni<sup>2</sup>, Govind Gaurav<sup>3</sup>, Satyavrat Singh<sup>4</sup> and R Pradeep Kumar<sup>5</sup>

<sup>1</sup>Chief Scientist, <sup>2</sup>Senior Scientist, <sup>3</sup>Scientist, <sup>4</sup>Project Fellow, <sup>5</sup>Director,  
CSIR-Central Building Research Institute, Roorkee, India – 247667

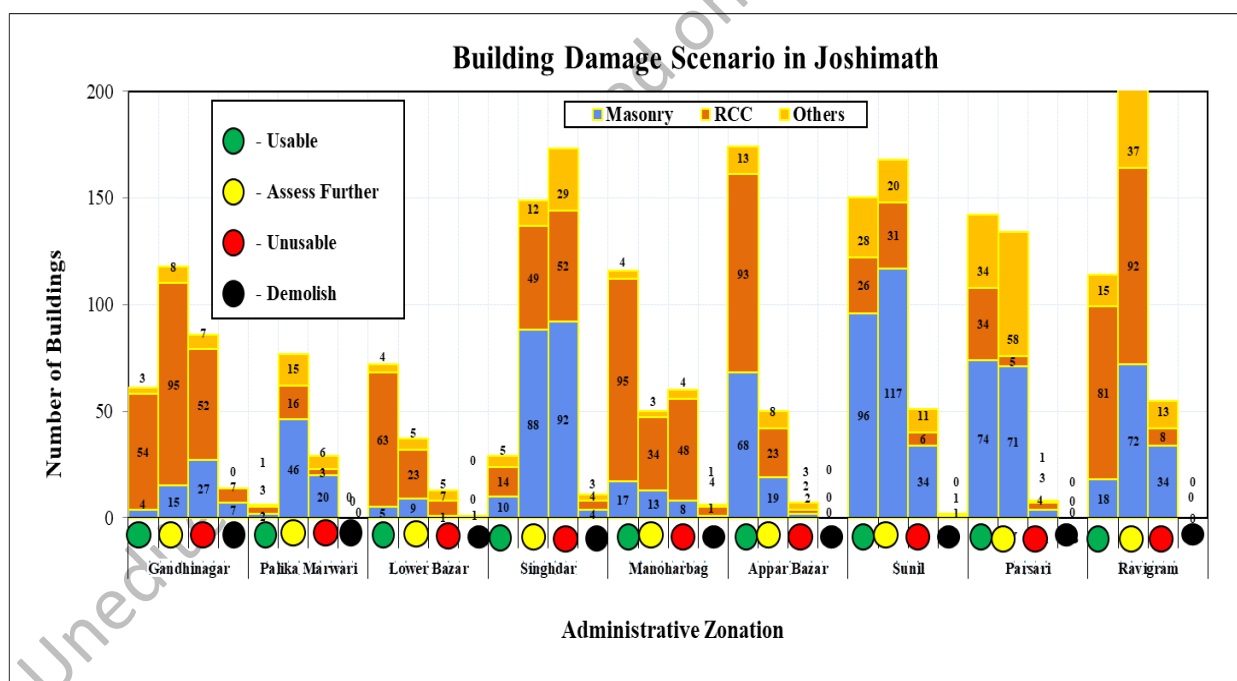
**Fig. 11: Building Damage Scenario in Joshimath**

The various damaged states of the buildings as per various administrative zones are shown in Fig.11. Also, the administrative zone-wise distribution of the damaged state of the buildings is presented in Fig.12, highlighting about 37% of the total buildings are under 'Usable', 42% of the total building's needs "Further Assessment", 20% of the total buildings are "Unusable" and 1% of the total building's needs "To be demolished".

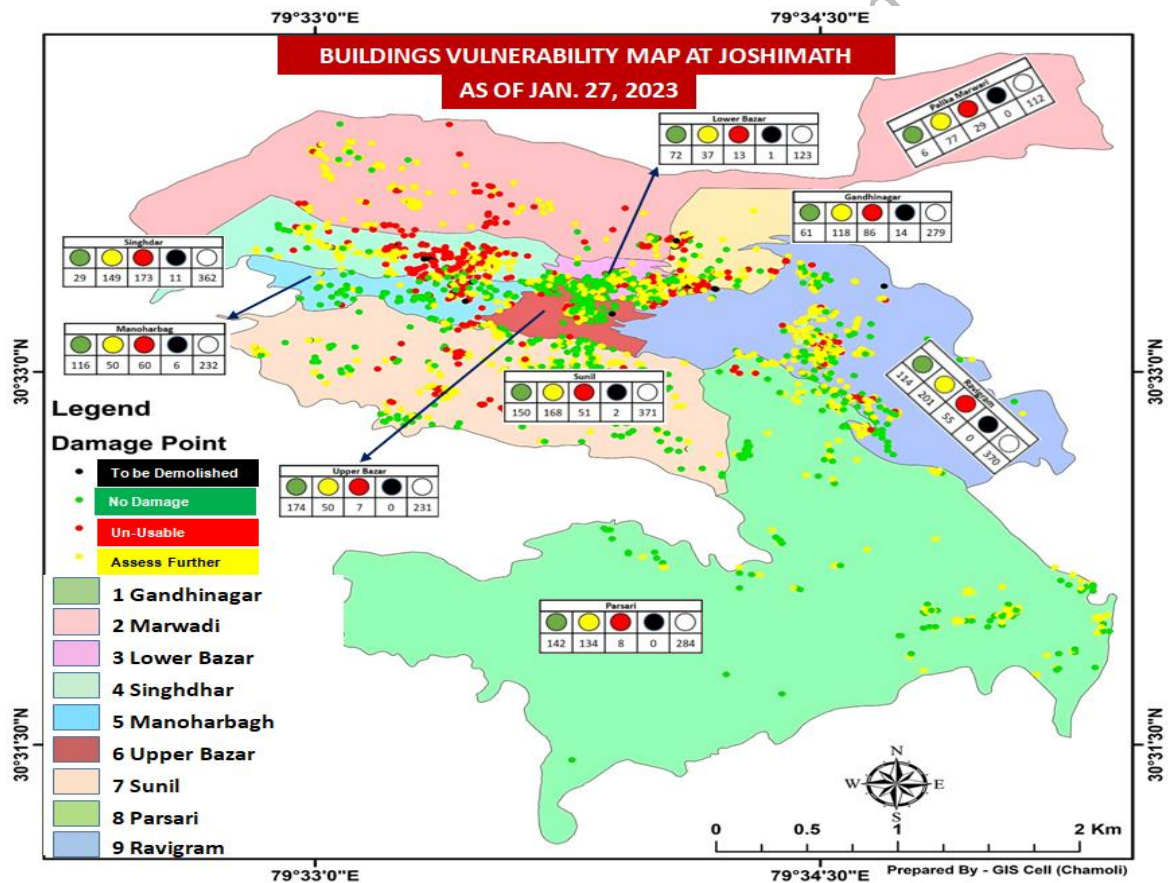
Fig. 13. Buildings Vulnerability Map for Joshimath

As a whole, these aspects are closely influencing the vulnerability of buildings in the region and point towards the construction practices implemented in the region. During the survey of the region, the authors have observed around 40 fissures having widths up to 300 mm and 3-4m deep, which the local administration informed, that have formed in January 2023, wherein most of the surrounding buildings were damaged. Based on the analysis and building vulnerability classification, the spatial distribution of all the buildings under different classes have been shown in Fig.13, which clearly indicates the high concentration of vulnerable buildings around the fissures-formed region.
